PPL Electric Utilities

PPL Electric Utilities Corporation
Quarterly Reliability Report
to the
Pennsylvania Public Utility Commission

November 2019

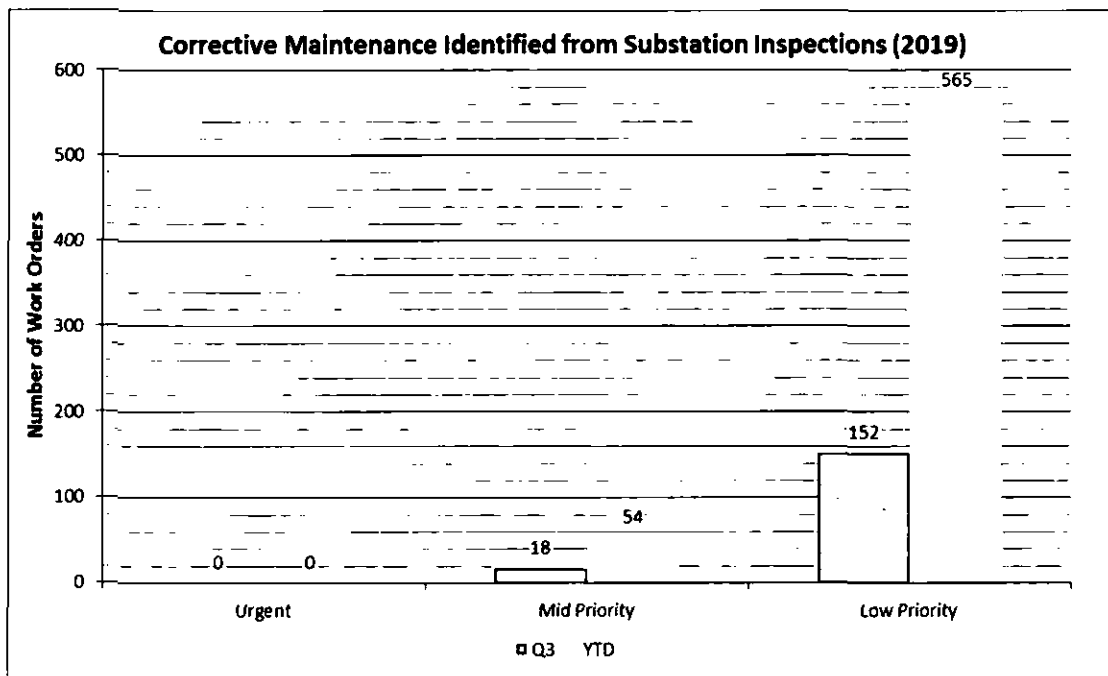
During the third quarter of 2019, 152 corrective work orders were created with the following breakdown by priority.

Figure 1: Corrective Maintenance Work Orders by Priority Level for third quarter and year-to-date 2019

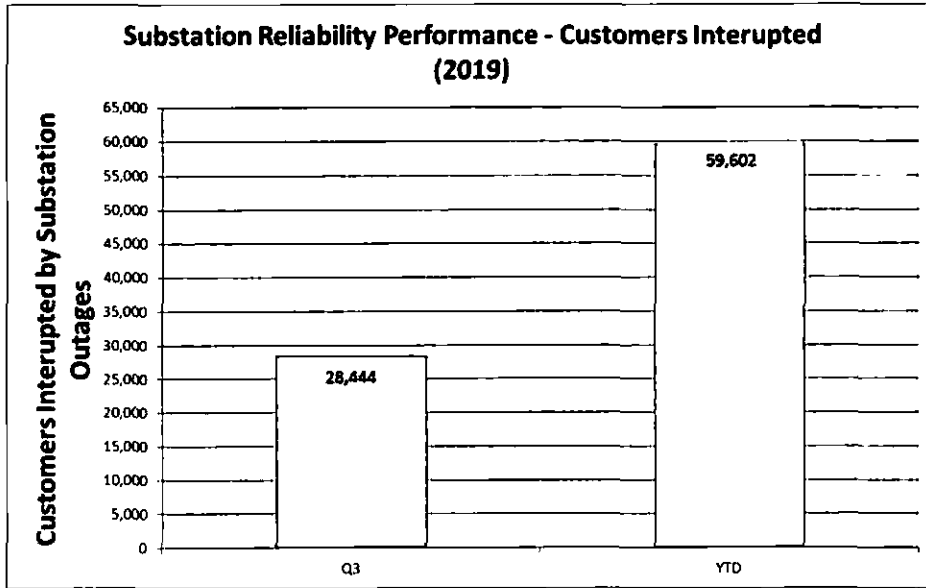
In the past three years, distribution substations have contributed a small amount toward the reliability metrics. During the third quarter of 2019, the Company interrupted about 28,000 customers for a total of approximately 412,000 CMI. The figures below show these results for the number of customers interrupted and CMI experienced, respectively.

Figure 4: Substation Customers Interrupted for third quarter and year-to-date 2019

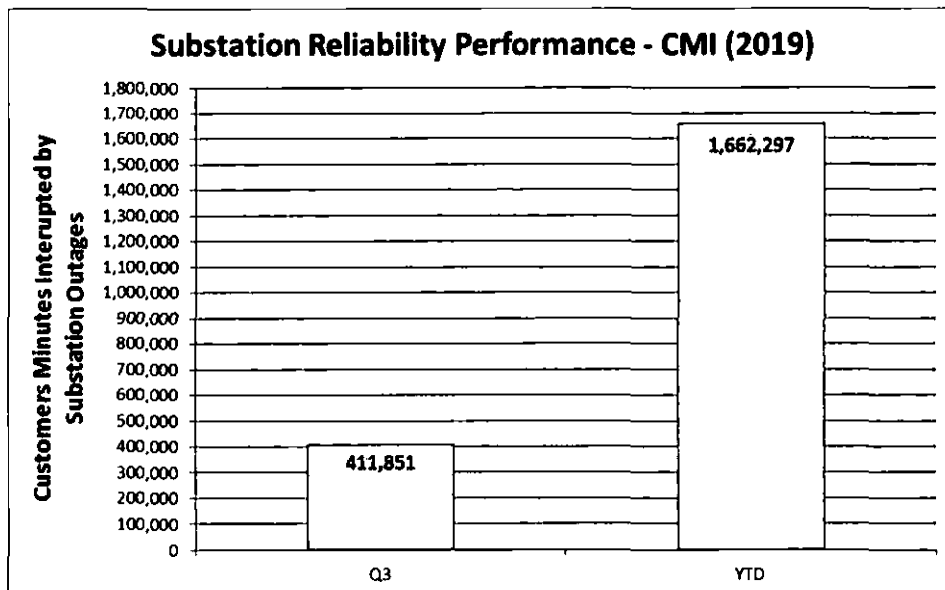
Figure 5: Substation Customer Minutes of Interruption for third quarter and year-to-date 2019

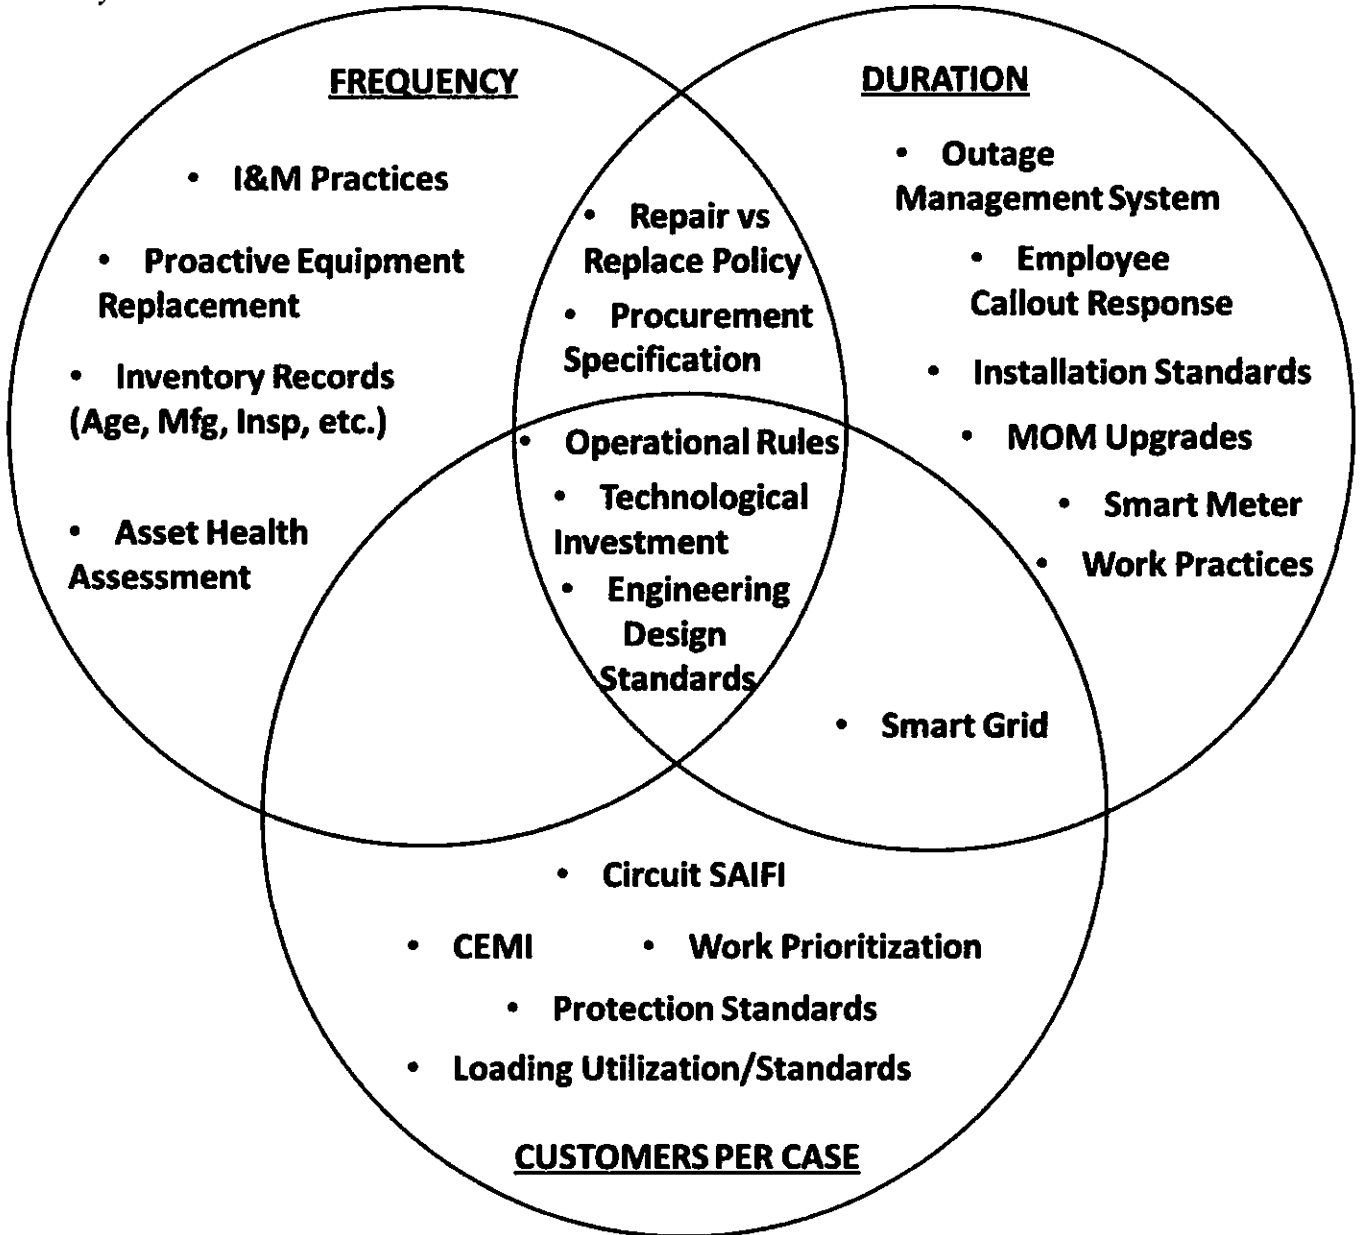
dramatically over time and geography. The manageable factors have an effect on service interruption frequency, duration, or number of customers affected, or a combination of all three. The figure below depicts a portfolio of manageable factors with inspection and maintenance (“I&M”) practices being one of many.

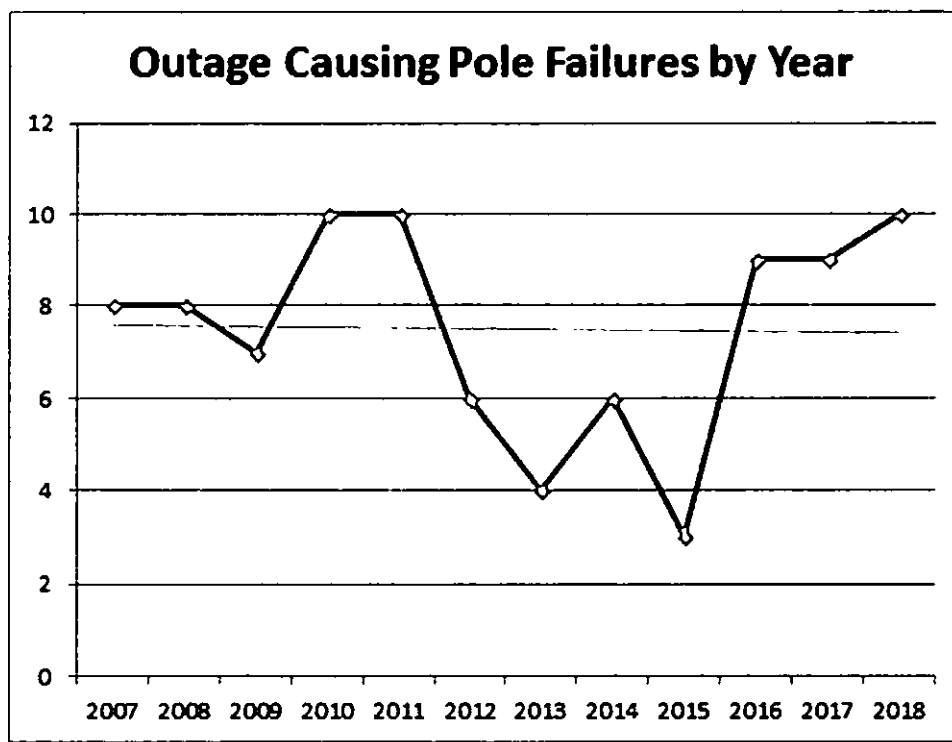
Figure 2- Outage Causing Pole Failures by Year

Additionally, PPL Electric is confident the proposed change will have minimal or no impact to reliability. As shown in Figure 2 below, during the first cycle of pole inspections, PPL Electric only saw on average seven to eight failures annually that caused an outage: this equates to a 0.001% failure rate observed. These trends are projected to continue through the second cycle of pole inspections.

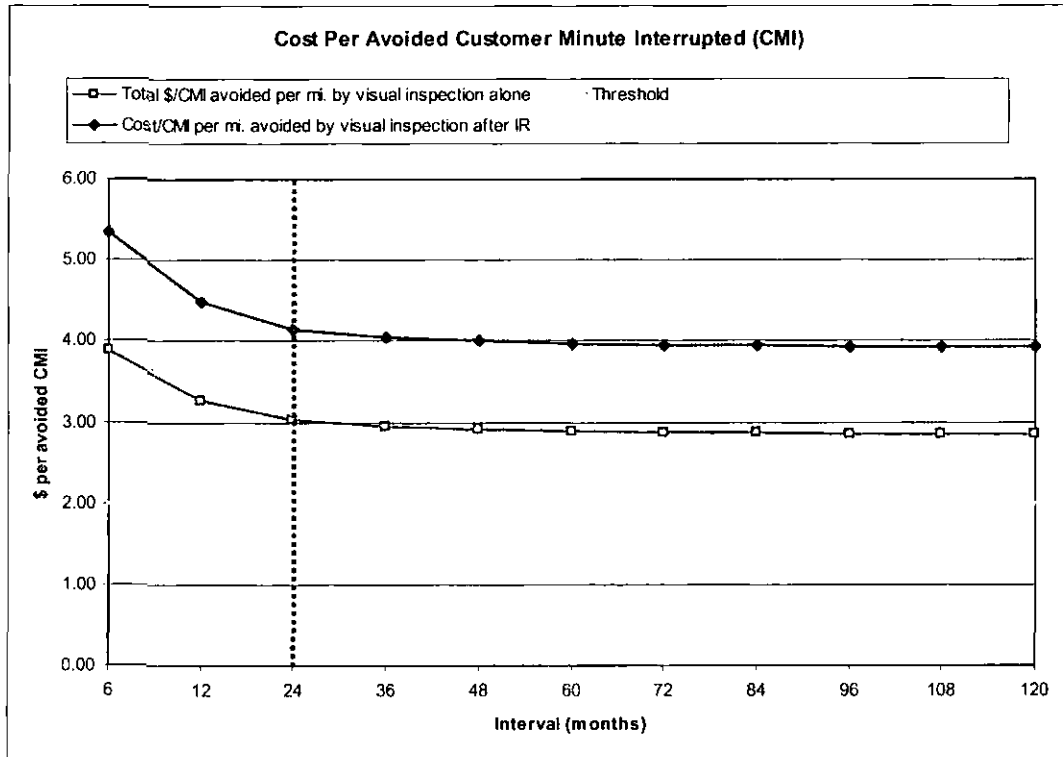
As the graphs below depict, given PPL Electric's reliability parameters, there is no interval for visual overhead inspections that meets the established cost threshold, particularly when performed in conjunction with infrared inspections. Visual inspections alone at two-year intervals are 50% above the threshold; two year visuals done in conjunction with infrared are 100% above the threshold.

Overhead Line Inspection Cost per Avoided CMI
