**Re: PPL Electric Utilities Corporation  
Quarterly Reliability Report for the  
Period Ended December 31, 2019  
Docket No. M-2016-2522508**

**PPL Electric Utilities Corporation**  
**Quarterly Reliability Report**  
**to the**  
**Pennsylvania Public Utility Commission**

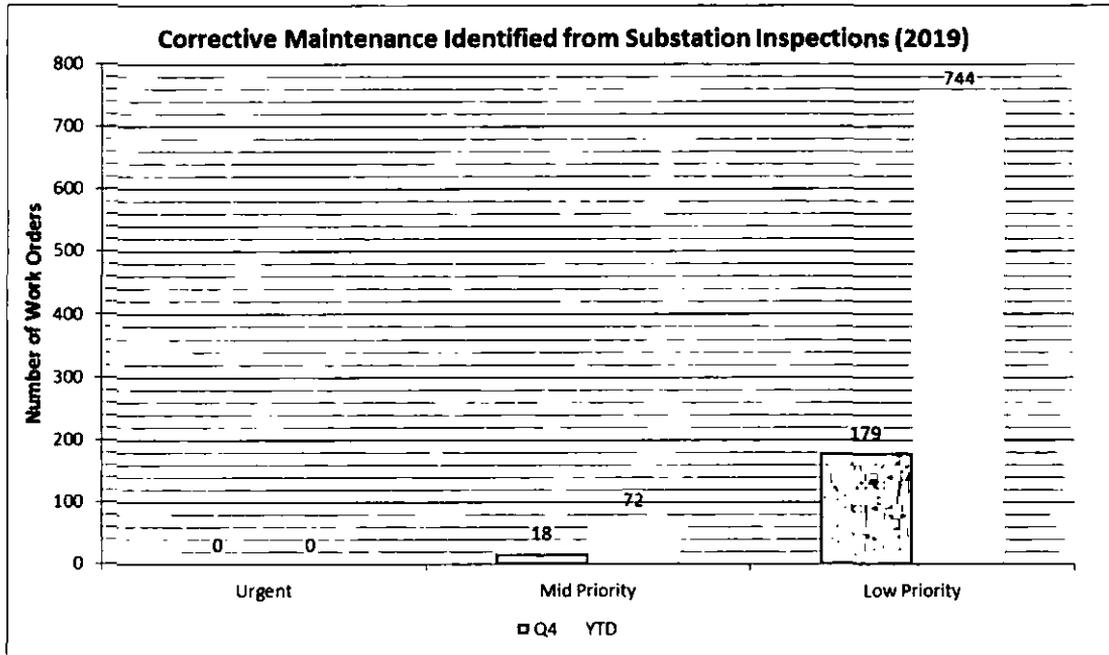
During the fourth quarter of 2019, 197 corrective work orders were created with the following breakdown by priority.

Figure 1: Corrective Maintenance Work Orders by Priority Level for fourth quarter and year-to-date 2019

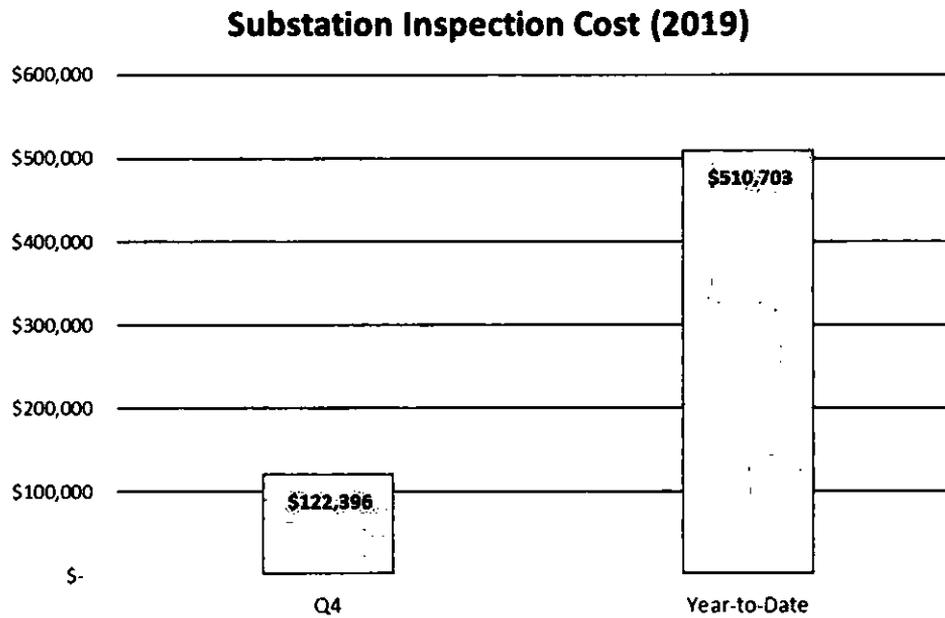
During the fourth quarter of 2019, PPL Electric spent approximately \$122,000 on substation inspections.

Figure 2: Substation Inspection Costs for fourth quarter and year-to-date 2019.

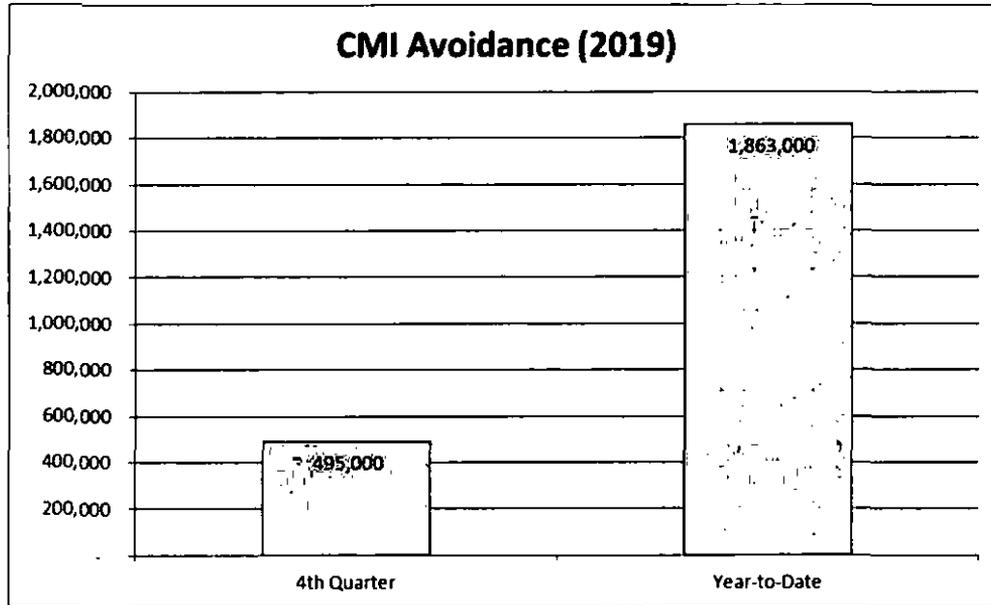
The figure below shows the amount of CMI avoidance that PPL Electric has estimated for the fourth quarter and year-to-date. During fourth quarter of 2019, PPL Electric avoided a projected 495,000 CMI.

**Figure 3: CMI Avoidance Due to Inspections for fourth quarter and year-to-date 2019**

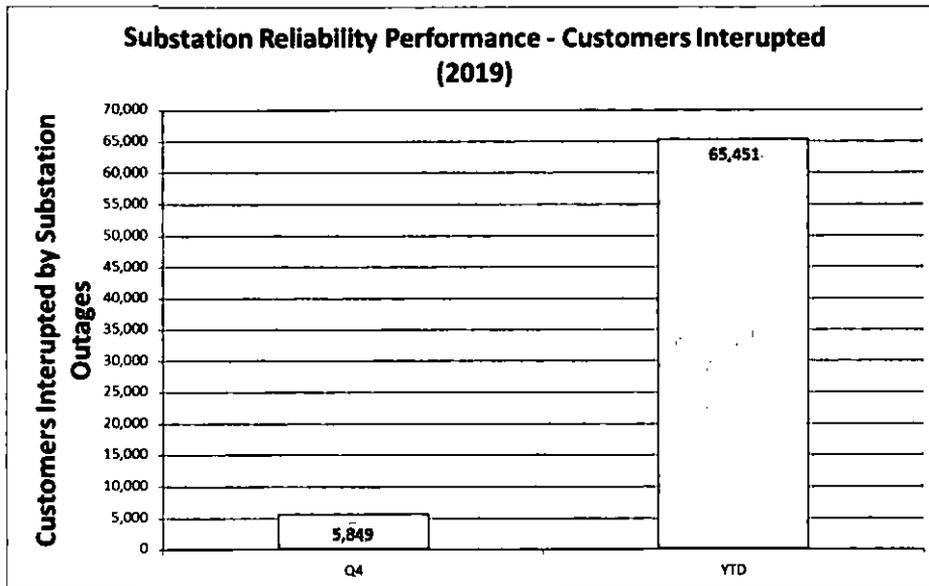
In the past three years, distribution substations have contributed a small amount toward the reliability metrics. During the fourth quarter of 2019, the Company interrupted about 6,000 customers for a total of approximately 172,000 CMI. The figures below show these results for the number of customers interrupted and CMI experienced, respectively.

Figure 4: Substation Customers Interrupted for fourth quarter and year-to-date 2019

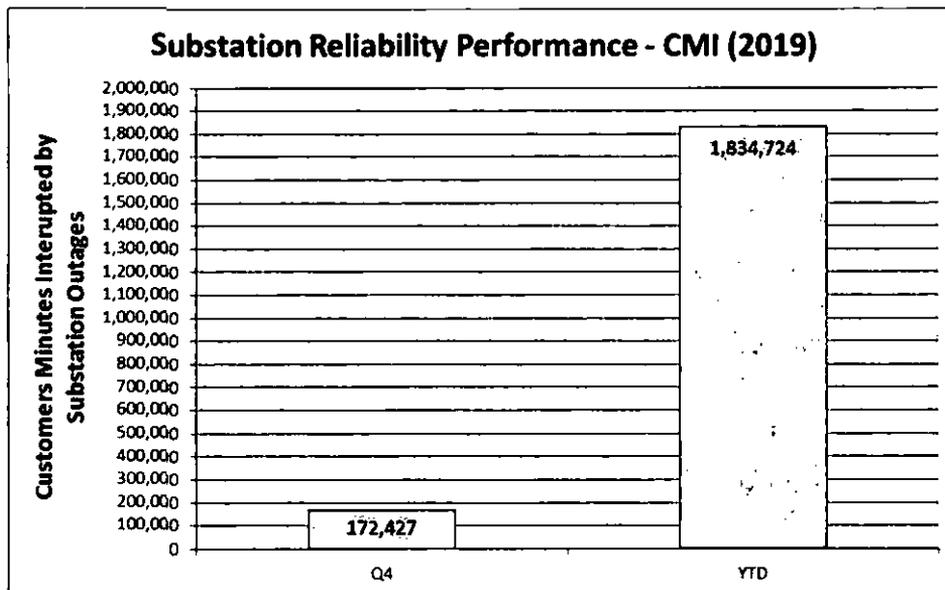
Figure 5: Substation Customer Minutes of Interruption for fourth quarter and year-to-date 2019
