**Re: PPL Electric Utilities Corporation  
Quarterly Reliability Report for the  
Period Ended March 31, 2020  
Docket No. M-2016-2522508**

**PPL Electric Utilities Corporation**  
**Quarterly Reliability Report**  
**to the**  
**Pennsylvania Public Utility Commission**

*April 2020*

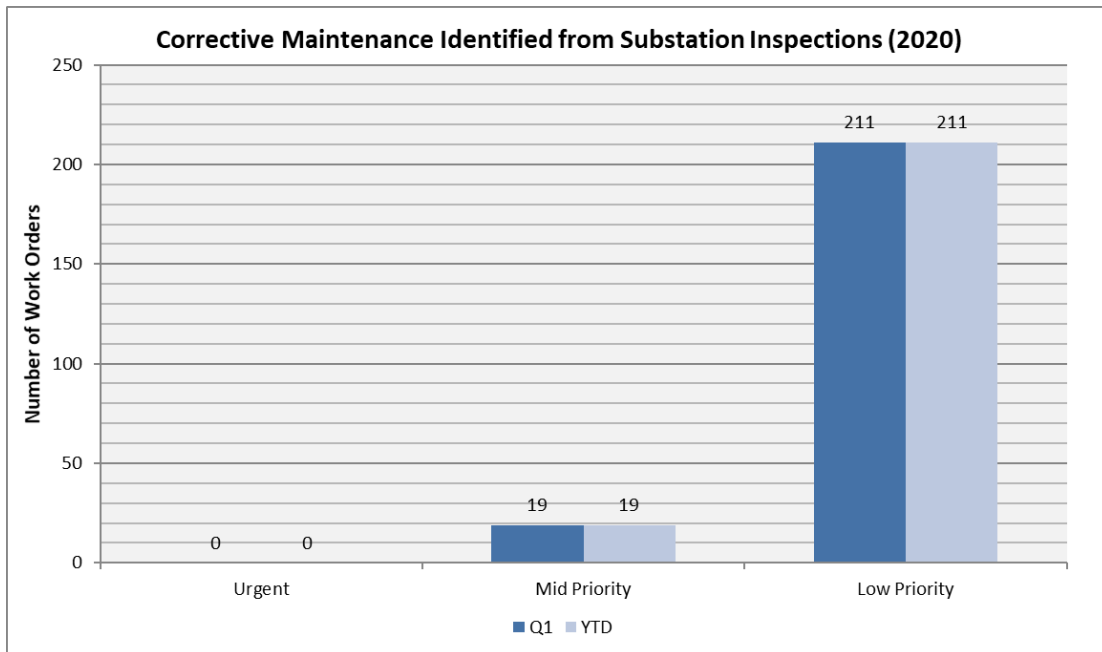
During the first quarter of 2020, 230 corrective work orders were created with the following breakdown by priority.

**Figure 1: Corrective Maintenance Work Orders by Priority Level for first quarter and year-to-date 2020**

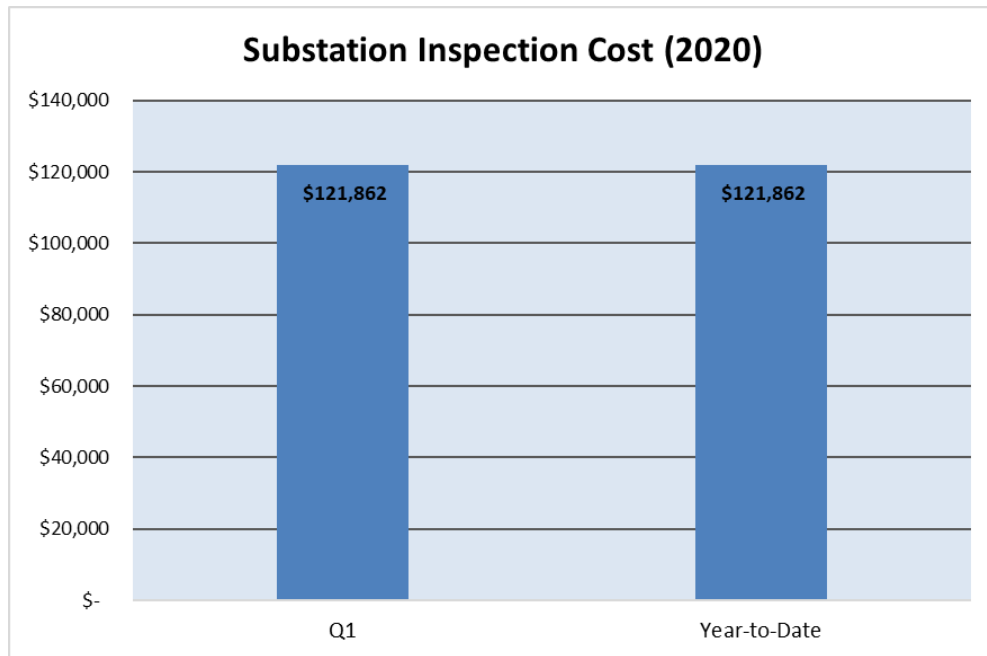
During the first quarter of 2020, PPL Electric spent approximately \$122,000 on substation inspections.

Figure 2: Substation Inspection Costs for first quarter and year-to-date 2020.

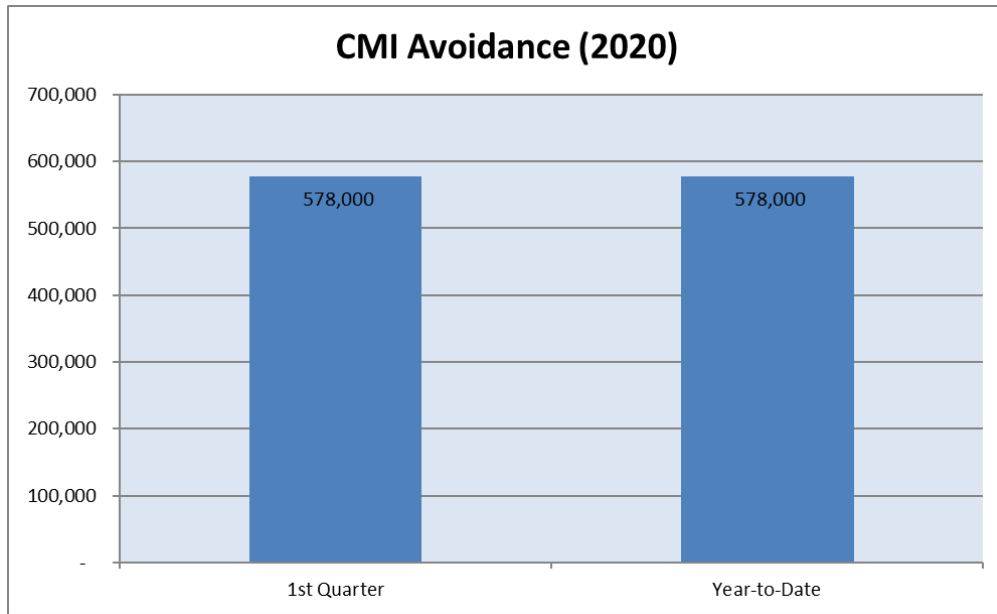
The figure below shows the amount of CMI avoidance that PPL Electric has estimated for the first quarter and year-to-date. During first quarter of 2020, PPL Electric avoided a projected 578,000 CMI.

**Figure 3: CMI Avoidance Due to Inspections for first quarter and year-to-date 2020**

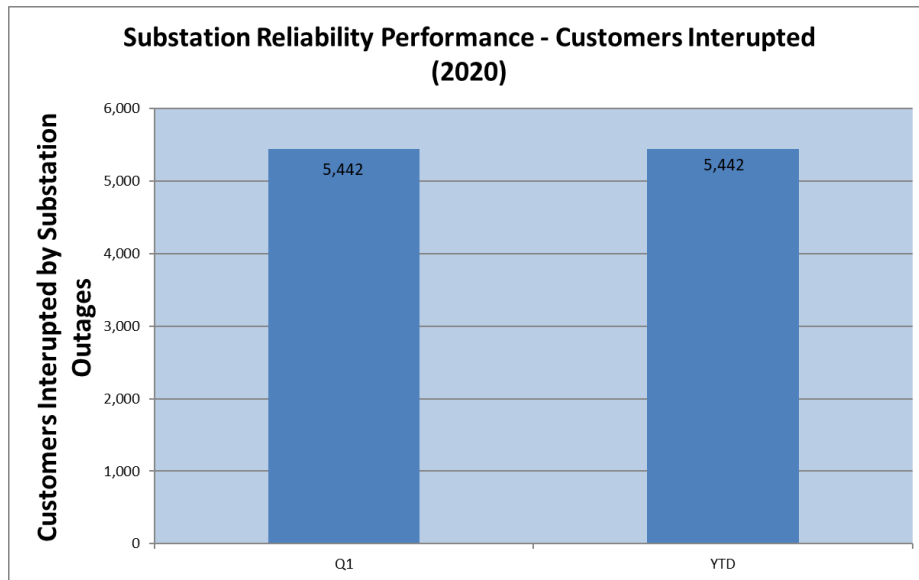
In the past three years, distribution substations have contributed a small amount toward the reliability metrics. During the first quarter of 2020, approximately 5,000 customers experienced an interruption for a total of approximately 268,000 CMI. The figures below show these results for the number of customers interrupted and CMI experienced, respectively.

Figure 4: Substation Customers Interrupted for first and year-to-date 2020

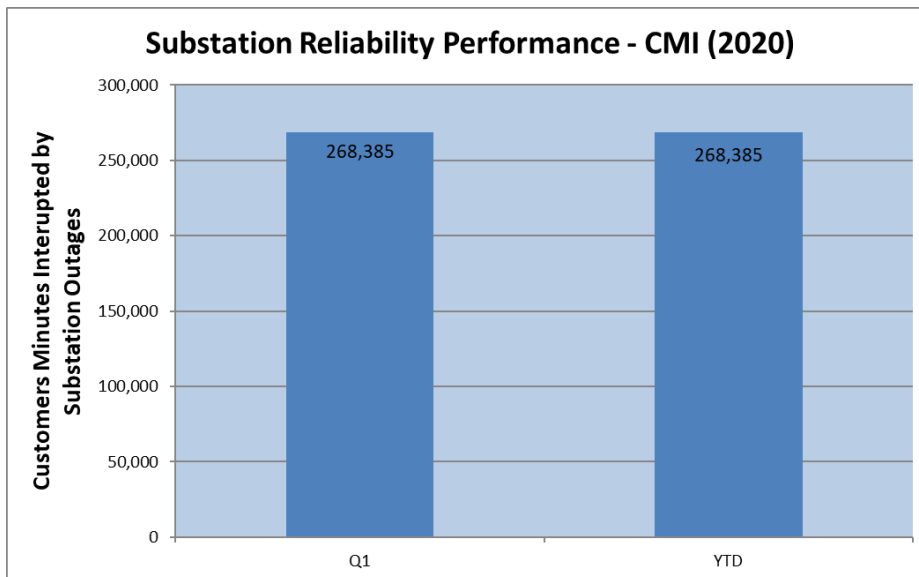
Figure 5: Substation Customer Minutes of Interruption for first quarter and year-to-date 2020
