**Re: PPL Electric Utilities Corporation  
Quarterly Reliability Report for the  
Period Ended September 30, 2020  
Docket No. M-2016-2522508**

**PPL Electric Utilities Corporation**  
**Quarterly Reliability Report**  
**to the**  
**Pennsylvania Public Utility Commission**

*October 2020*

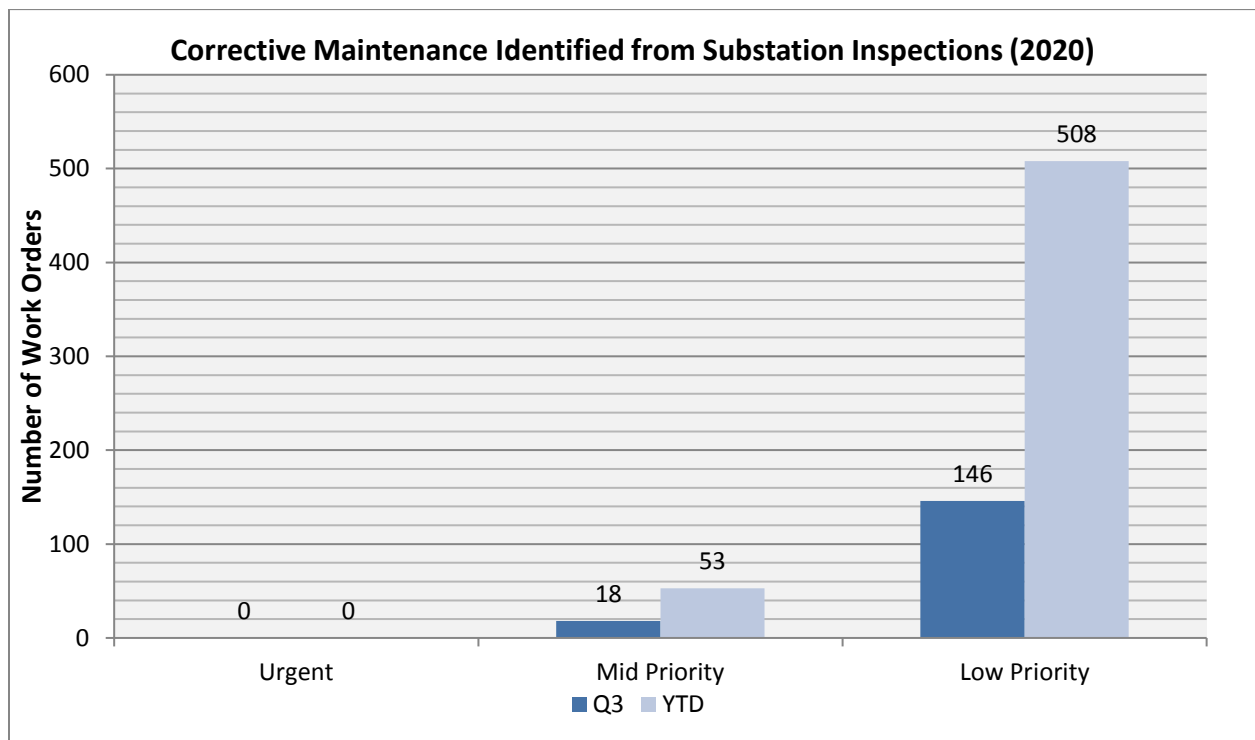
During the 3<sup>rd</sup> quarter of 2020, 164 corrective work orders were created with the following breakdown by priority.

Figure 1: Corrective Maintenance Work Orders by Priority Level for 3<sup>rd</sup> Quarter and Year-to-Date 2020

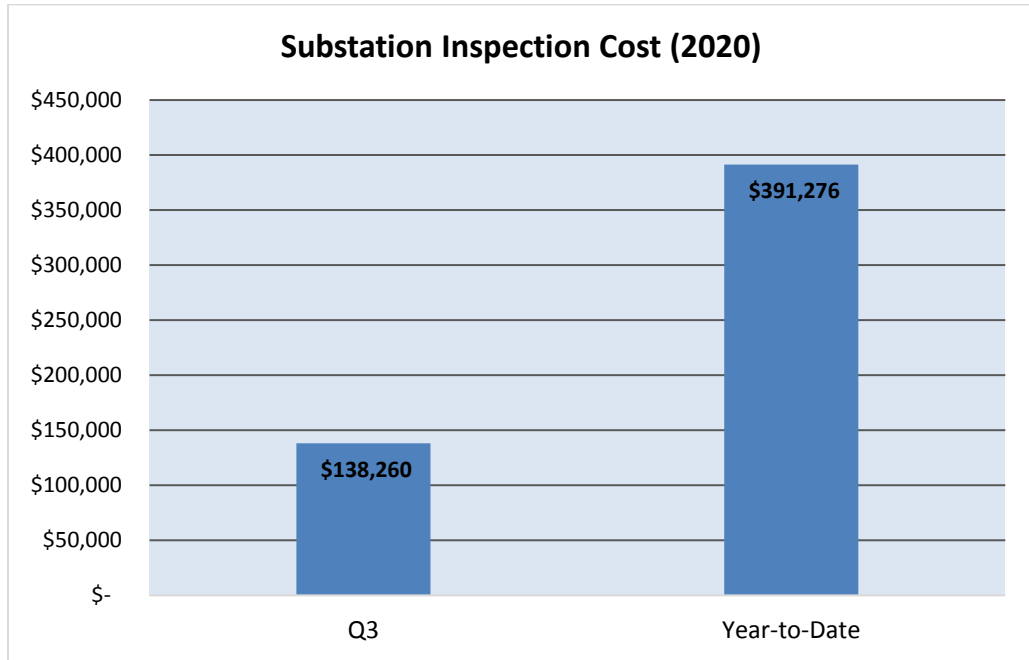
During the 3<sup>rd</sup> quarter of 2020, PPL Electric Utilities spent approximately \$138,000 on substation inspections.

Figure 2: Substation Inspection Costs for 3<sup>rd</sup> Quarter and Year-to-Date 2020.

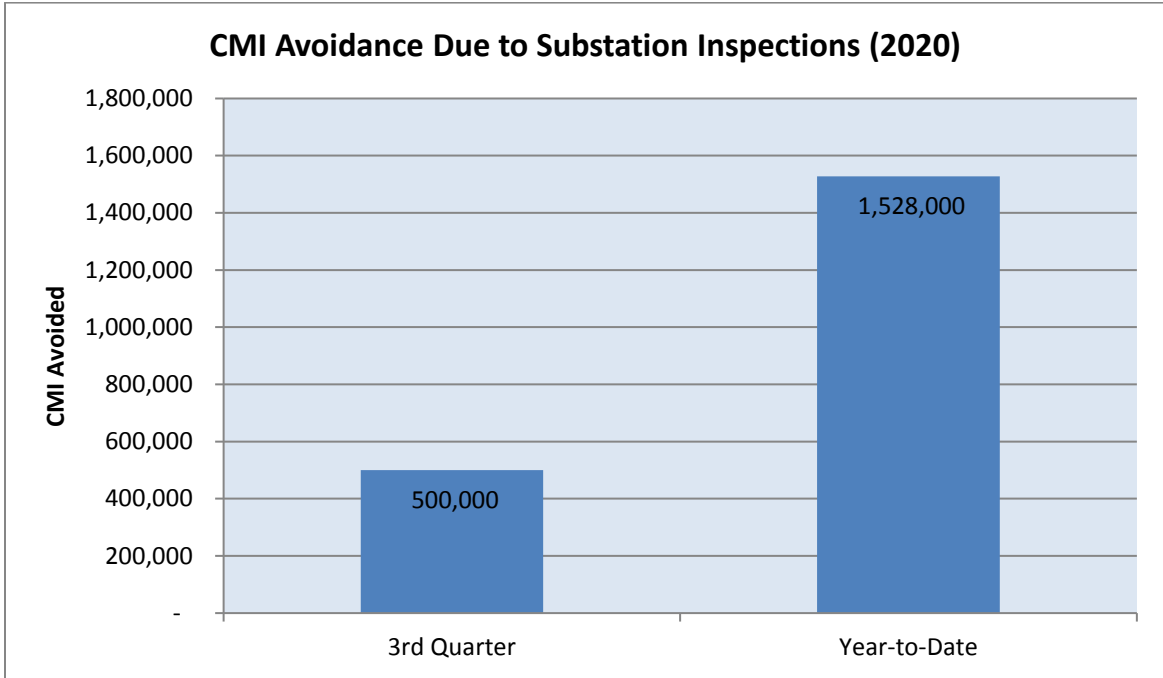
Figure 3 below shows the CMI avoidance that PPL Electric Utilities has estimated for the 3<sup>rd</sup> quarter and year-to-date. During the 3<sup>rd</sup> quarter of 2020, PPL Electric Utilities avoided a projected 500,000 CMI.

**Figure 3: Projected CMI Avoidance Due to Substation Inspections for 3<sup>rd</sup> Quarter and Year-to-Date 2020**

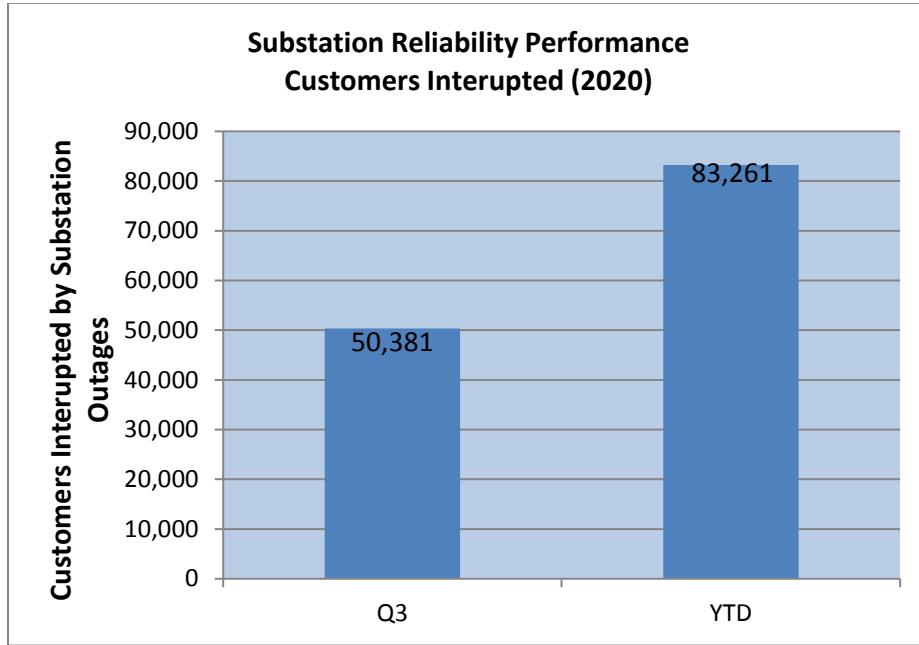
In the past three years, distribution substations have contributed a small amount toward the reliability metrics. During the 3<sup>rd</sup> quarter of 2020, the Company interrupted approximately 50,000 customers for a total of 3.8M CMI. The figures below show these results for the number of customers interrupted and CMI experienced, respectively.

Figure 4: Substation Customers Interrupted for 3<sup>rd</sup> Quarter and Year-to-Date 2020

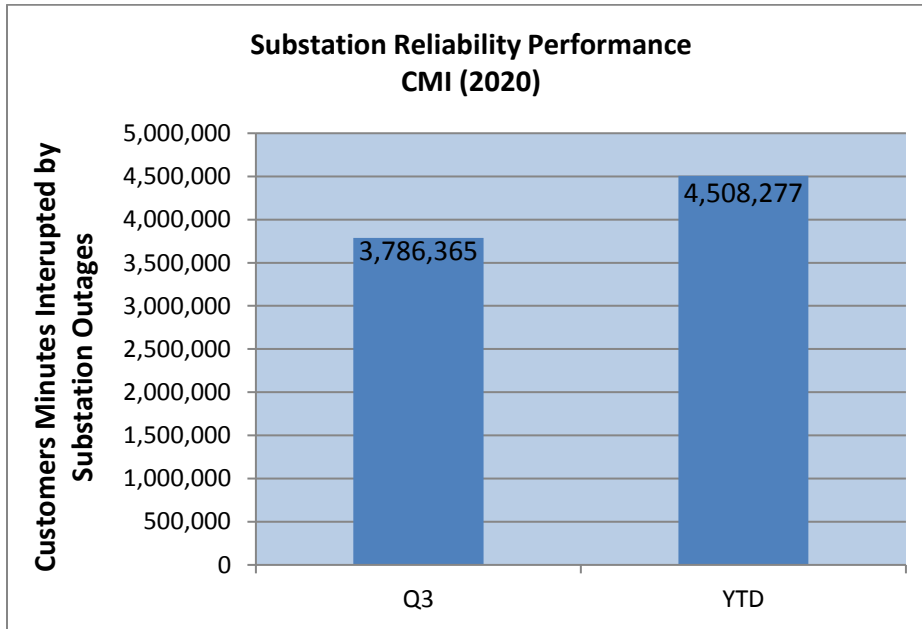
Figure 5: Substation Customer Minutes of Interruption for 3<sup>rd</sup> Quarter and Year-to-Date 2020
