**Re: PPL Electric Utilities Corporation  
Quarterly Reliability Report for the  
Period Ended December 31, 2020  
Docket No. M-2016-2522508**

**PPL Electric Utilities Corporation**  
**Quarterly Reliability Report**  
**to the**  
**Pennsylvania Public Utility Commission**

*January 2021*

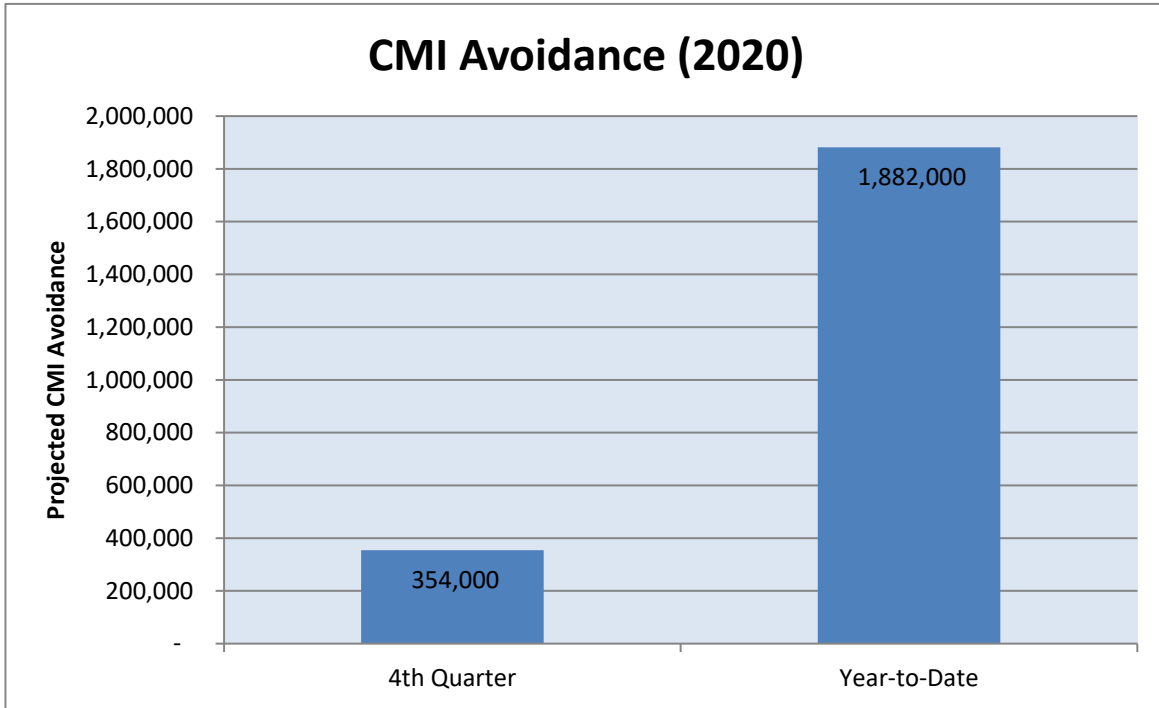
Figure 3 below shows the CMI avoidance that PPL Electric Utilities has estimated for the 4<sup>th</sup> quarter and year-to-date. During the 4<sup>th</sup> quarter of 2020, PPL Electric Utilities avoided a projected 354,000 CMI.

**Figure 3: Projected CMI Avoidance Due to Substation Inspections for 4<sup>th</sup> Quarter and Year-to-Date 2020**

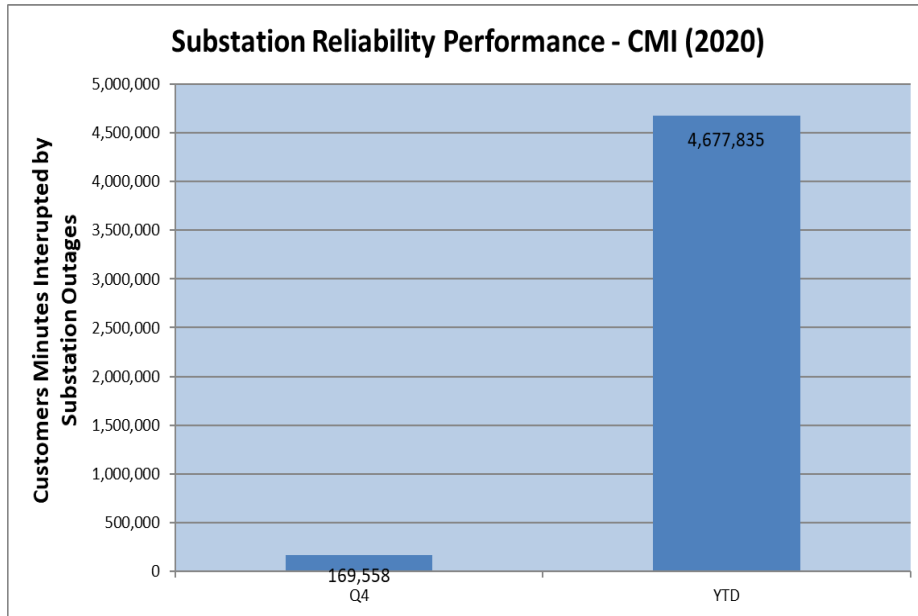
In the past three years, distribution substations have contributed a small amount toward the reliability metrics. During the 4<sup>th</sup> quarter of 2020, the Company interrupted approximately 17,000 customers for a total of 170,000 CMI. The figures below show these results for the number of customers interrupted and CMI experienced, respectively.

Figure 5: Substation Customer Minutes of Interruption for 4<sup>th</sup> Quarter and Year-to-Date 2020
