**Re: PPL Electric Utilities Corporation
2020 Annual Reliability Report
Docket No. ~~E-00000464~~**

**PPL Electric Utilities Corporation
2020 Annual Reliability Report
to the
Pennsylvania Public Utility Commission**

April 30, 2021

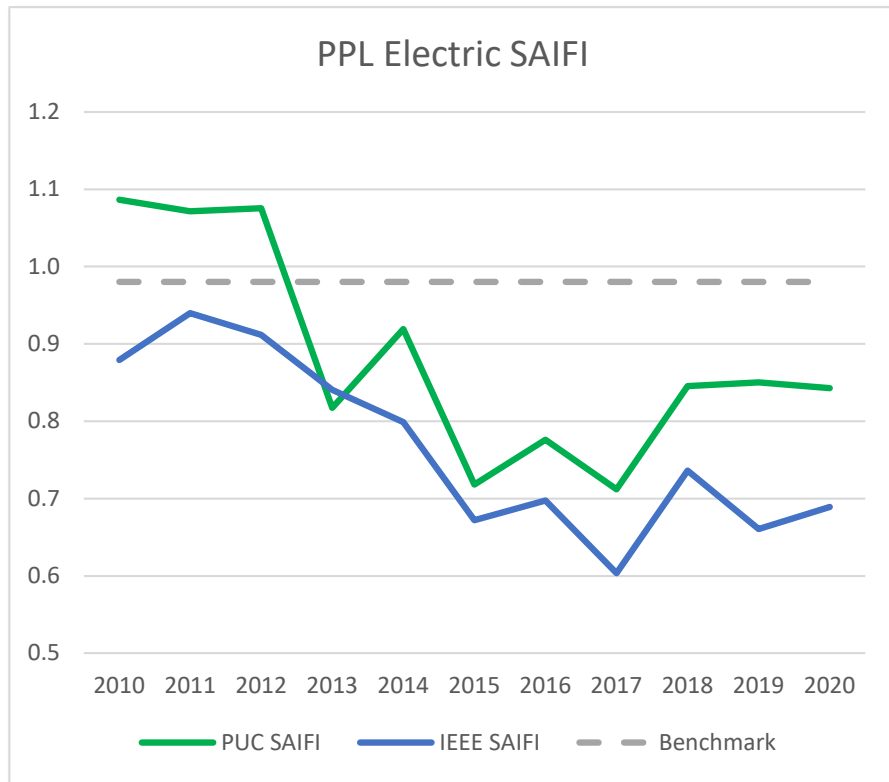
Our ongoing focus around preventing customer interruptions through system automation, vegetation management and asset performance continues to directly support overall strong reliability results, with over 200,000 customer outages eliminated in 2020 through automation. This level of SAIFI performance is directly related to our high levels of customer satisfaction, with outages being reduced by 27% since 2011 as shown in the SAIFI graph below.

IEEE SAIFI finished at 0.69 which was the fourth best in company history, and top quartile industry performance among large electric utilities nationally.

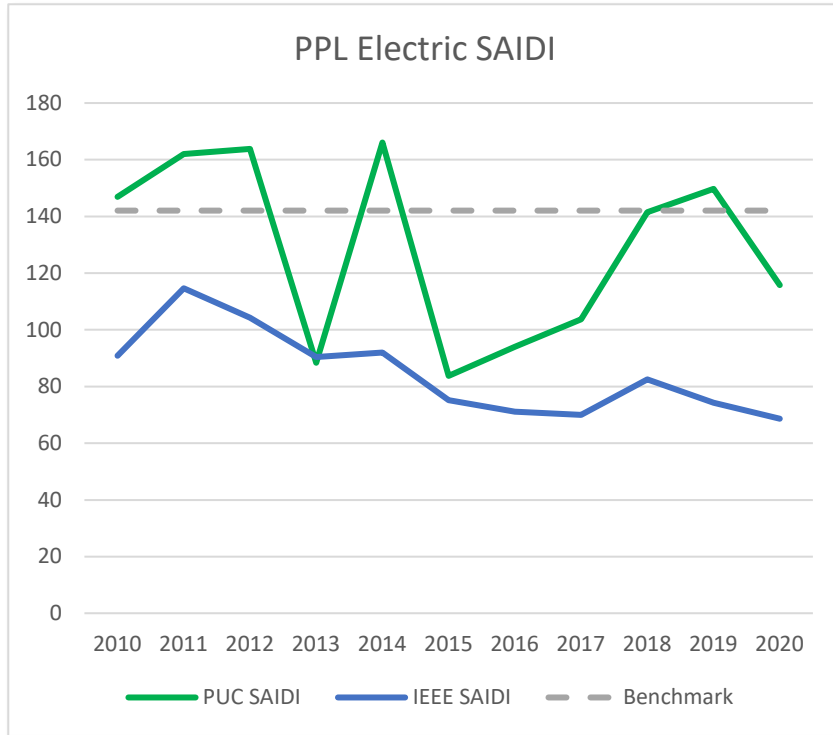
SAIDI Performance

2020 PUC SAIDI performance saw a 23% improvement over 2019 performance and was well within PUC benchmark. IEEE SAIDI, which is more weather-normalized, shows 2020 SAIDI performance at the best on record, and is indicative of the long-term core system performance improvement.

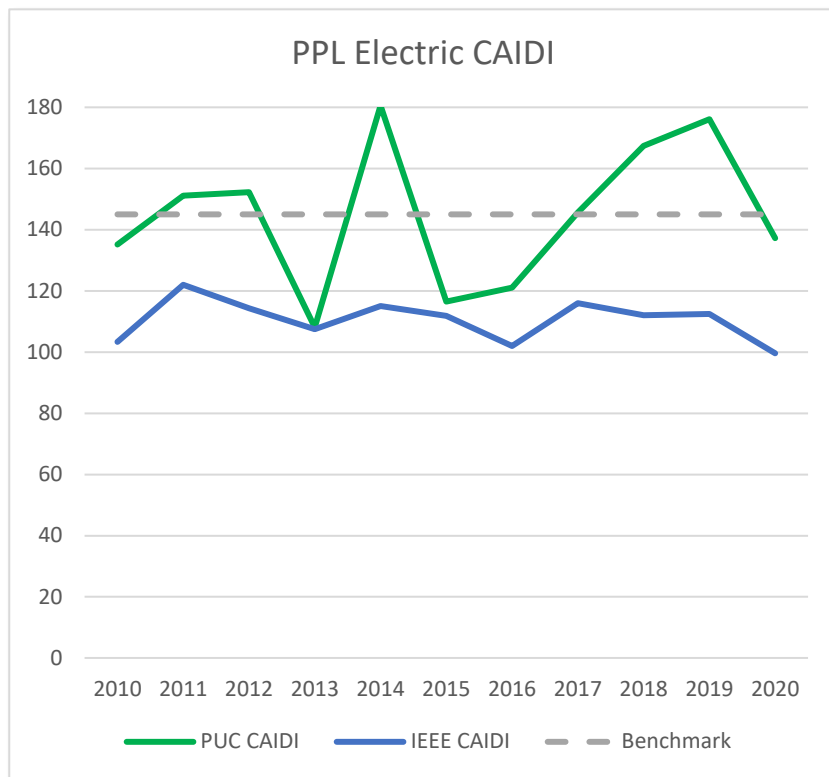
CAIDI Performance

In 2020 PUC CAIDI performance was 22% improved over 2019, and 5% below the PUC benchmark. Our more weather normalized IEEE CAIDI was under 100, and the best ever achieved.
