**Re: PPL Electric Utilities Corporation  
Quarterly Reliability Report for the  
Period Ended March 31, 2021  
Docket No. M-2016-2522508**

**PPL Electric Utilities Corporation**  
**Quarterly Reliability Report**  
**to the**  
**Pennsylvania Public Utility Commission**

*April 2021*

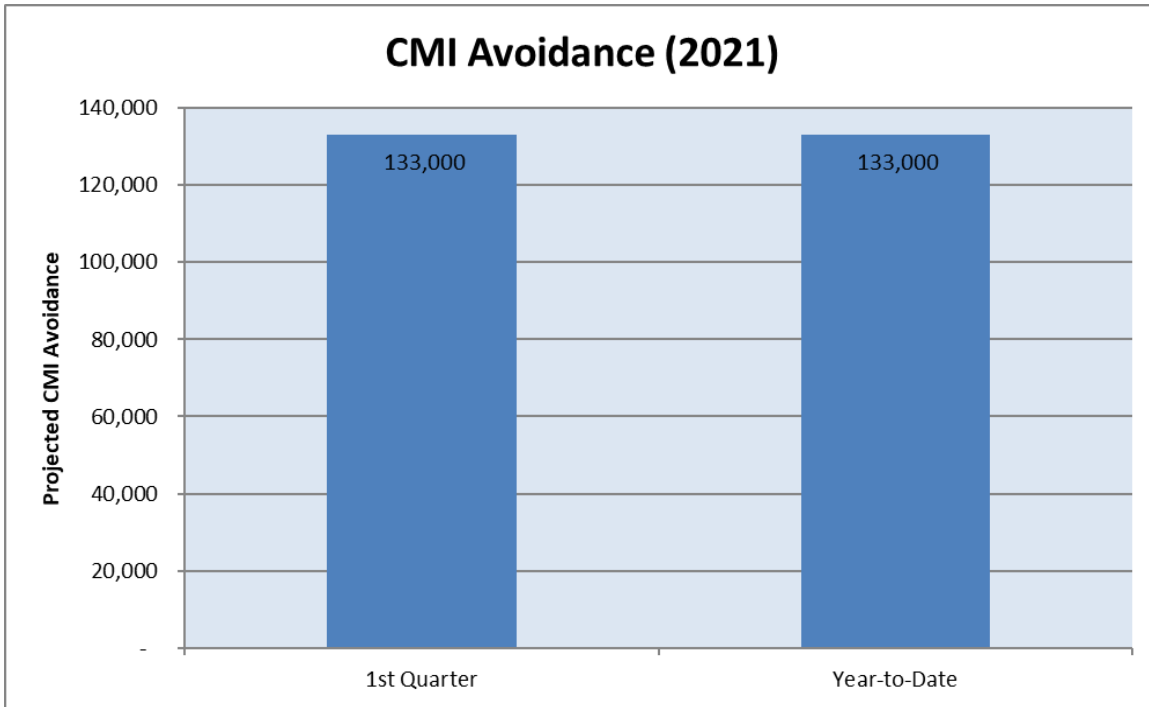
Figure 3 below shows the CMI avoidance that PPL Electric Utilities has estimated for the 1<sup>st</sup> quarter and year-to-date. During the 1<sup>st</sup> quarter of 2021, PPL Electric Utilities avoided a projected 133,000 CMI.

**Figure 3: Projected CMI Avoidance Due to Substation Inspections for 1<sup>st</sup> Quarter and Year-to-Date 2021**

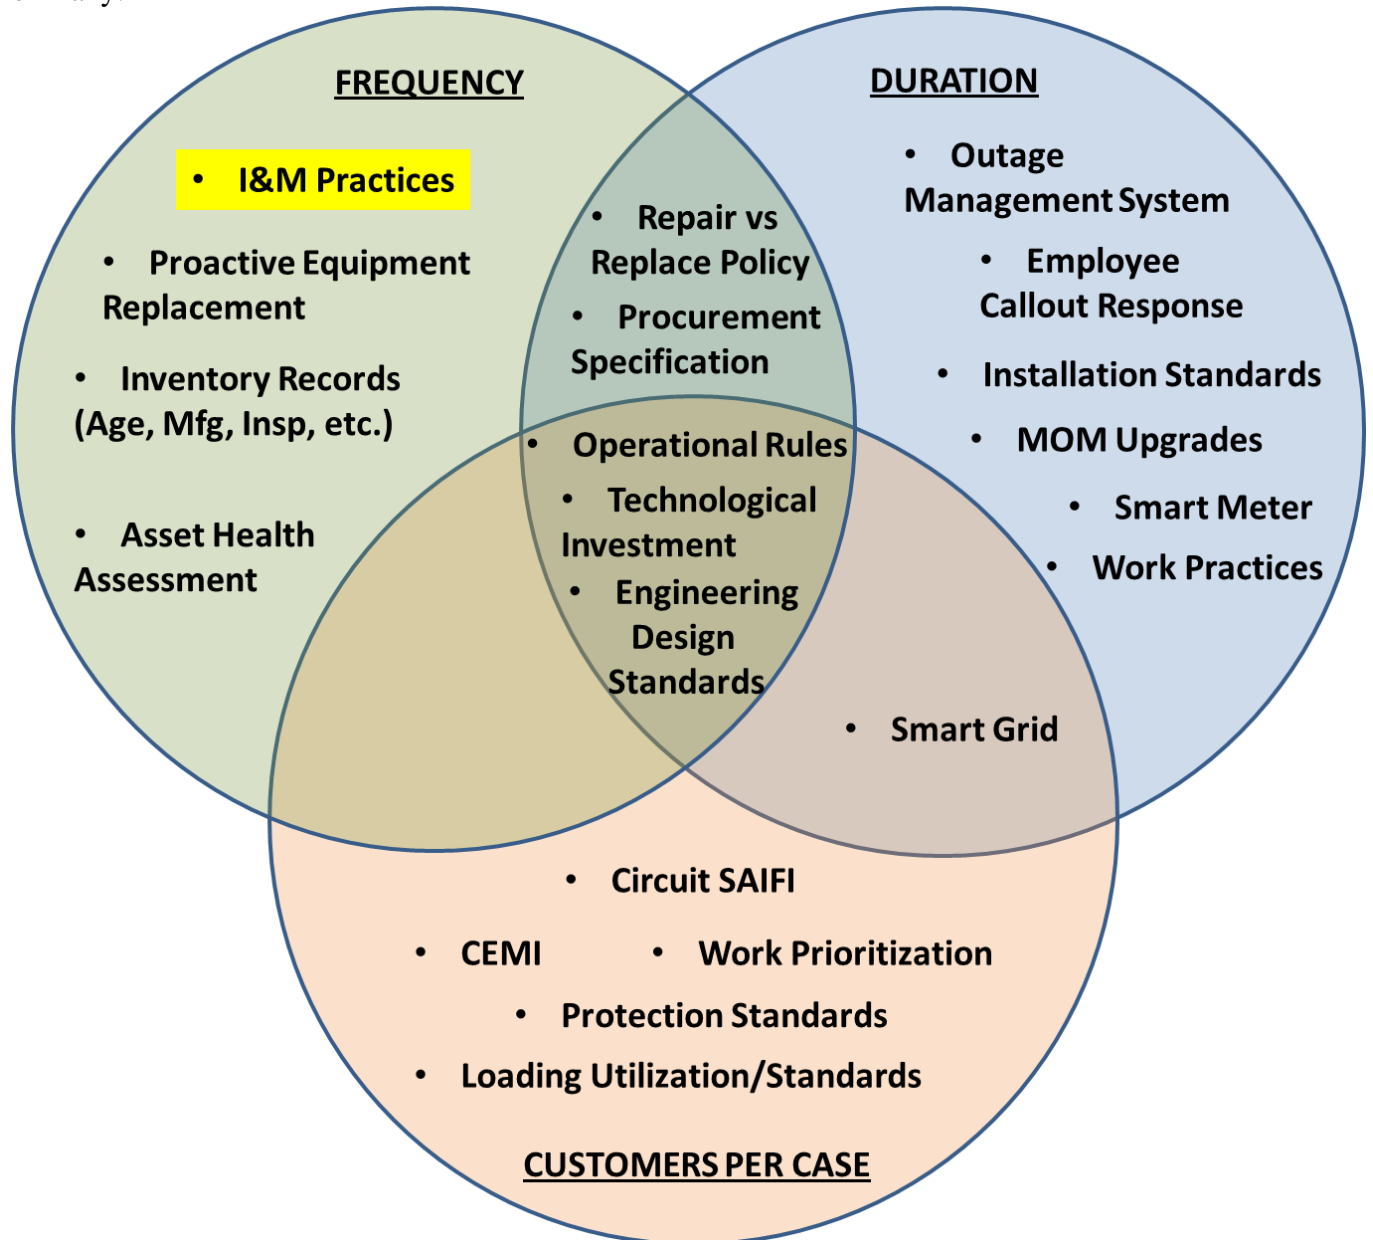
dramatically over time and geography. The manageable factors have an effect on service interruption frequency, duration, or number of customers affected, or a combination of all three. The figure below depicts a portfolio of manageable factors with inspection and maintenance (“I&M”) practices being one of many.

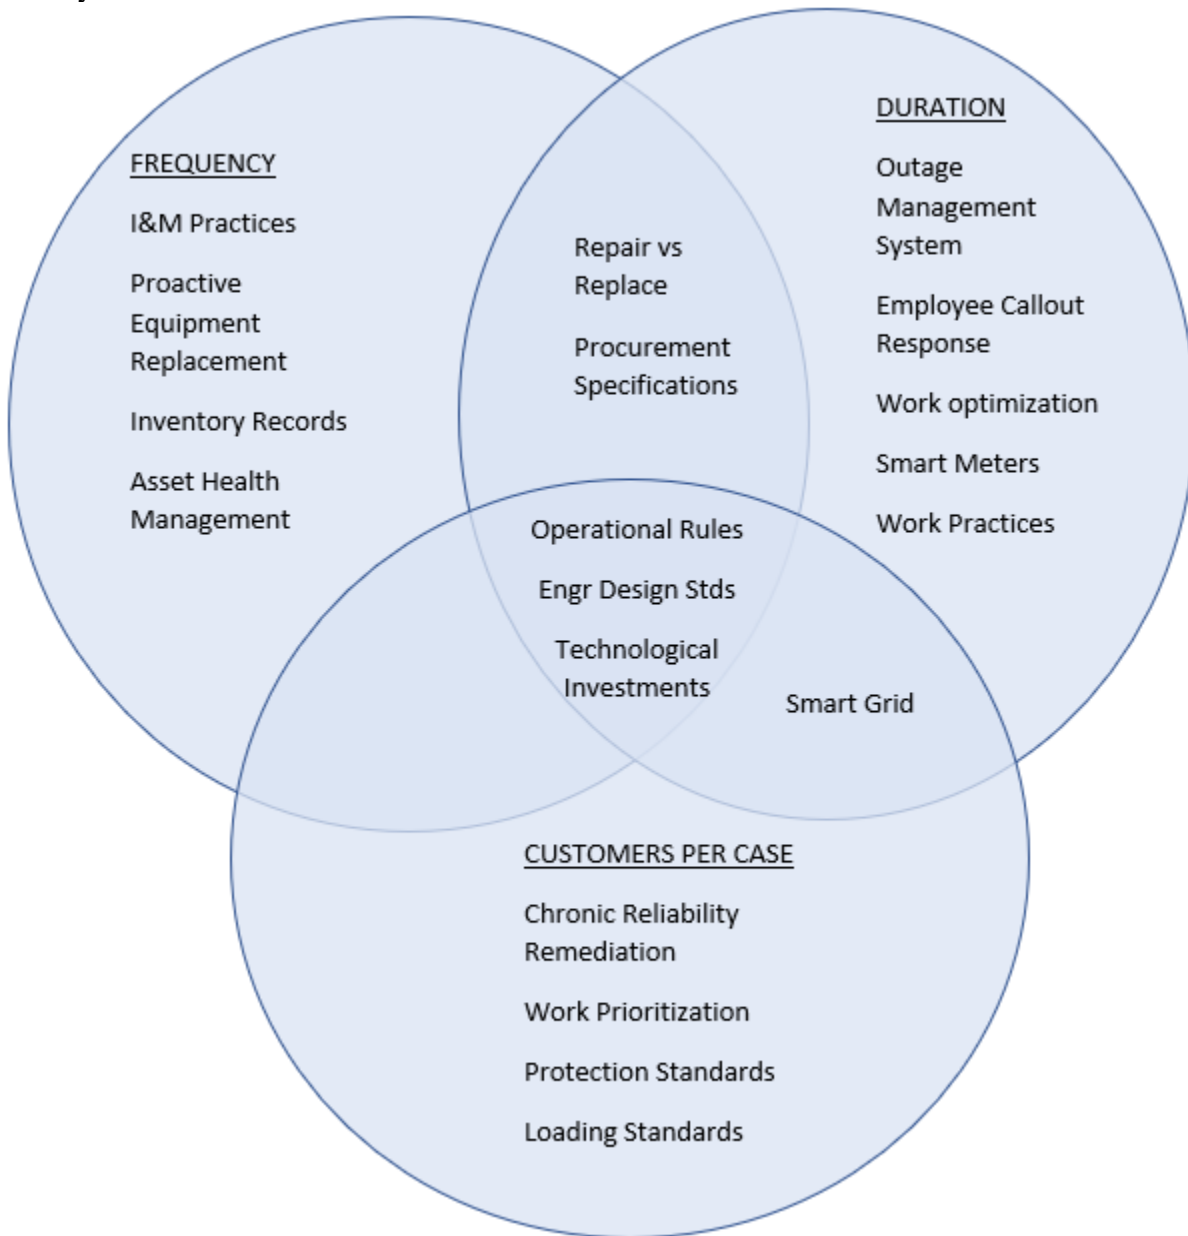
dramatically over time and geography. The manageable factors have an effect on service interruption frequency, duration, or number of customers affected, or a combination of all three. The figure below depicts a portfolio of manageable factors with inspection and maintenance (“I&M”) practices being one of many.

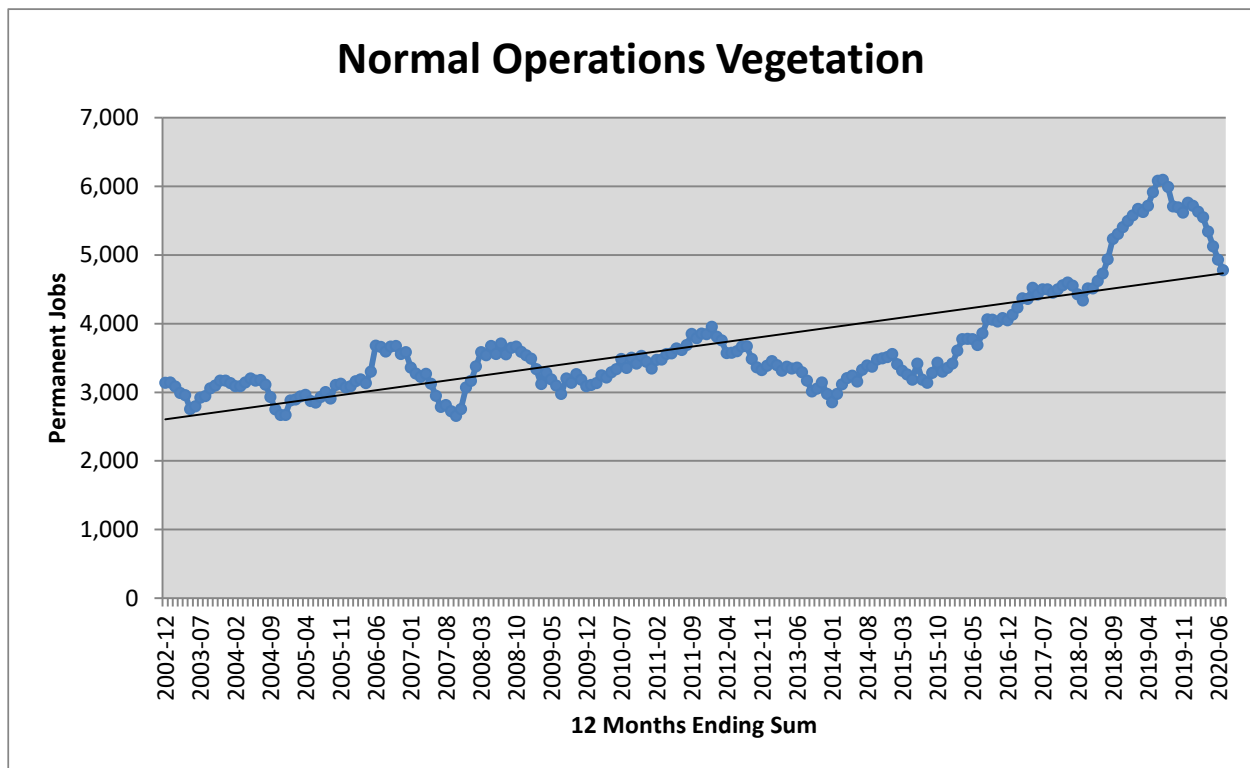
Identification and understanding of trends create the opportunity to plan programs to mitigate undesirable trends. Most of the year-to-year variation in service interruptions is explained by differences in storm experience. Therefore, PPL Electric generally removes all declared-storm caused service outages (though not all weather related outages) for internal analysis to identify other causal trends affecting reliability. Each data point in the following charts represents a 12-month ending value to eliminate the effect of seasonal variation.

**Vegetation Related Service Interruption Cases**

PPL Electric is committed to continuing an aggressive Vegetation Management program to address the threat of tree related outages. It is worth noting that even when excluding major and PUC reportable storm events, 77% of vegetation related outages occur during adverse weather conditions. The strong storms and saturated ground conditions prevalent in 2018 and 2019 resulted in higher than normal occurrences of vegetation outages, including healthy trees toppling into overhead conductor.

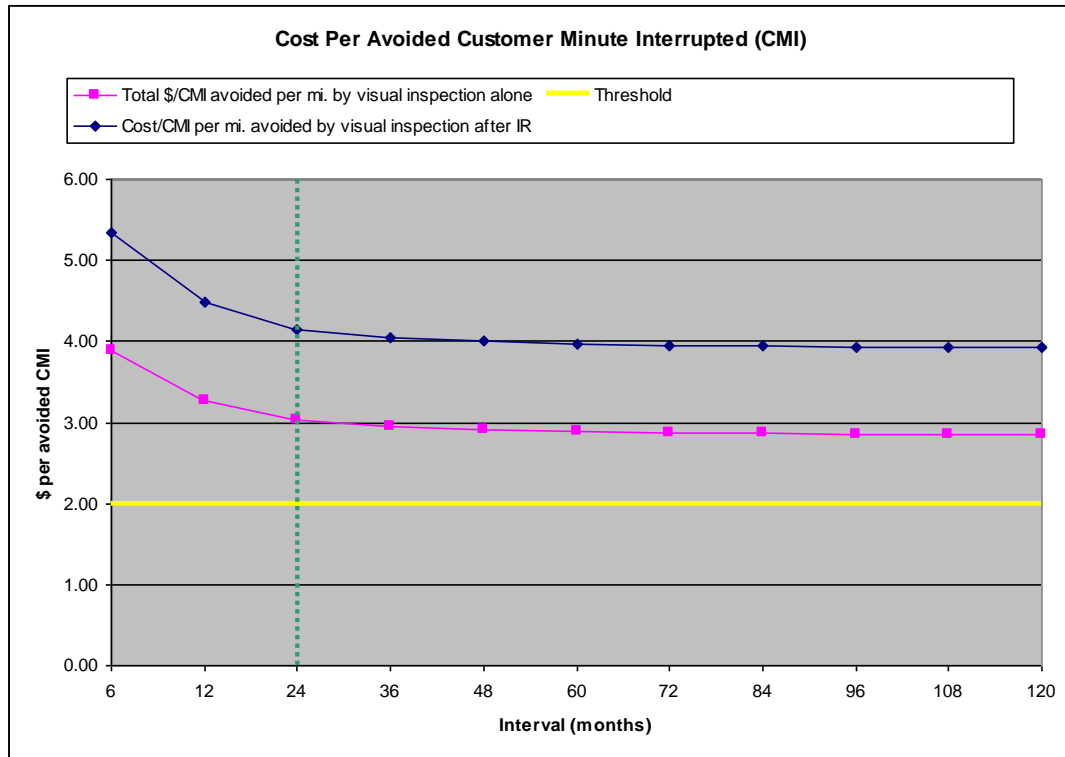
**Overhead Line Inspection Cost per Avoided CMI**

Although universal overhead visual inspections are not cost-effective, targeted visual inspections have more value. In a typical year, less than 15% of the circuits are responsible for 80% of equipment failure CMI. For the period 2002 to 2009, 30% of the circuits were responsible for 80% of equipment failure CMI.
