**Re: PPL Electric Utilities Corporation
Quarterly Reliability Report for the
Period Ended June 30, 2021
Docket No. M-2016-2522508**

PPL Electric Utilities Corporation
Quarterly Reliability Report
to the
Pennsylvania Public Utility Commission

July 2021

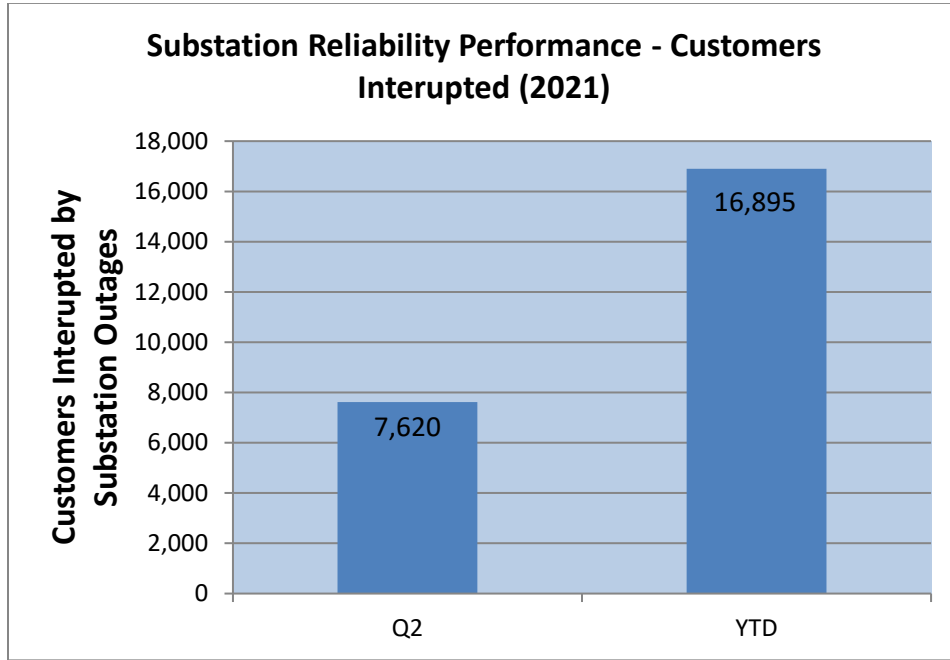
In the past three years, distribution substations have contributed a small amount toward the reliability metrics. During the 2nd quarter of 2021, the Company interrupted approximately 7,500 customers for a total of 118,000 CMI. The figures below show these results for the number of customers interrupted and CMI experienced, respectively.

Figure 4: Substation Customers Interrupted for 2nd Quarter and Year-to-Date 2021

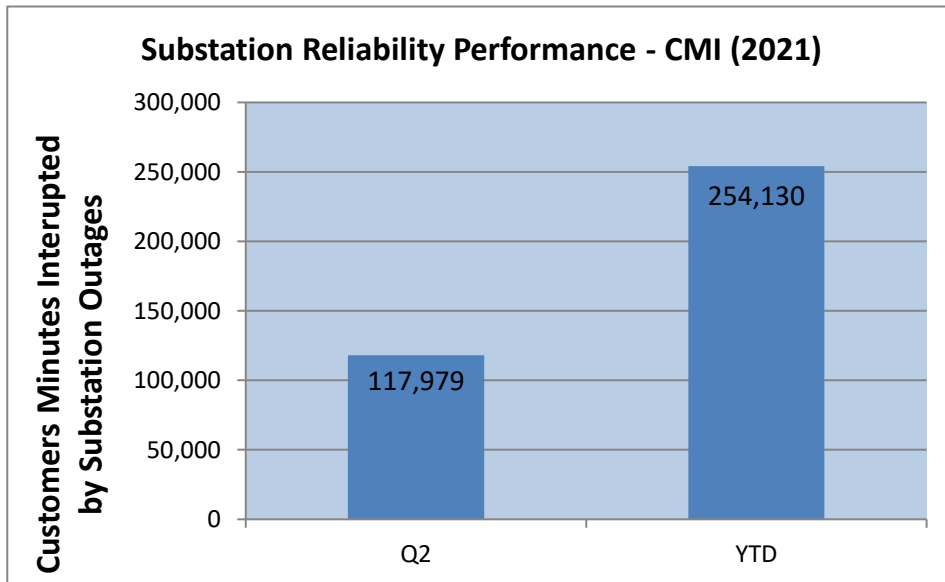
Figure 5: Substation Customer Minutes of Interruption for 2nd Quarter and Year-to-Date 2021
