**Re: PPL Electric Utilities Corporation
Quarterly Reliability Report for the
Period Ended September 30, 2021
Docket No. M-2016-2522508**

PPL Electric Utilities Corporation
Quarterly Reliability Report
to the
Pennsylvania Public Utility Commission

October 2021

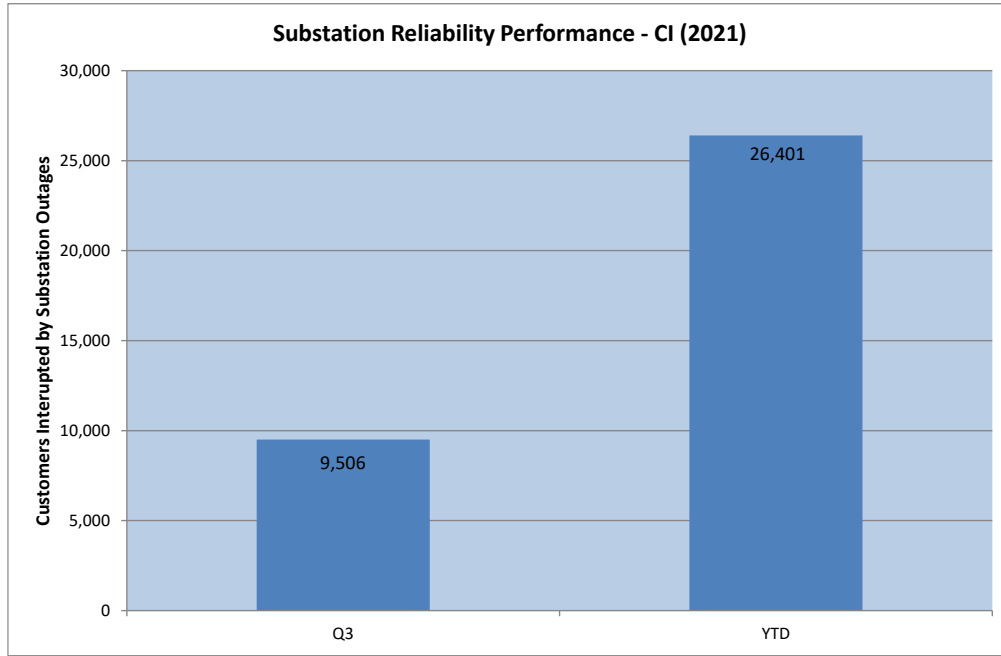
In the past three years, distribution substations have contributed a small amount toward the reliability metrics. During the 3rd quarter of 2021, the Company interrupted approximately 9,500 customers for a total of 127,000 CMI. The figures below show these results for the number of customers interrupted and CMI experienced, respectively.

Figure 4: Substation Customers Interrupted for 3rd Quarter and Year-to-Date 2021
