**Re: PPL Electric Utilities Corporation  
2021 Annual Reliability Report - CORRECTED  
Docket No. M-2016-2522508**

**PPL Electric Utilities Corporation  
2021 Annual Reliability Report  
to the  
Pennsylvania Public Utility Commission**

*April 29, 2022*

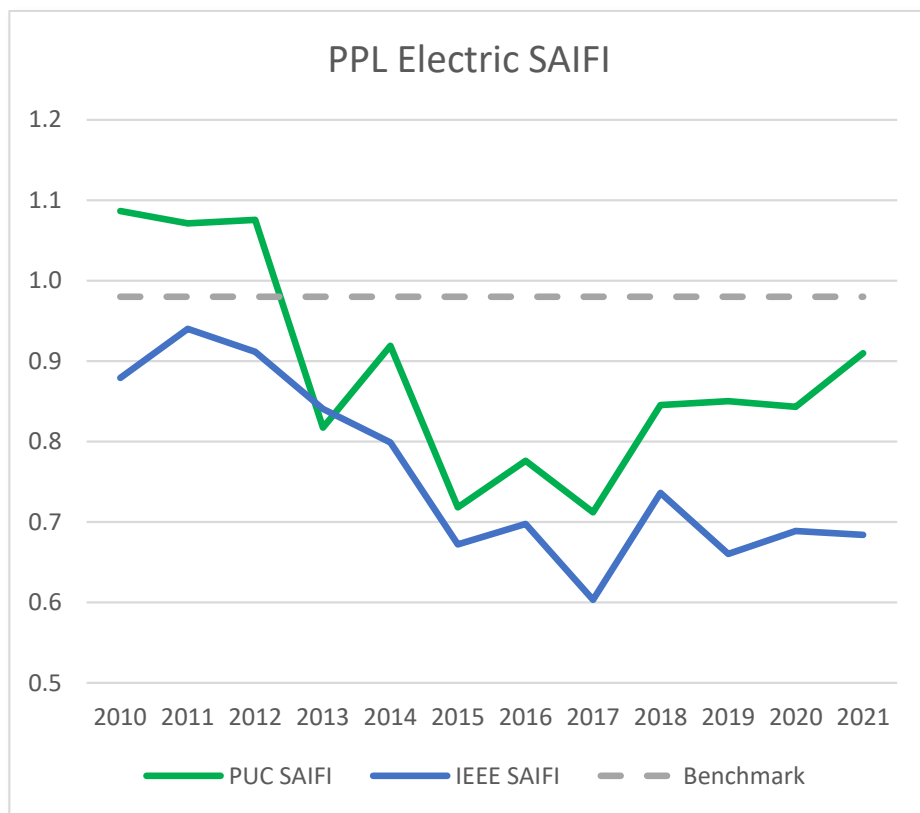
IEEE SAIFI finished at 0.68 which was the fourth best in company history, and top quartile industry performance among large electric utilities nationally.

Our ongoing focus around preventing customer interruptions through system automation, vegetation management and asset performance continues to directly support overall strong reliability results, with over 200,000 customer outages eliminated in 2021 through automation, and over 1.2 million outages saved since the inception of automation in 2017. This level of SAIFI performance is directly related to our high levels of customer satisfaction, with outages being reduced by 27% since 2011 as shown in the SAIFI graph below.

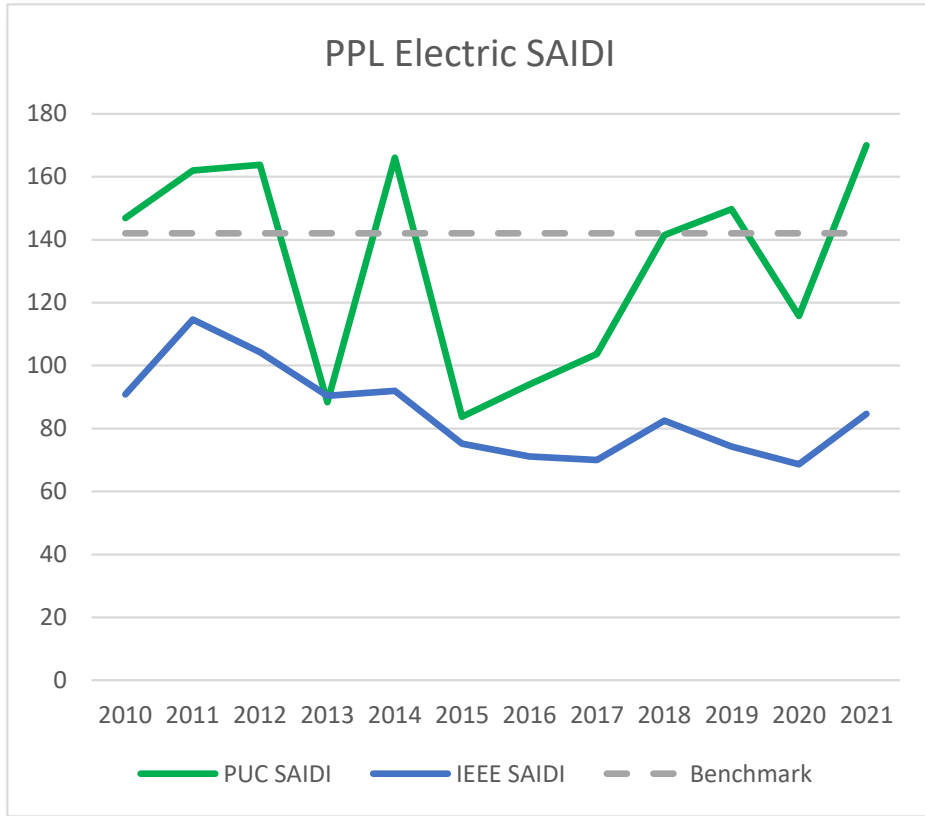
SAIDI Performance

2021 PUC SAIDI performance was well within standard, but 19.7% above benchmark, largely attributable to a record storm year. IEEE SAIDI, which is more weather-normalized, shows 2021 SAIDI performance at 84.6 versus the non-weather normalized PUC value of 170.
