**Re: PPL Electric Utilities Corporation
Quarterly Reliability Report for the
Period Ended March 31, 2022 - CORRECTED
Docket No. M-2016-2522508**

PPL Electric Utilities Corporation
Quarterly Reliability Report
to the
Pennsylvania Public Utility Commission

April 2022

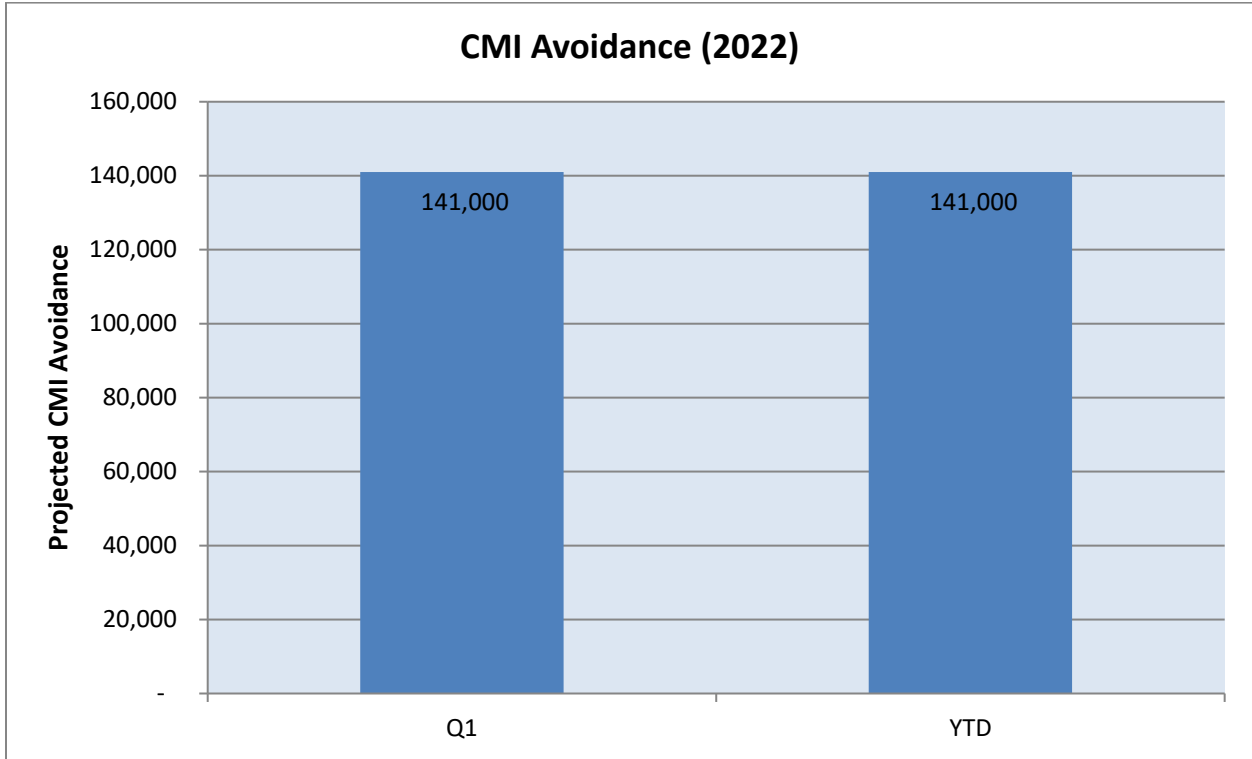
Figure 3 below shows the CMI avoidance that PPL Electric Utilities has estimated for the 1st quarter and year-to-date. During the 1st quarter of 2022, PPL Electric Utilities avoided a projected 141,000 CMI.

Figure 3: Projected CMI Avoidance Due to Substation Inspections for 1st Quarter and Year-to-Date 2022
