**Re: PPL Electric Utilities Corporation  
Quarterly Reliability Report for the  
Period Ended June 30, 2022  
Docket No. M-2016-2522508**

**PPL Electric Utilities Corporation**  
**Quarterly Reliability Report**  
**to the**  
**Pennsylvania Public Utility Commission**

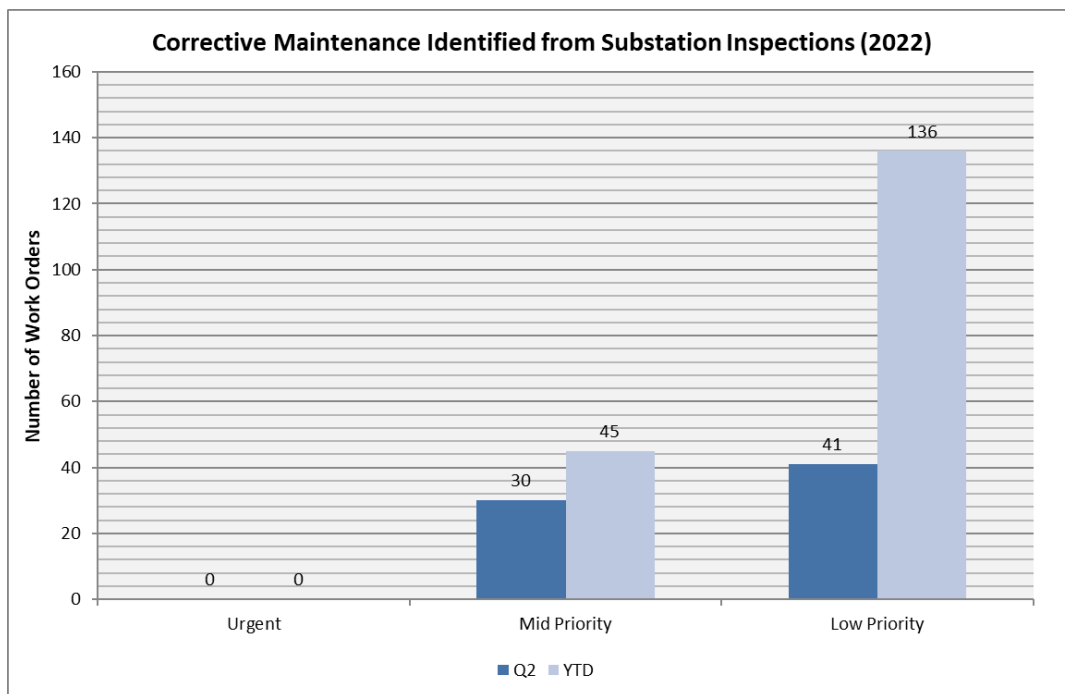
During the 2<sup>nd</sup> quarter of 2022, 71 corrective work orders were created with the following breakdown by priority.

**Figure 1: Corrective Maintenance Work Orders by Priority Level for 2<sup>nd</sup> Quarter and Year-to-Date 2022**

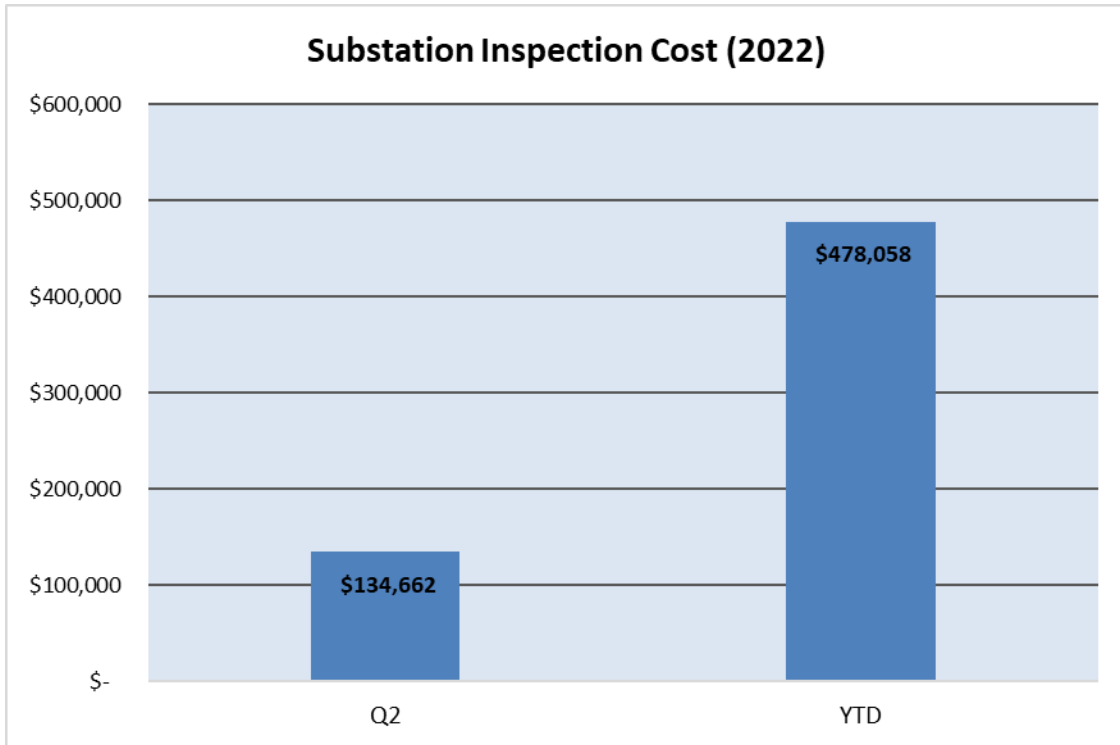
During the 2<sup>nd</sup> quarter of 2022, PPL Electric Utilities spent approximately \$135,000 on substation inspections.

Figure 2: Substation Inspection Costs for 2<sup>nd</sup> Quarter and Year-to-Date 2022

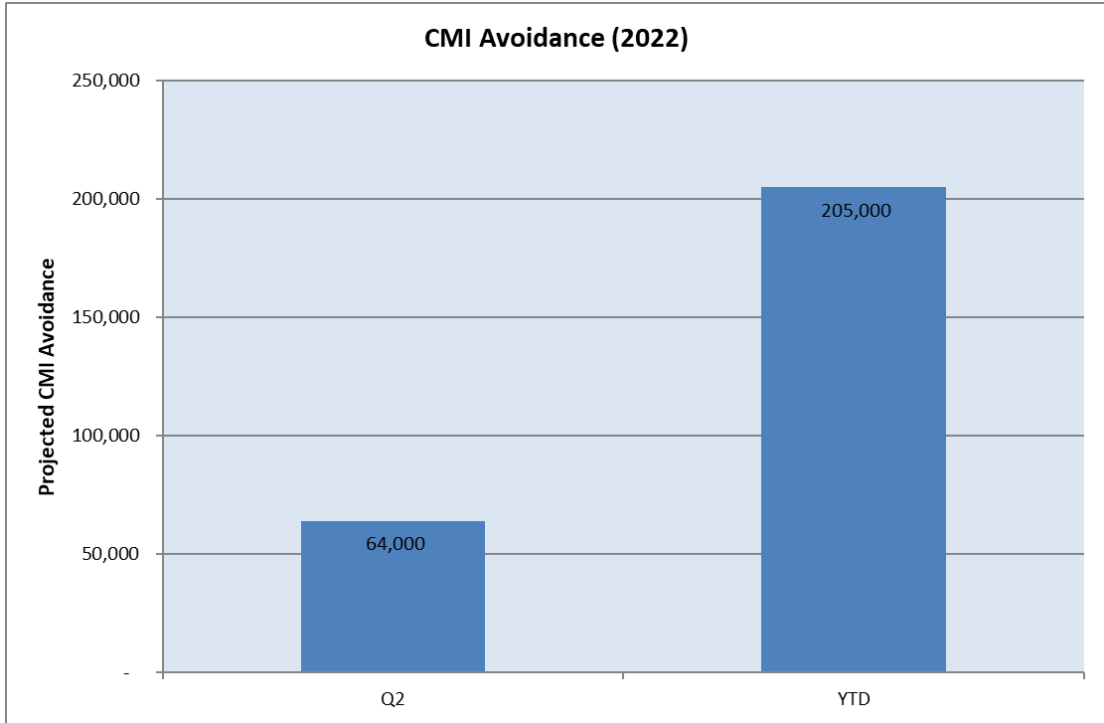
Figure 3 below shows the CMI avoidance that PPL Electric Utilities has estimated for the 2<sup>nd</sup> quarter and year-to-date. During the 2<sup>nd</sup> quarter of 2022, PPL Electric Utilities avoided a projected 64,000 CMI.

**Figure 3: Projected CMI Avoidance Due to Substation Inspections for 2<sup>nd</sup> Quarter and Year-to-Date 2022**

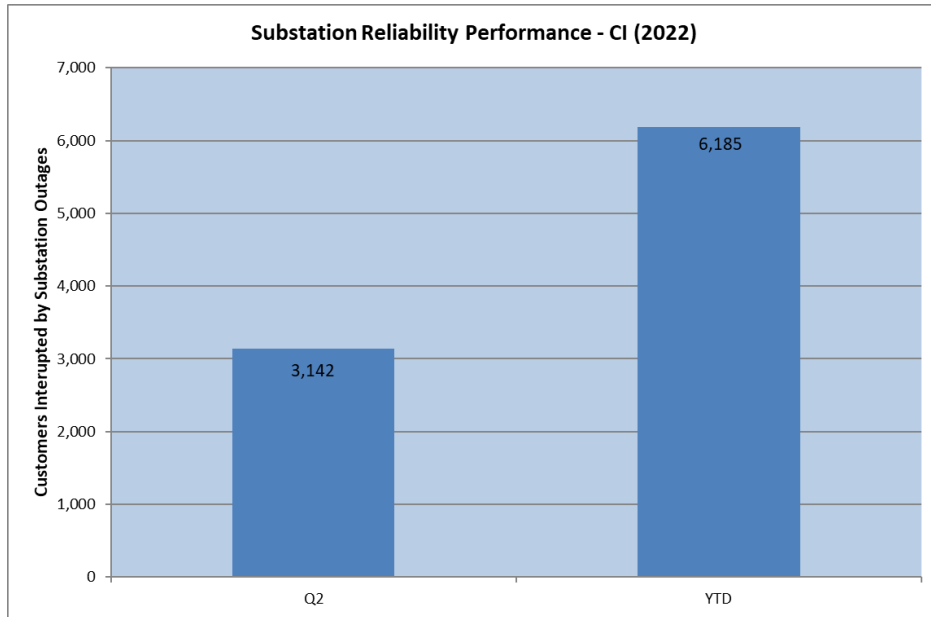
In the past three years, distribution substations have contributed a small amount toward the reliability metrics. During the 2<sup>nd</sup> quarter of 2022, the Company interrupted approximately 3,000 customers for a total of 115,000 CMI. The figures below show these results for the number of customers interrupted and CMI experienced, respectively.

**Figure 4: Substation Customers Interrupted for 2<sup>nd</sup> Quarter and Year-to-Date 2022**

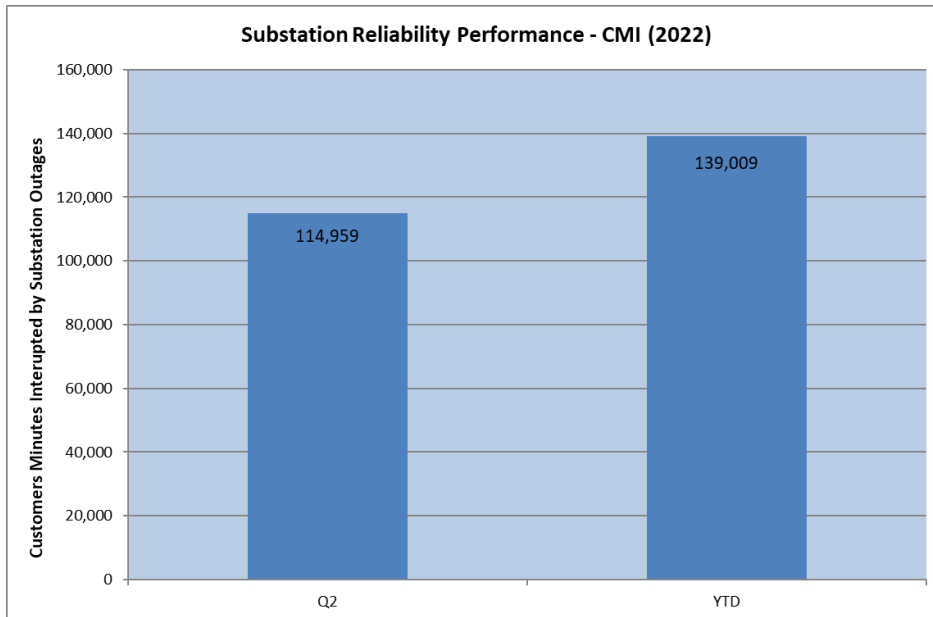
**Figure 5: Substation Customer Minutes of Interruption for 2<sup>nd</sup> Quarter and Year-to-Date 2022**
