**Re: PPL Electric Utilities Corporation
Quarterly Reliability Report for the
Period Ended September 30, 2022
Docket No. M-2016-2522508**

PPL Electric Utilities Corporation
Quarterly Reliability Report
to the
Pennsylvania Public Utility Commission

October 2022

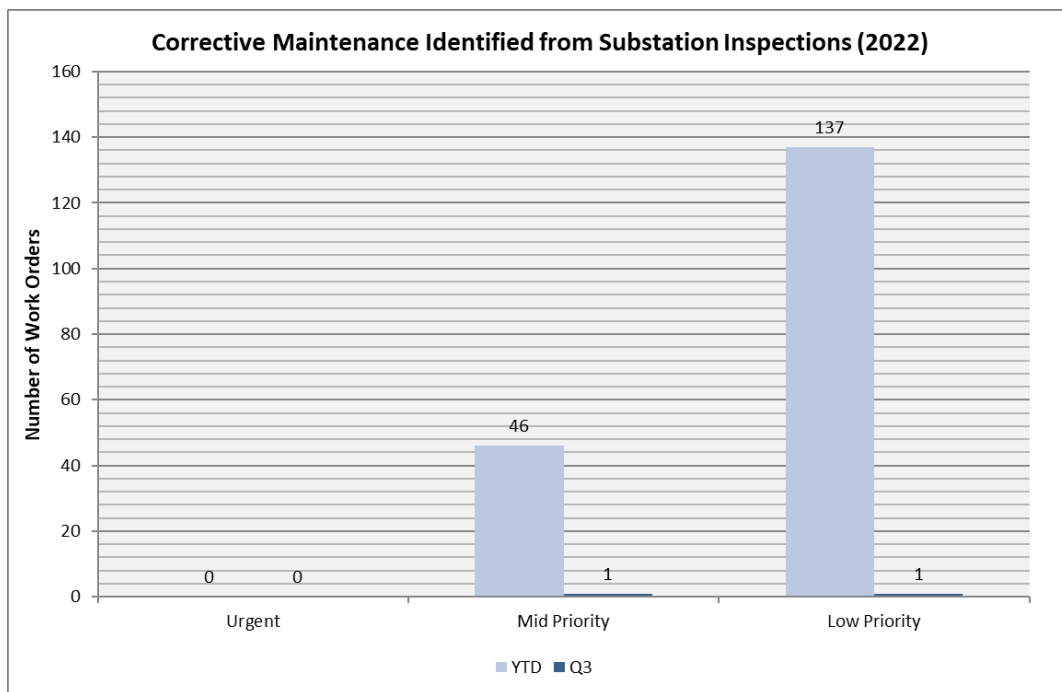
During the 3rd quarter of 2022, two corrective work orders were created with the following breakdown by priority.

Figure 1: Corrective Maintenance Work Orders by Priority Level for 3rd Quarter and Year-to-Date 2022

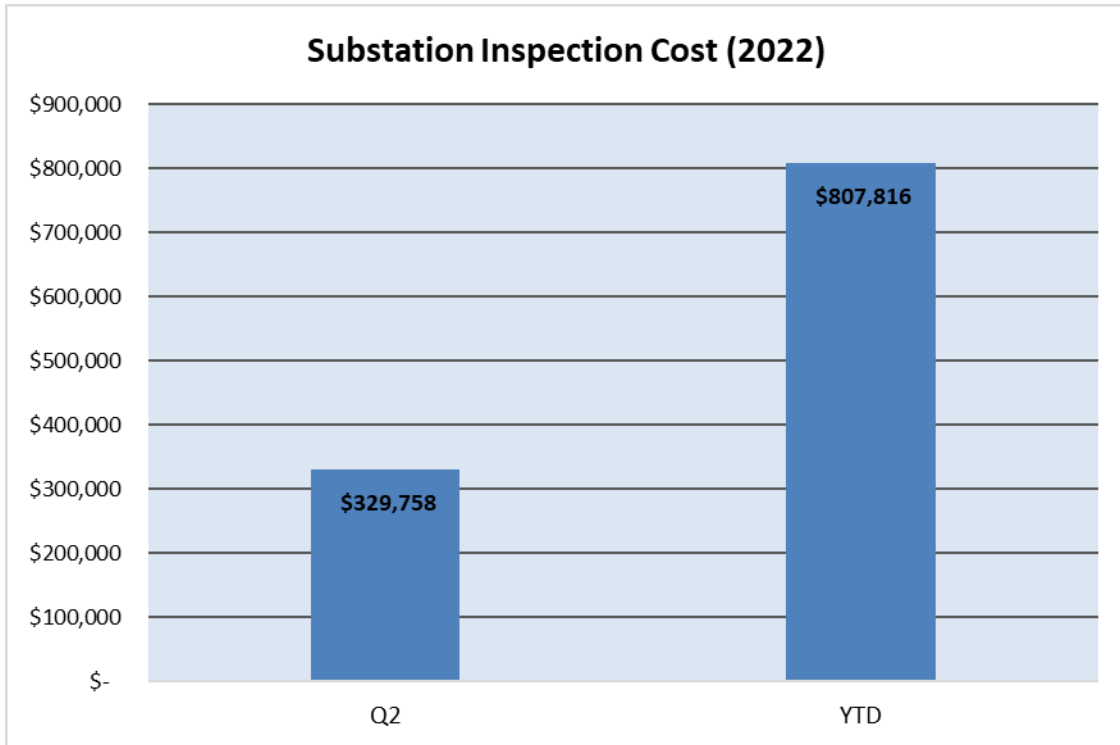
During the 3rd quarter of 2022, PPL Electric Utilities spent approximately \$330,000 on substation inspections.

Figure 2: Substation Inspection Costs for 3rd Quarter and Year-to-Date 2022

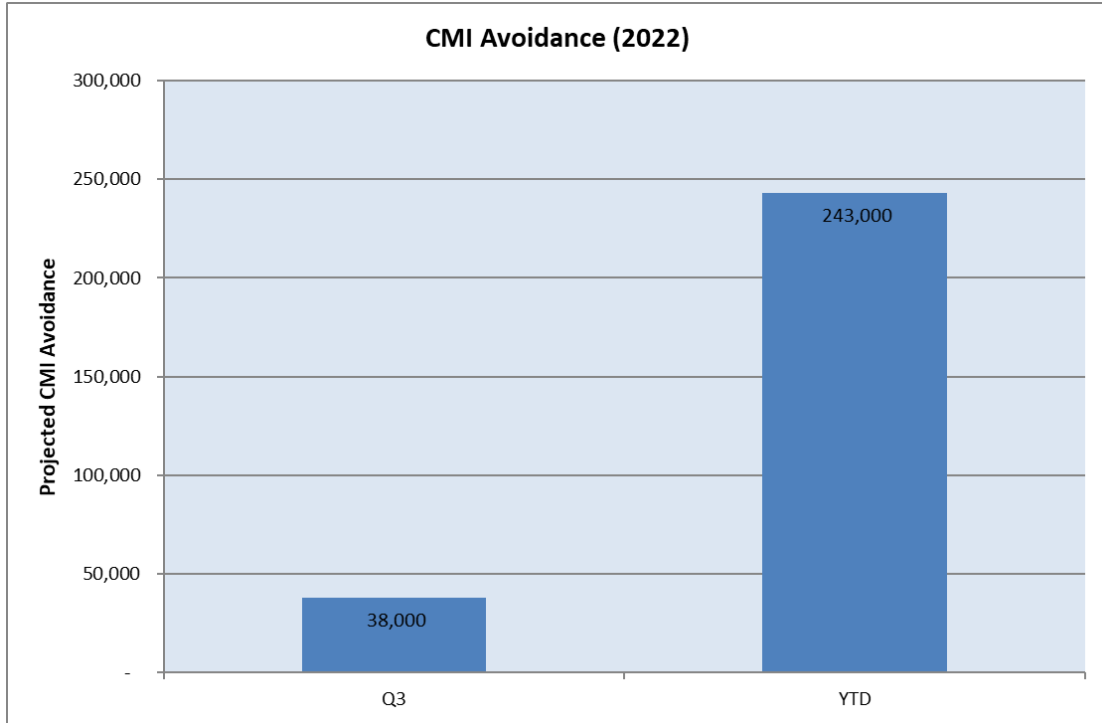
Figure 3 below shows the CMI avoidance that PPL Electric Utilities has estimated for the 3rd quarter and year-to-date. During the 3rd quarter of 2022, PPL Electric Utilities avoided a projected 38,000 CMI.

Figure 3: Projected CMI Avoidance Due to Substation Inspections for 3rd Quarter and Year-to-Date 2022

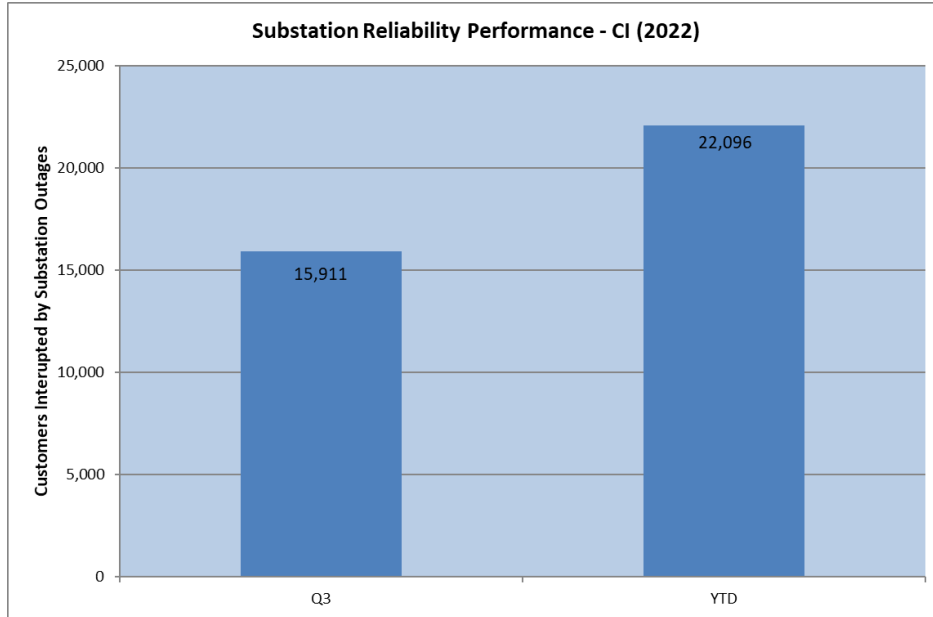
In the past three years, distribution substations have contributed a small amount toward the reliability metrics. During the 3rd quarter of 2022, the Company interrupted approximately 16,000 customers for a total of 273,000 CMI. The figures below show these results for the number of customers interrupted and CMI experienced, respectively.

Figure 4: Substation Customers Interrupted for 3rd Quarter and Year-to-Date 2022

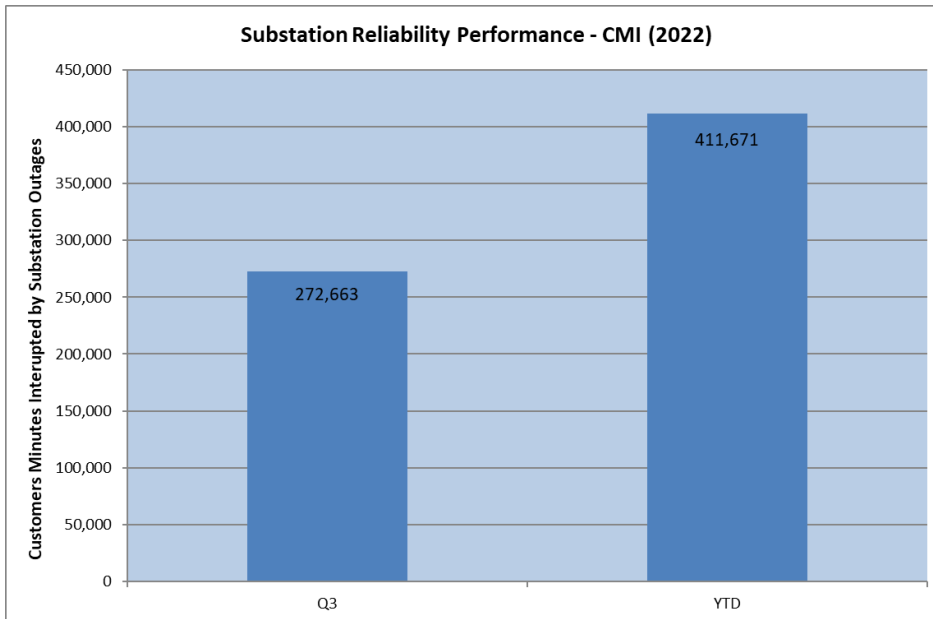
Figure 5: Substation Customer Minutes of Interruption for 3rd Quarter and Year-to-Date 2022
