**Re: PPL Electric Utilities Corporation
2022 Annual Reliability Report
Docket No. M-2016-2522508**

**PPL Electric Utilities Corporation
2022 Annual Reliability Report
to the
Pennsylvania Public Utility Commission**

April 28, 2023

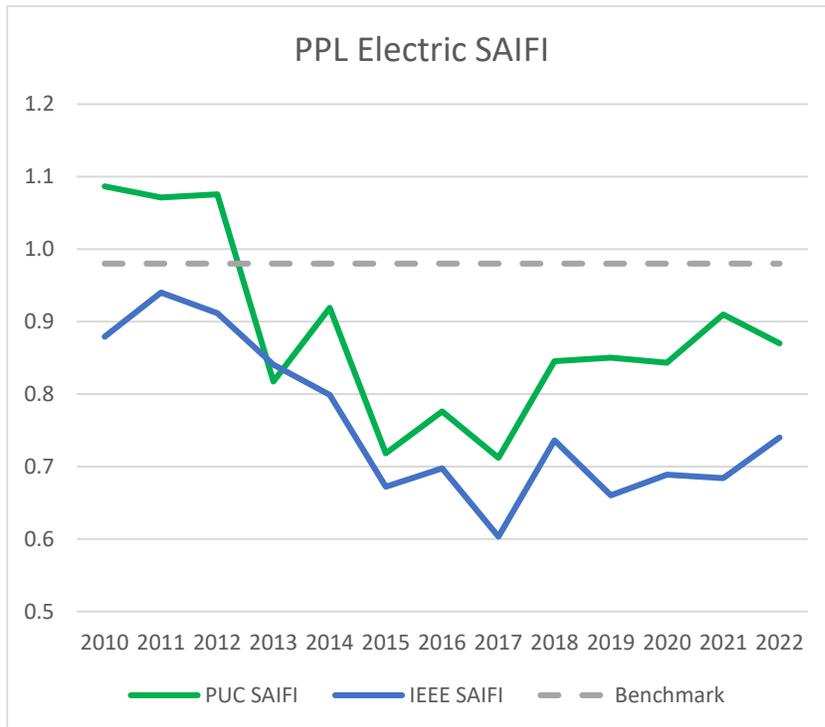
Our ongoing focus around preventing customer interruptions through system automation, vegetation management and asset performance continues to directly support overall strong reliability results, with over 1.6 million outages saved since the inception of automation in 2017. This level of SAIFI performance is directly related to our high levels of customer satisfaction, with outages being reduced by 19% (IEEE and PUC) since 2012 as shown in the SAIFI graph below.

IEEE SAIFI finished at 0.74 which is expected to be top quartile industry performance among large electric utilities nationally, and potentially top decile.

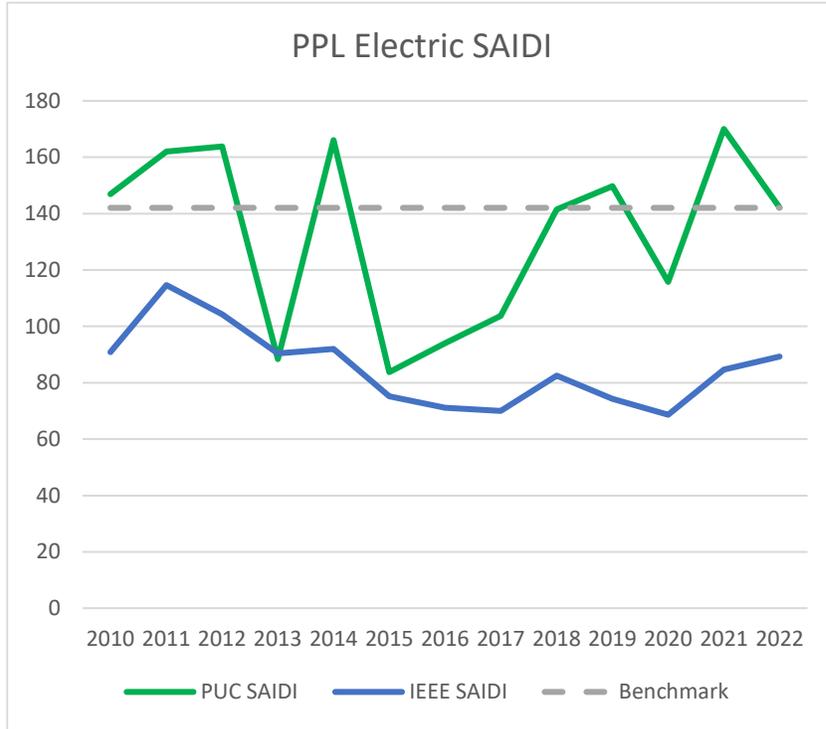
SAIDI Performance

2022 PUC SAIDI performance was well within standard, and effectively on benchmark at 142.2. IEEE SAIDI, which is more weather-normalized, shows 2022 SAIDI performance at 89.3 which is expected to be top quartile industry performance among large electric utilities nationally, and potentially top decile.

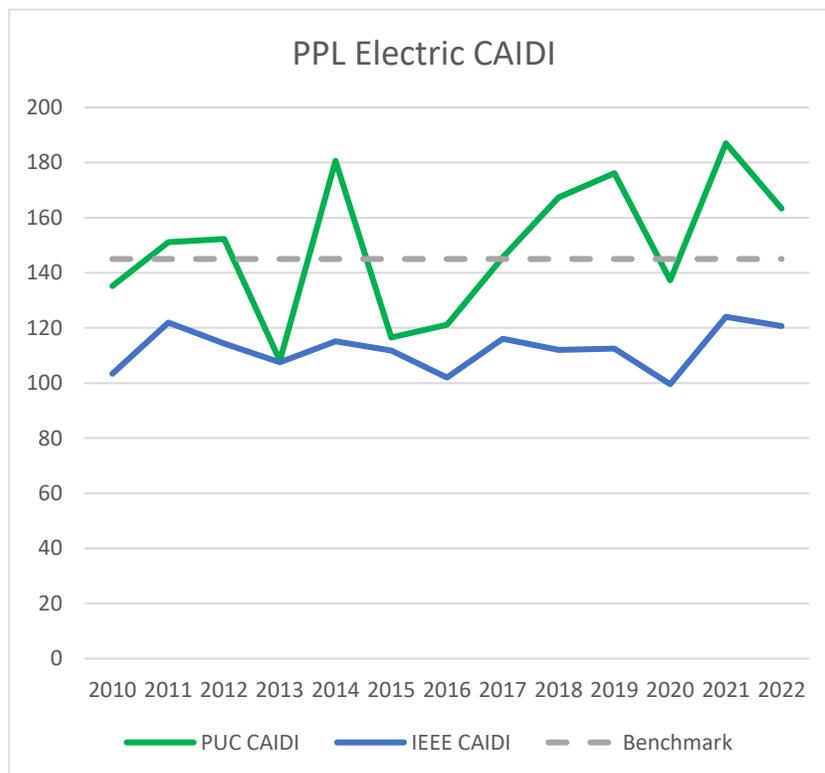
CAIDI Performance

In 2022 PUC CAIDI was heavily impacted by storms and was 12.7% above benchmark. 2022 CAIDI was improved over 2021 CAIDI by 24 minutes. Our more weather normalized IEEE CAIDI was 120.7, versus the non-weather normalized PUC value of 163.
