**Re: PPL Electric Utilities Corporation
2023 Annual Reliability Report
Docket No. M-2016-2522508**

**PPL Electric Utilities Corporation
2023 Annual Reliability Report
to the
Pennsylvania Public Utility Commission**

April 30, 2024

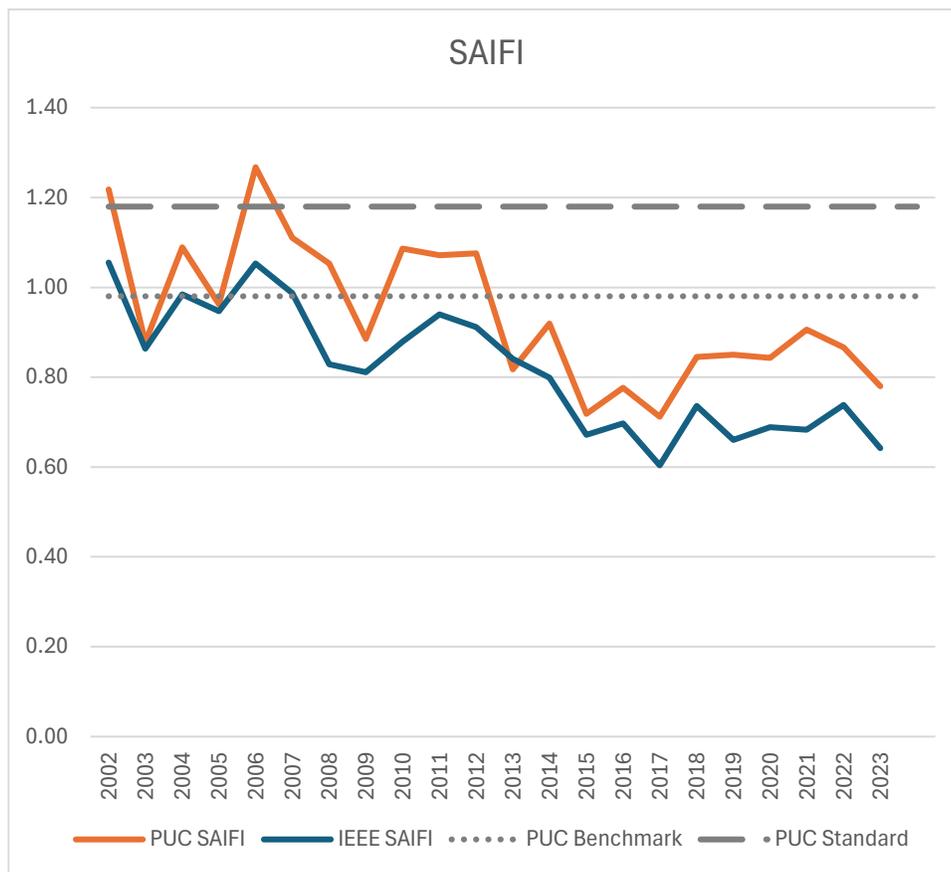
IEEE SAIFI finished at 0.642 which is expected to be top quartile industry performance among large electric utilities nationally, and likely top decile.

Our ongoing focus around preventing customer interruptions through system automation, vegetation management and asset performance continues to directly support overall strong reliability results, with over 1.9 million outages saved since the inception of automation in 2017. This level of SAIFI performance is directly related to our high levels of customer satisfaction.

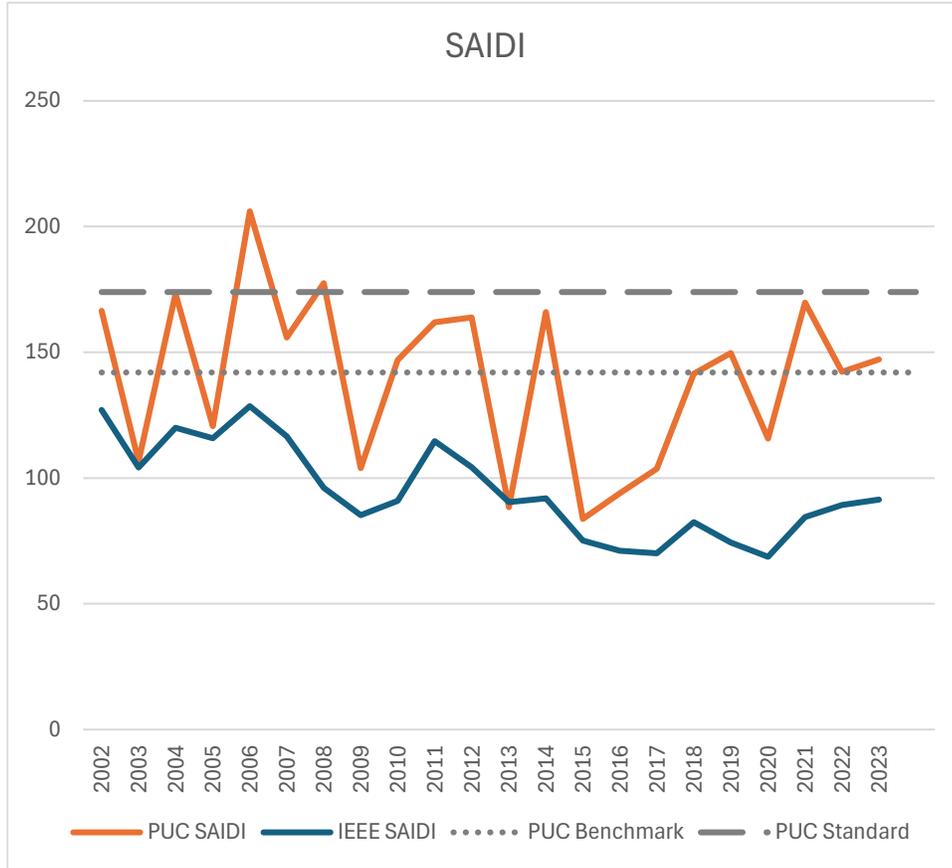
SAIDI Performance

2023 PUC SAIDI performance was well within standard, and 3.6% above benchmark at 147.2. IEEE SAIDI, which is more weather-normalized, shows 2023 SAIDI performance at 91.5 which is expected to be near top quartile industry performance among large electric utilities nationally.

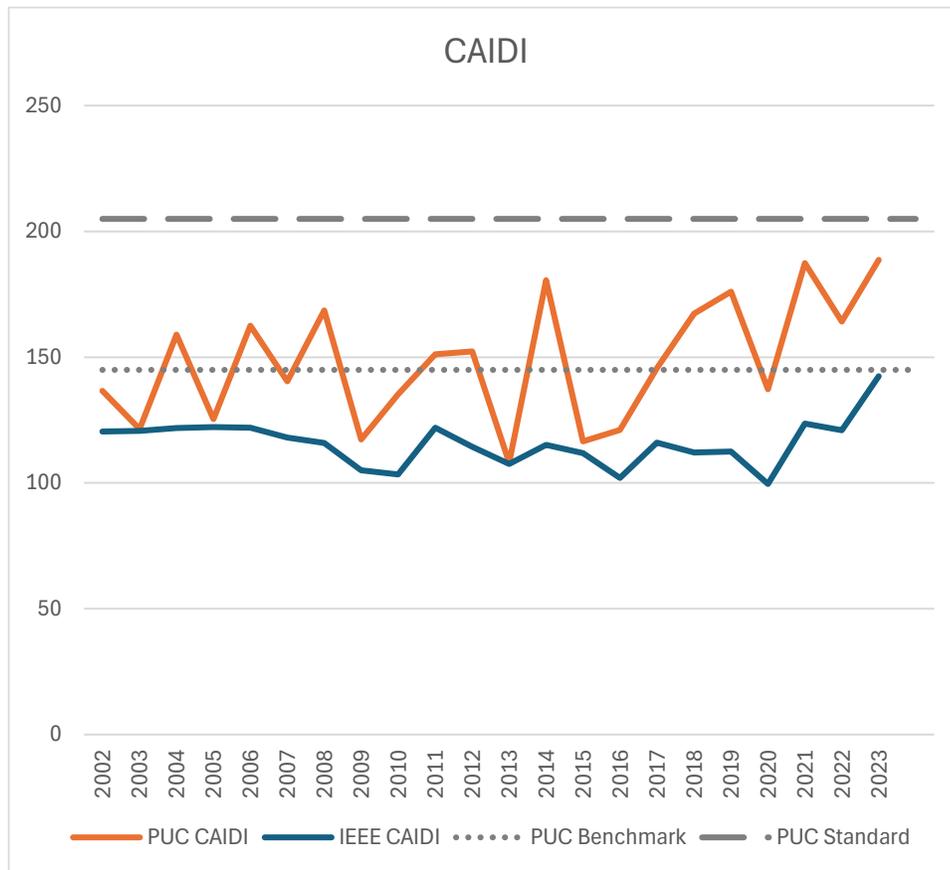
CAIDI Performance

In 2023 PUC CAIDI was heavily impacted by storms and was 30% above benchmark. Our more weather normalized IEEE CAIDI was 142.5, versus the non-weather normalized PUC value of 188.7.

With 2023 storms at record frequency, along with automated systems preventing and converting outages to momentary interruptions, higher CAIDI values are not unexpected. However, several initiatives continue to be evaluated to improve CAIDI performance. Some of these strategic areas include:
