**Re: PPL Electric Utilities Corporation
Quarterly Reliability Report for the
Period Ended June 30, 2024
Docket No. M-2023-3039027**

PPL Electric Utilities Corporation
Quarterly Reliability Report
to the
Pennsylvania Public Utility Commission

July 2024

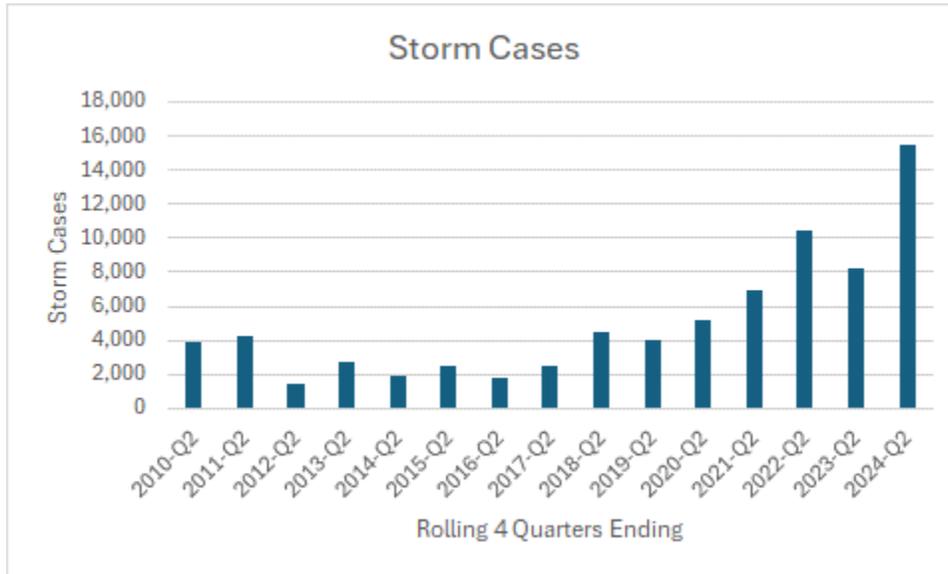
Reviewing rolling four quarter periods ending in Q2, the period ending 2024 Q2 saw 258% more storm cases than the average of 2010-2023.
