**Re: PPL Electric Utilities Corporation  
Quarterly Reliability Report for the  
Period Ended September 30, 2024  
Docket No. M-2023-3039027**

**PPL Electric Utilities Corporation**  
**Quarterly Reliability Report**  
**to the**  
**Pennsylvania Public Utility Commission**

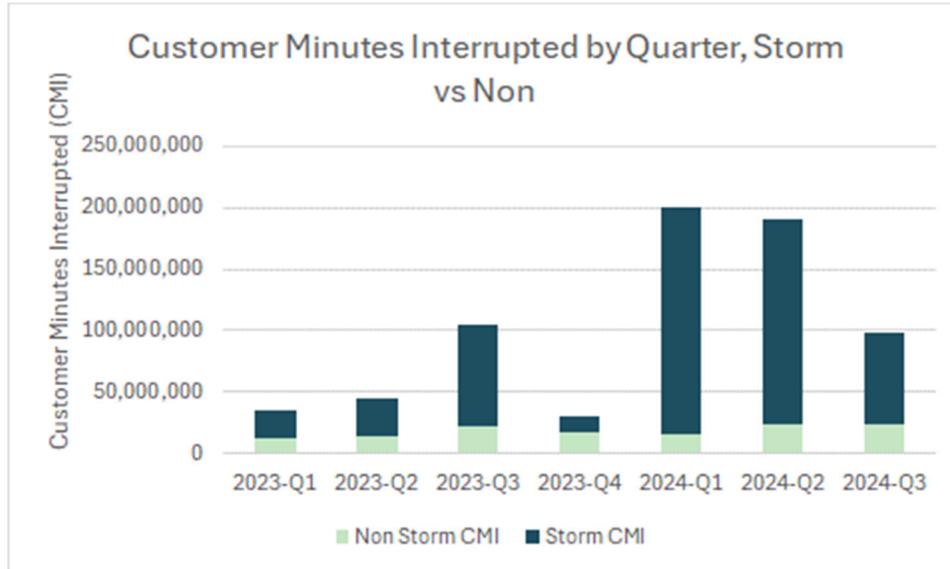
While PPL Electric’s third-quarter SAIFI was within the PUC standard, other metrics were significantly behind, largely attributable to high storm impact.

For the rolling four quarters ending on 9/30/2024, storm impacts remain highly elevated by historical standards. In 2024 alone, PPL Electric has seen ten storms of 600 cases or higher, including five storms of over 1,000 cases. As mentioned in section (1), the five 1,000+ case events, which may have been excludable prior to the implementation of FLISR, account for over half of all Customer Minutes Interrupted in the reporting period.
