**Re: PPL Electric Utilities Corporation
Quarterly Reliability Report for the
Period Ended December 31, 2024
Docket No. M-2023-3039027**

PPL Electric Utilities Corporation
Quarterly Reliability Report
to the
Pennsylvania Public Utility Commission

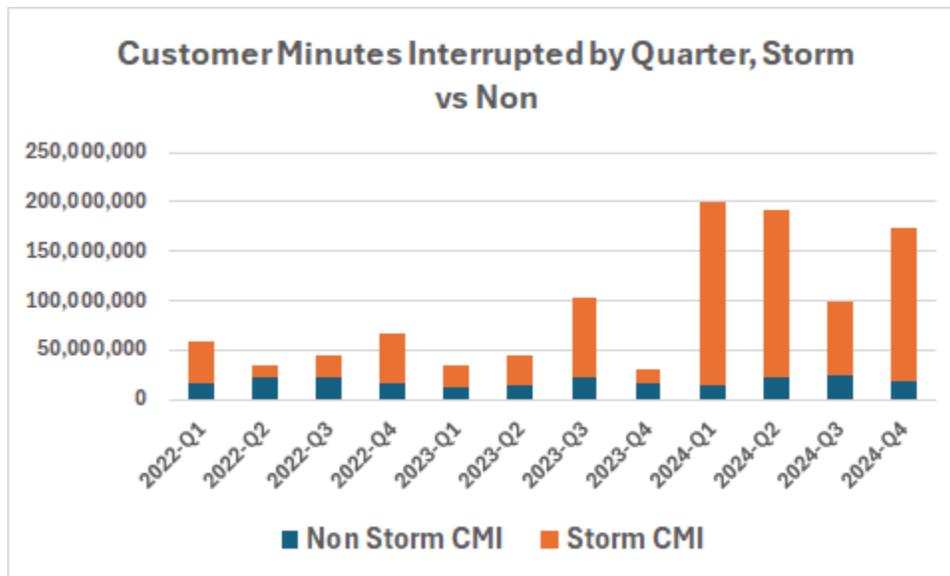
The chart below demonstrates the outsized impact of storms in 2024.

For the rolling four quarters ending on 12/31/2024, storm impacts remain highly elevated by historical standards. In 2024 alone, PPL Electric has seen eleven storms of 600 cases or higher, including six storms of over 1,000 cases. As mentioned in section (1), the five 1,000+ case events, which may have been excludable prior to the implementation of FLISR, account for over half of all Customer Minutes Interrupted in the reporting period.
