**RE: Danger Tree near Duquesne Light Distribution Line
Return Receipt**

Update on case C-2015-2479258, Ivan Yotov vs. Duquesne Light Company

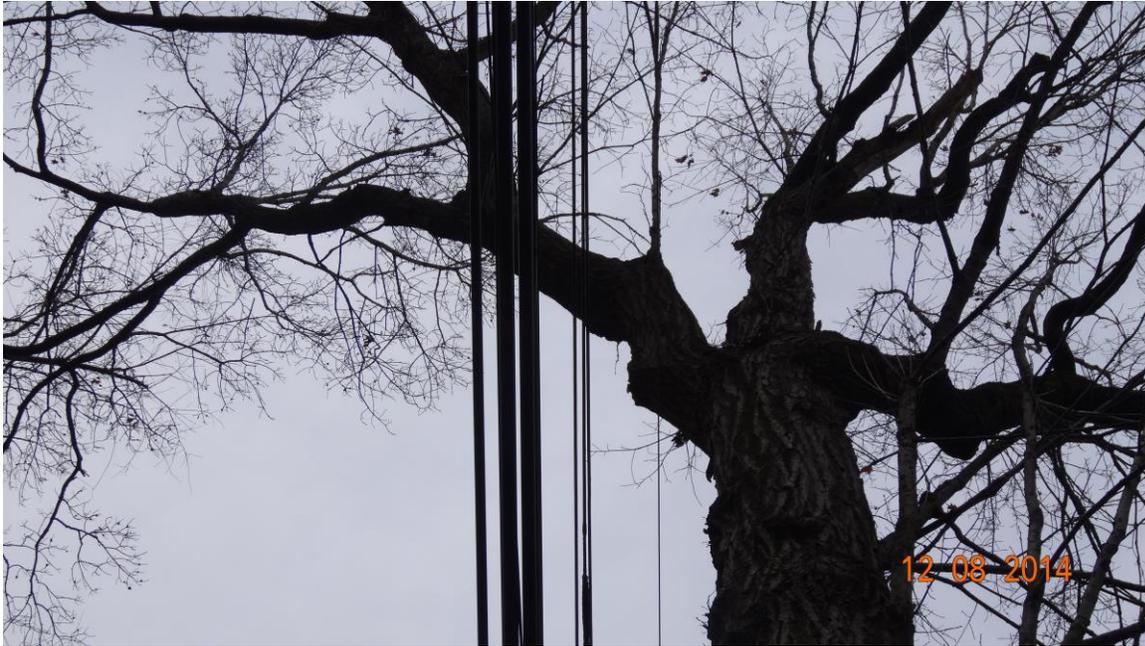
PHOTO # 1

I have been retained by Dr. Ivan and Maria Yotov, of 144 Woodshire Road, Pittsburgh, PA, 15215, to inspect and document a potentially dangerous tree situation to the Duquesne Light distribution line, utility pole #787/14, service line to their residence and the Yotov rear property. A large oak tree on the utility right-of way at the right rear of their property has a large section of dead top directly above the energized electric distribution line, and less than 6 feet from the pole. The distribution line is on the rear side of the tree 12 to 15 inches from the trunk, and their service line is on the opposite side of the tree originating near the pole. From the ground, daylight is visible through a split in the upright vertical trunk portion that is above all these wires and pole.(photo #4) A cyclone fence surrounding the VA hospital is under and turns a corner directly under the wires. The normal compliment of phone and cable lines is also on the pole and crosses their property with and directly under the Duquesne distribution line.

I have attached several photos to help identify the tree and wires. The wire closest to the tree in photos # 1, 2 and 5 is the energized distribution wire.

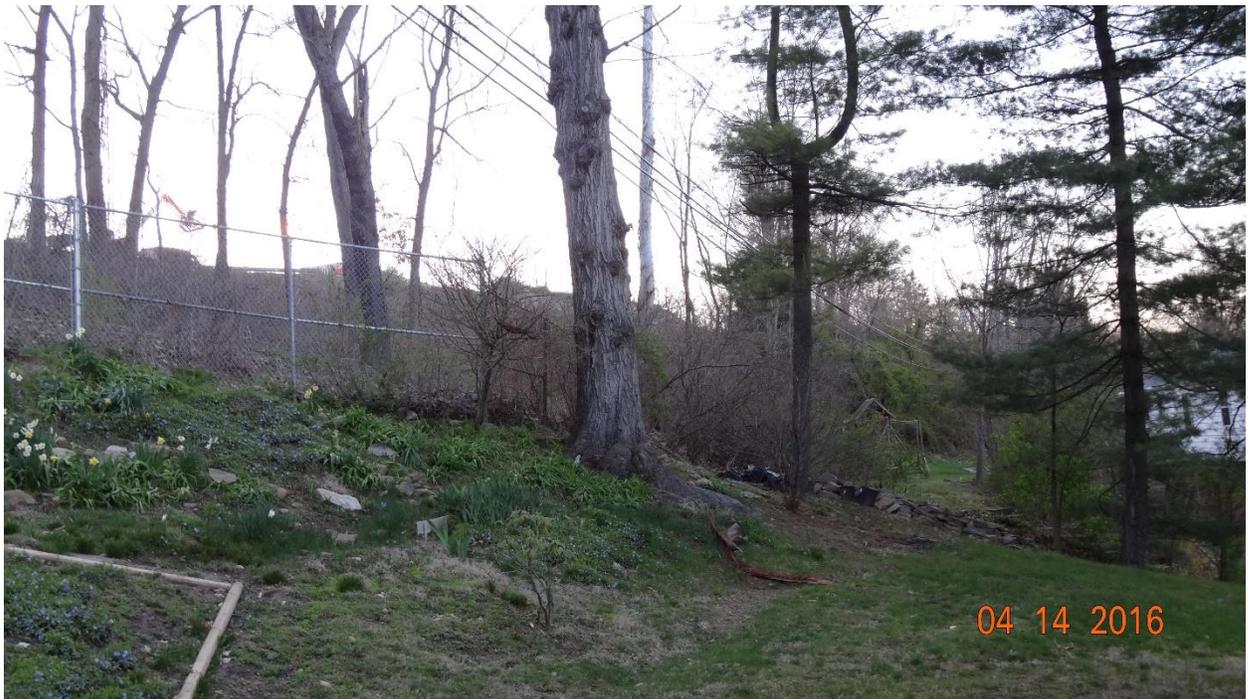
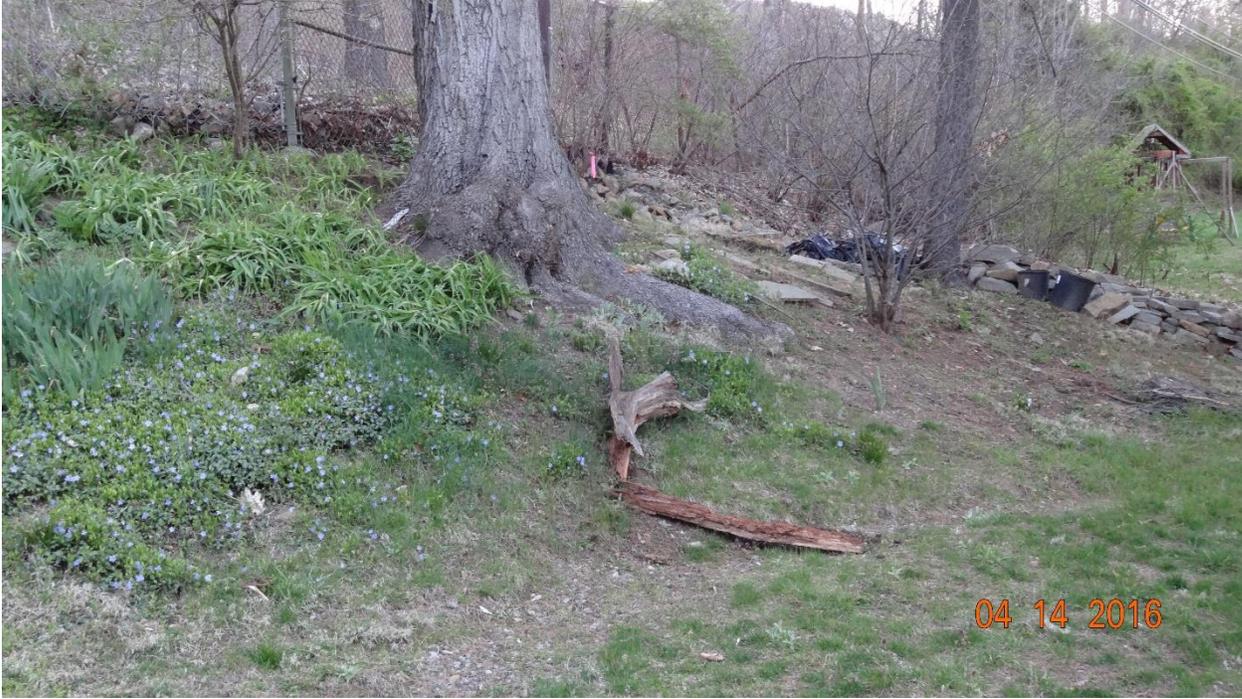
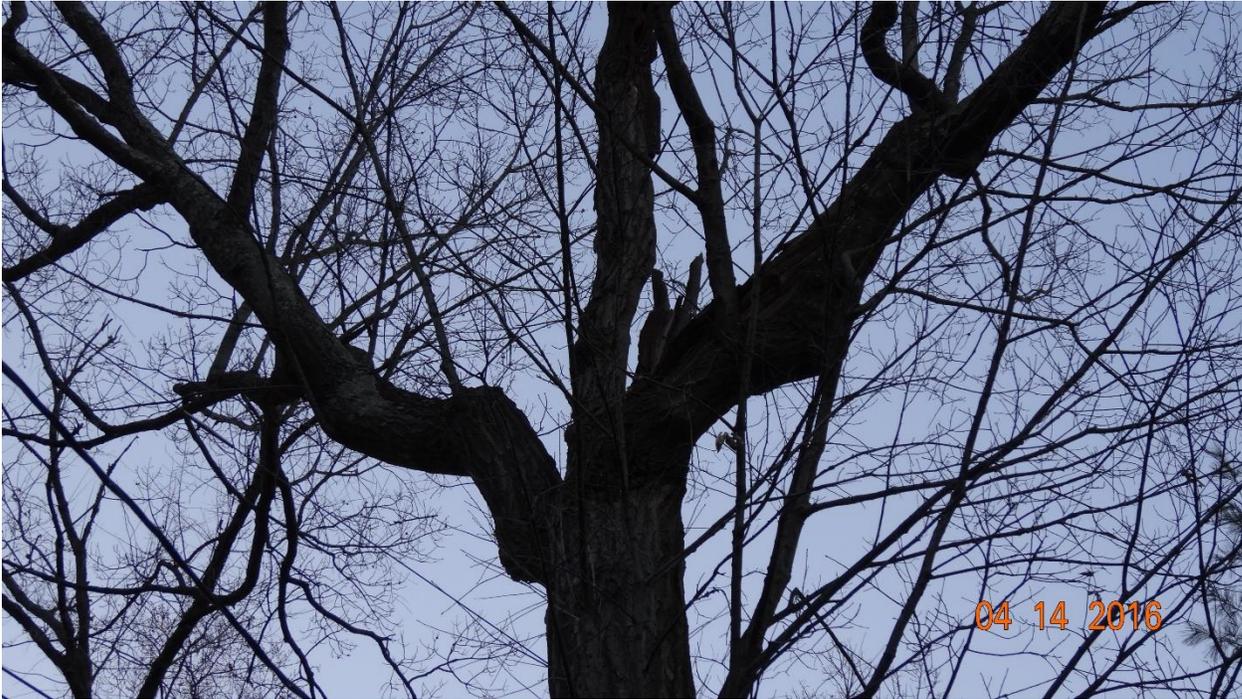
I am also attaching the updated information filed on April 14, 2016 in the original case. It shows the fallen large chunk as well as a branch on the tree that is partially detached and in danger of falling.

At 7:40 pm this evening a large chunk of the tree under question fell while we were out in the yard. The chunk fell 5 yards from my wife. We were lucky that no one was hurt. The weather was sunny and calm. Below are some photos I took immediately after the chunk fell. This event confirms that this is an extremely dangerous tree that has to be removed immediately.

I ask the PUC to enforce the safety regulations by requiring Duquesne Light to remove the tree.
