Re: Pennsylvania Public Utility Commission,
Bureau of Investigation and Enforcement v.
West Penn Power Company
Docket No. C-2021-
Formal Complaint

FORMAL COMPLAINT

12. On April 12, 2018, a conductor owned and operated by West Penn Power fell into the wooded property of Terry and Frances Colton at 203 McKrell Road, Tarentum, Pennsylvania 15084 ("Colton Property").

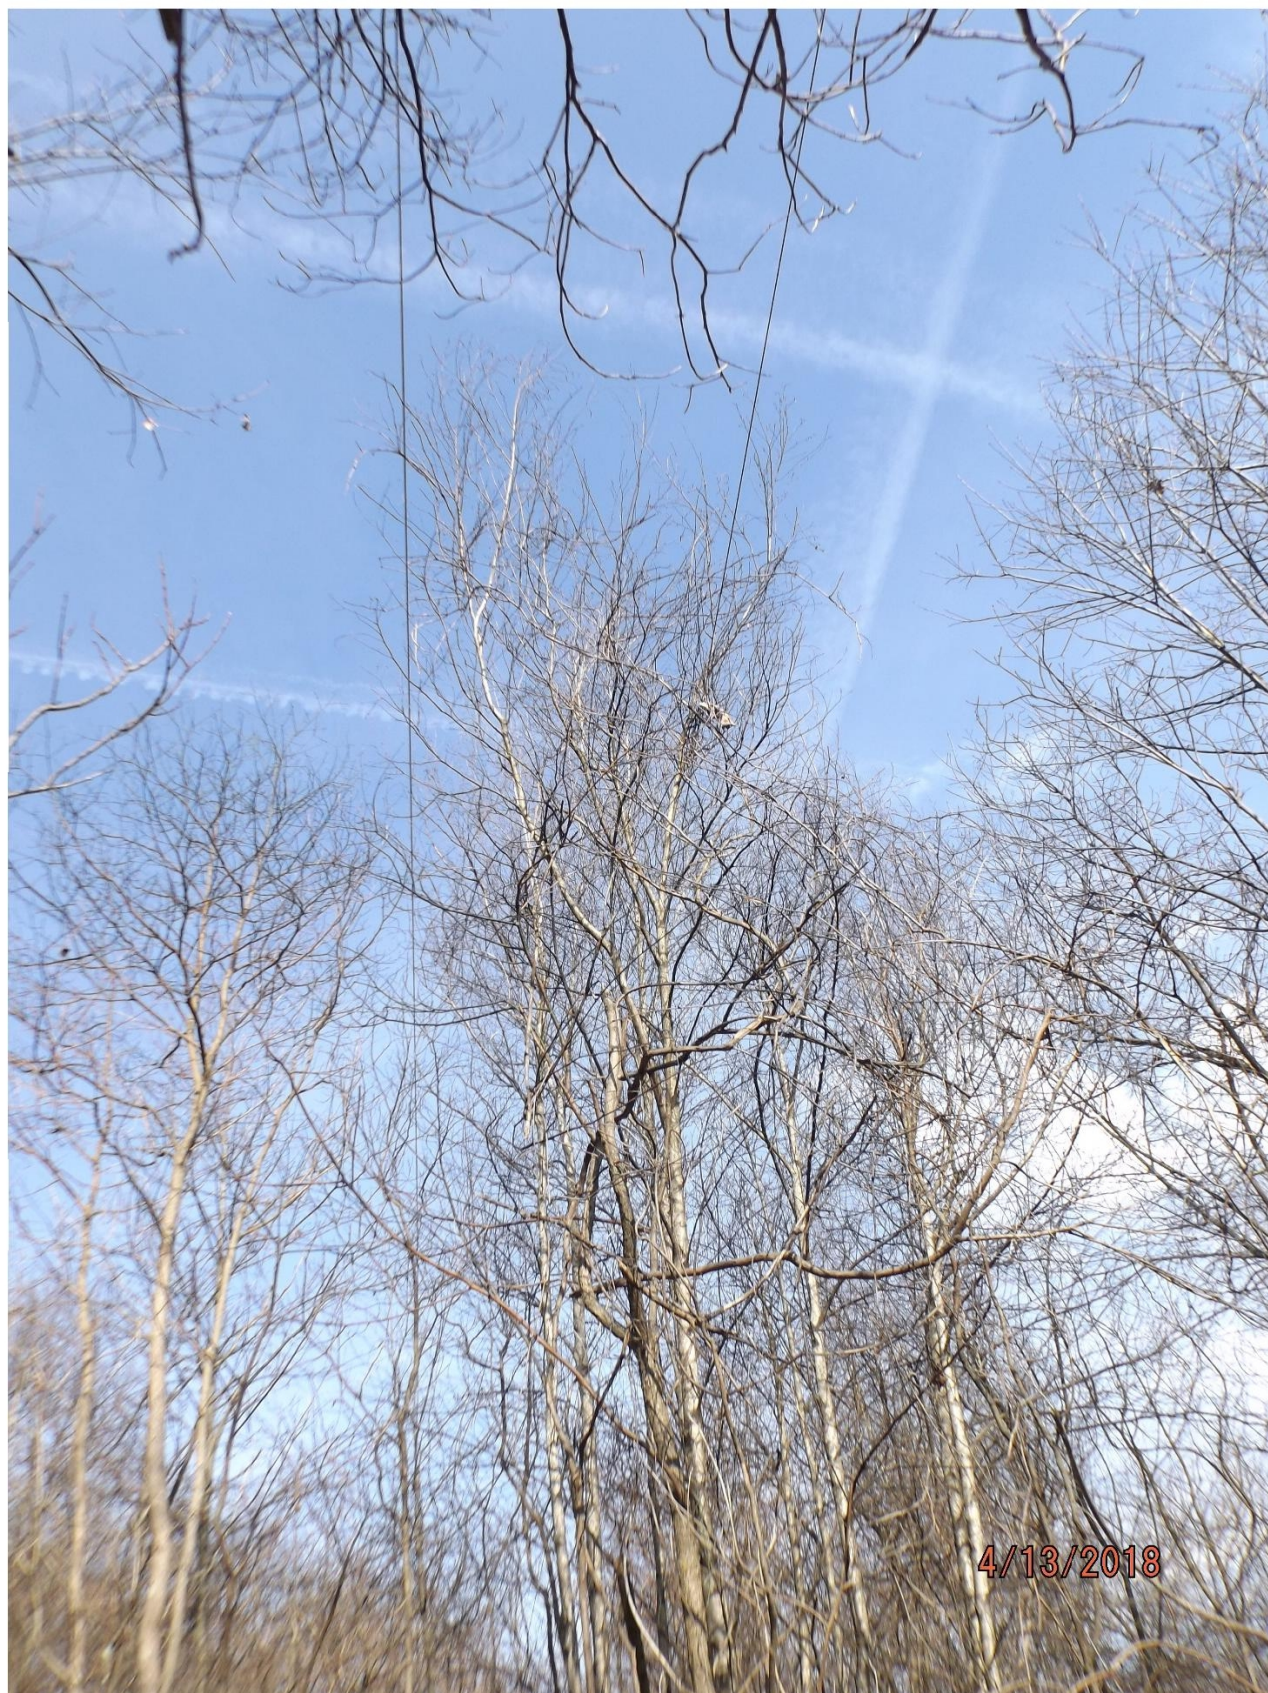
I&E
EXHIBIT 1B

4/13/2018
