**Re: Letter Of Notification Of PPL Electric Utilities Corporation, Filed Pursuant To 52 Pa. Code Chapter 57 Subchapter G, for Approval Of The Elimsport-Lycoming #2 And #3 230 kV Transmission Lines Connecting The Elimsport 230 kV Substation And They Lycoming 203 kV Substation In Washington And Armstrong Township, And Williamsport Borough, Lycoming County, Pennsylvania
Docket No. A-2021-_____**

ELIMSPORT-LYCOMING 230 kV COR-TEN® REBUILD PROJECT

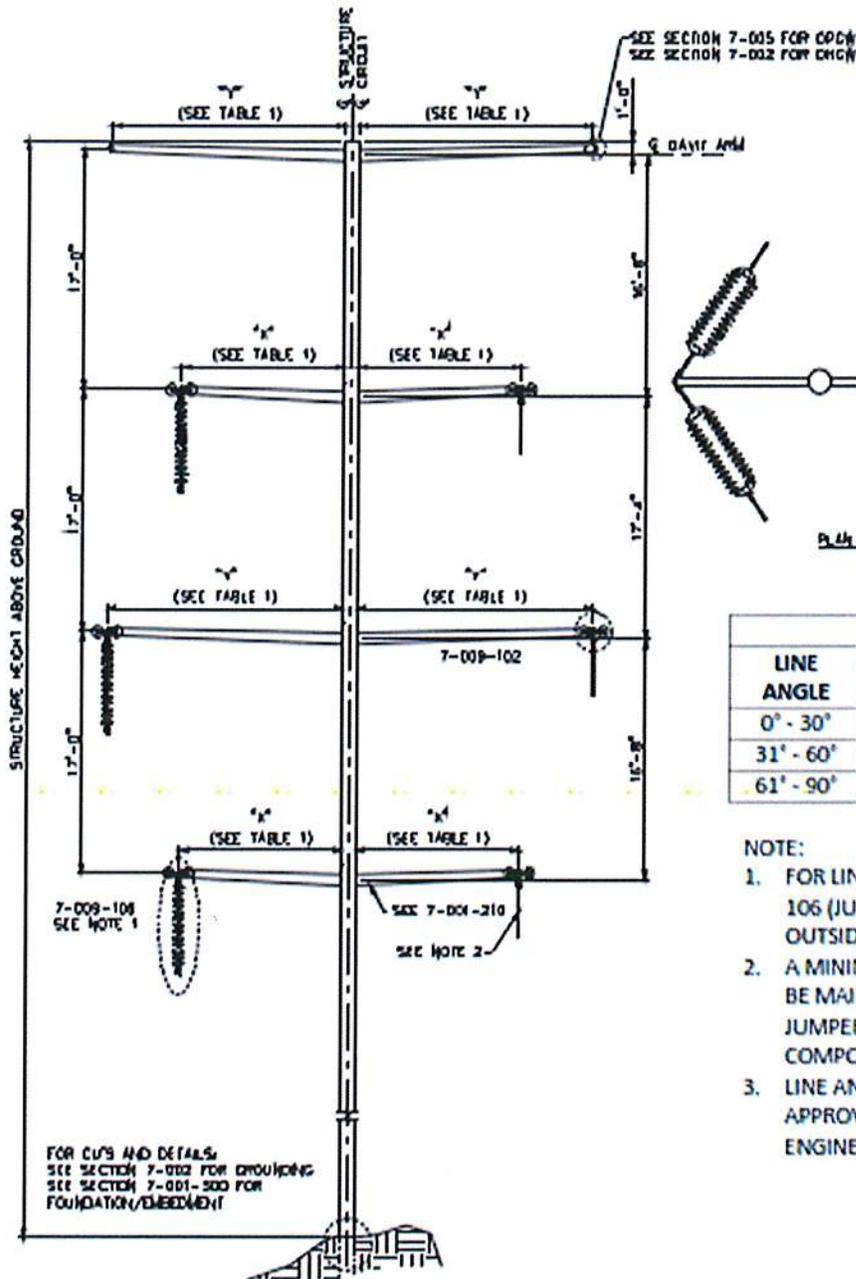
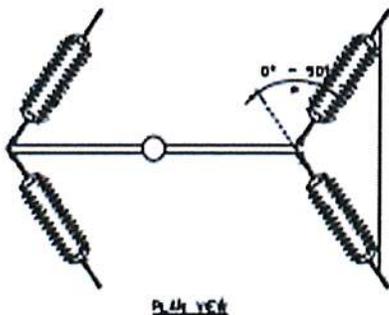
Figure 2-3: Typical 230 kV Long Span Double-Circuit Steel Pole Angle Tension on Arm Structure

230kV Long Span Double Circuit Steel Pole
0° To 90° Angle Tension on Arm Structure

LINE ANGLE	DAVIT ARM LENGTH "X"	DAVIT ARM LENGTH "Y"
0° - 30°	12'-0"	16'-0"
31° - 60°	14'-0"	18'-0"
61° - 90°	17'-0"	21'-0"

- NOTE:
1. FOR LINE ANGLES OVER 10° INSTALL 7-009-106 (JUMPER SUSPENSION ASSEMBLY) ON OUTSIDE CIRCUIT ONLY.
 2. A MINIMUM 86 1/4 INCH CLEARANCE SHALL BE MAINTAINED FROM ANY POINT ON THE JUMPER TO ALL GROUNDED STRUCTURAL COMPONENTS AND HARDWARE.
 3. LINE ANGLE MAY EXCEED 90° WITH APPROVAL FROM PPL ENGINEERING/STANDARDS.

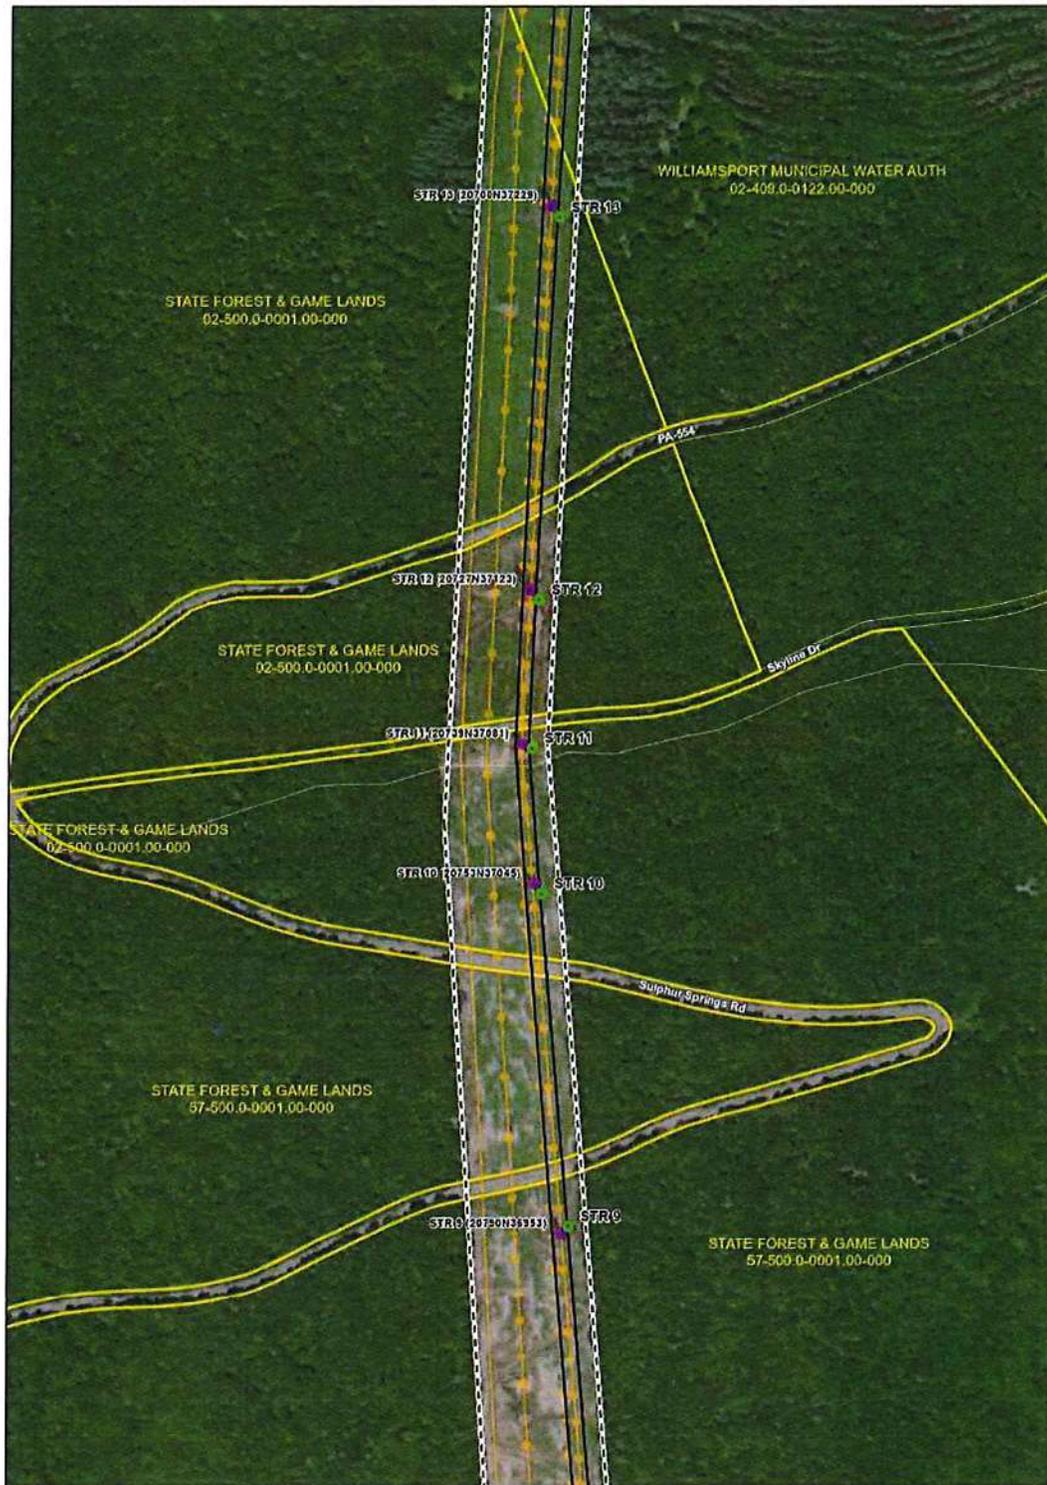
Figure 3-1
Aerial Map of the Project
Elimsport - Lycoming COR-TEN@
Rebuild Project
Sheet 2 of 6
 Lycoming County, Pennsylvania
 PPL Electric Utilities
 Allentown, Pennsylvania

Existing Structure (To Be Replaced)	Parcel's Crossed by ROW
Proposed Structure	Adjacent Parcel
PPL Electric Existing ROW	10M Wetlands
Existing Transmission Line	Existing Transmission Line
	69 kV
	230 kV

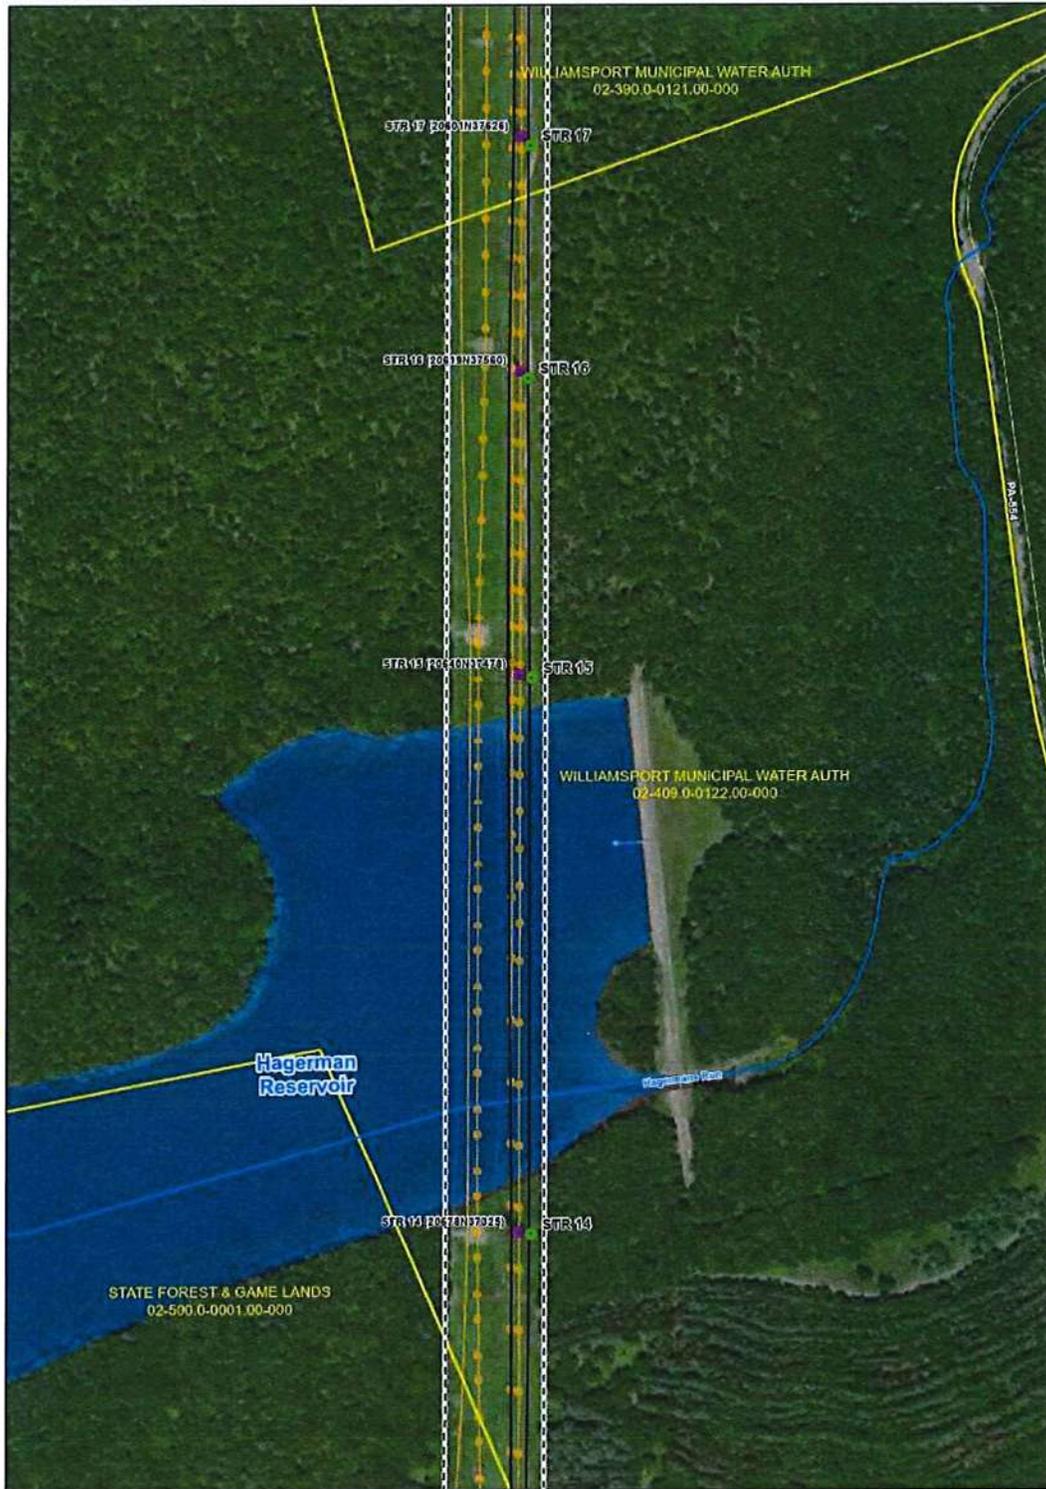
Figure 3-1
Aerial Map of the Project
Elmsport - Lycoming COR-TEN
Rebuild Project
Sheet 3 of 6
 Lycoming County, Pennsylvania
 PPL Electric Utilities
 Abington, Pennsylvania

Existing Structure (To Be Replaced)	Parcels Crossed by ROW
Proposed Structure	Adjacent Forest
PPL Deck or Existing ROW	Chapter 93 Designated Use Stream
Existing Circuit	CDF
	WAB Outlines
	Existing Transmission Lines
	66 kV
	230 kV

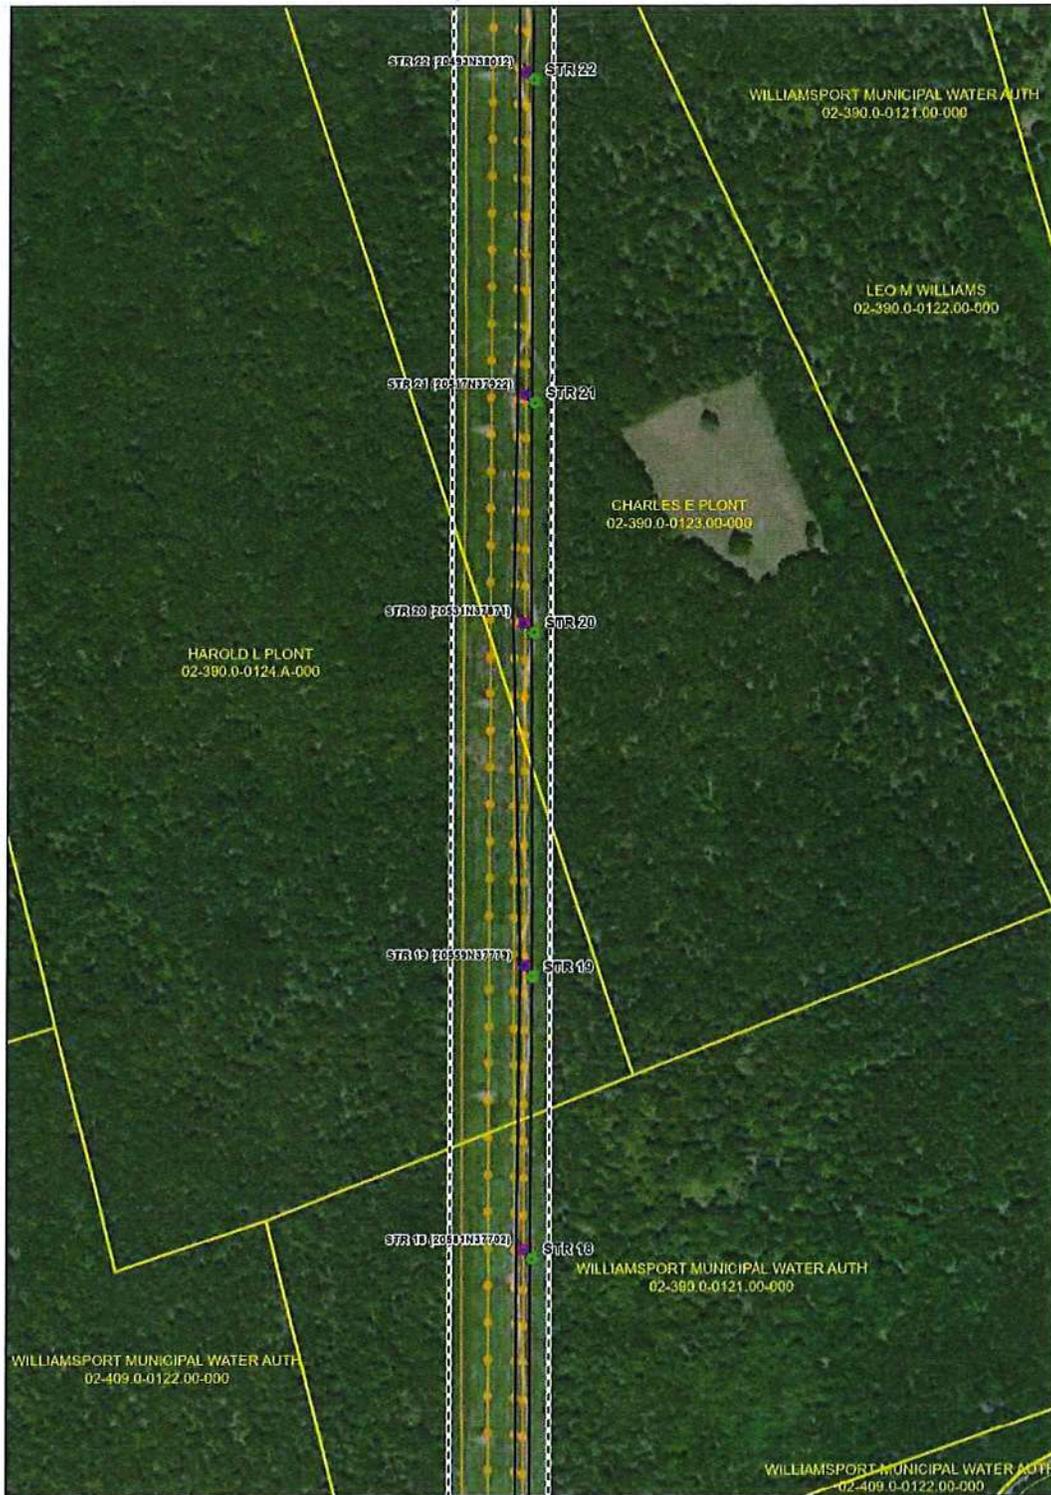
- Existing Structure (To Be Replaced)
- Proposed Structure
- PPL Electric Existing ROW
- Existing Circuit
- Parcels Crossed by ROW
- Adjacent Parcels
- NM Wetlands
- Existing Transmission Lines
 - 69 kV
 - 230 kV
