RE: Philadelphia Gas Works ("PGW") Quarterly Leak Report, Docket No. P-2012-2337737 and Quarterly Report on Mains and Training, Docket No. P-2015-2501500

## Summary of Cast Iron Main Performance

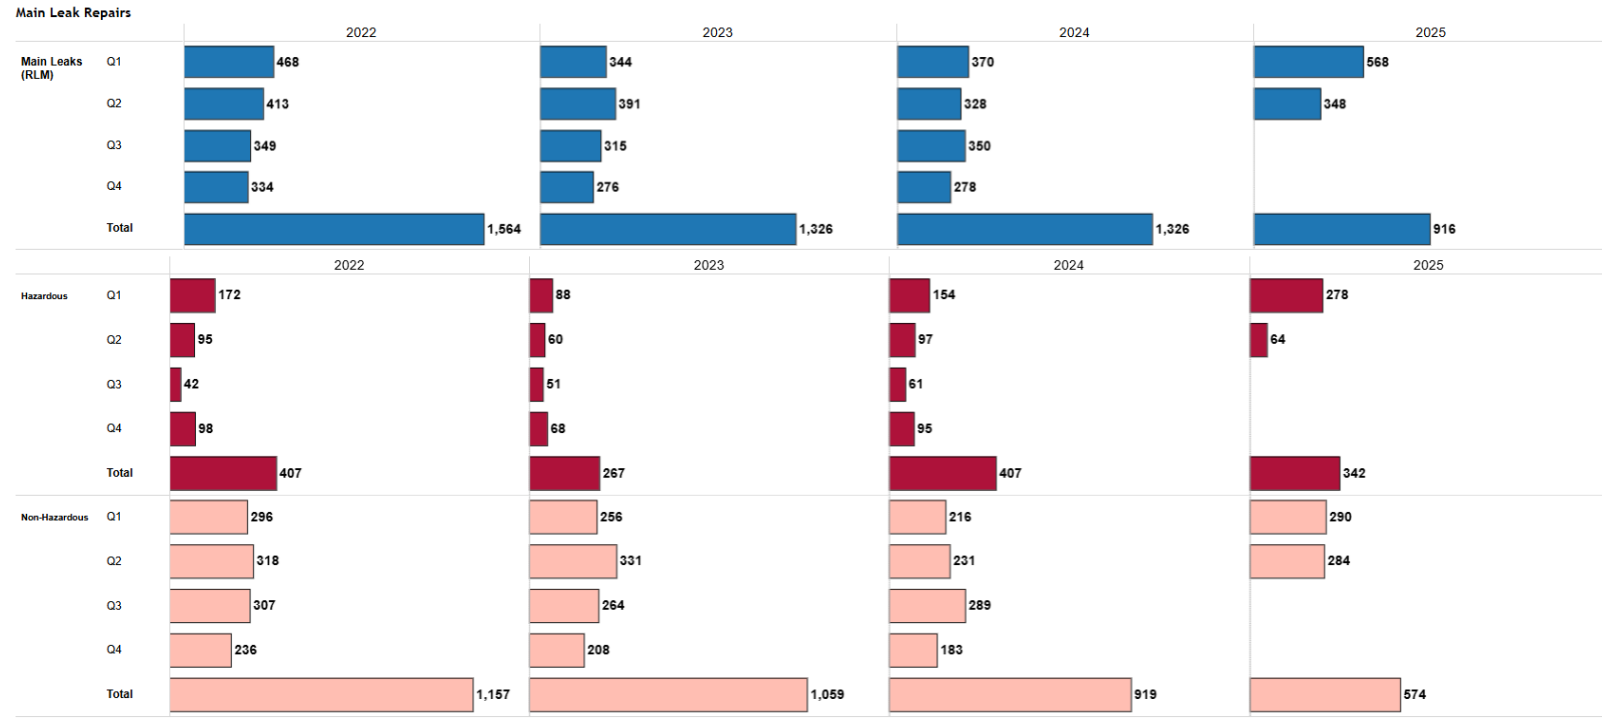
## 10” and Smaller Cast Iron Main Leak Repairs – Low / Intermediate Pressure (4.5” WC – 5 psig)

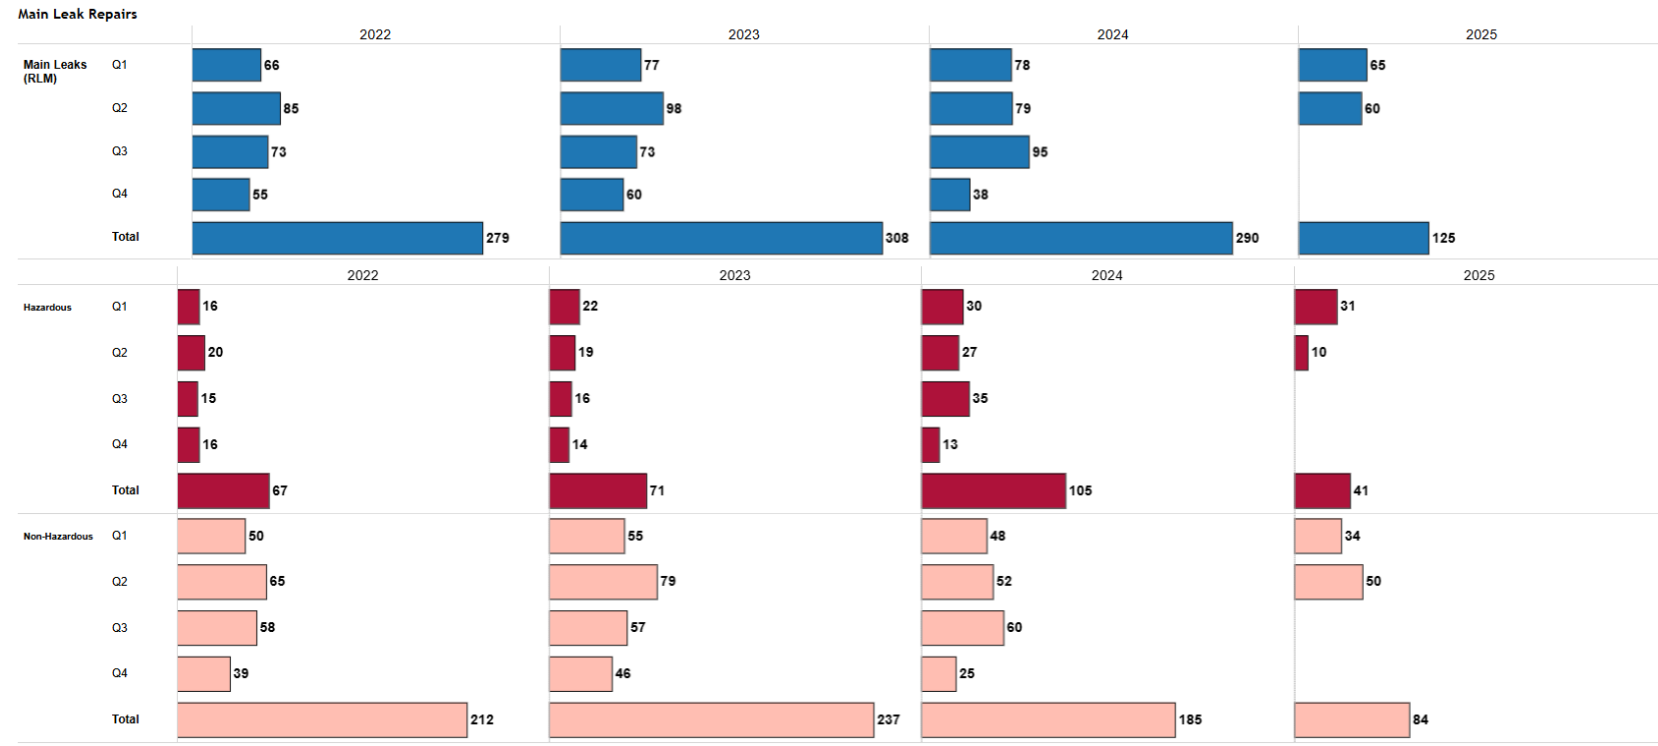
## 12” and Larger Cast Iron Main Leak Repairs – Low Pressure (4.5” WC – 14” WC)

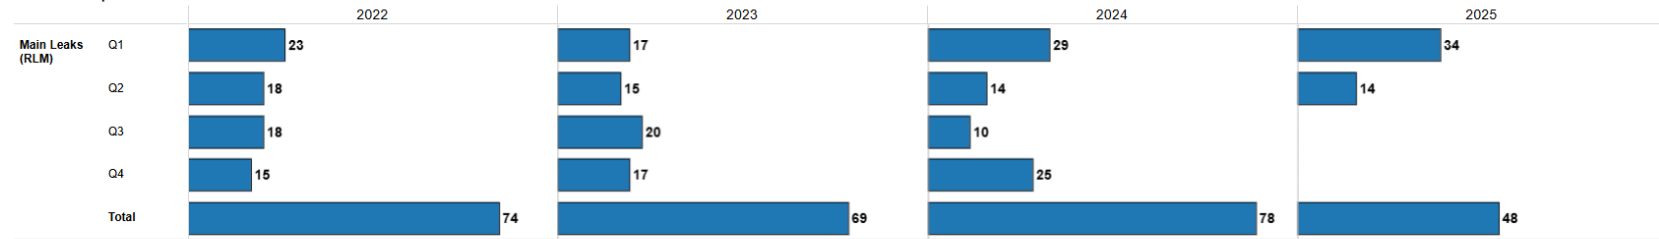
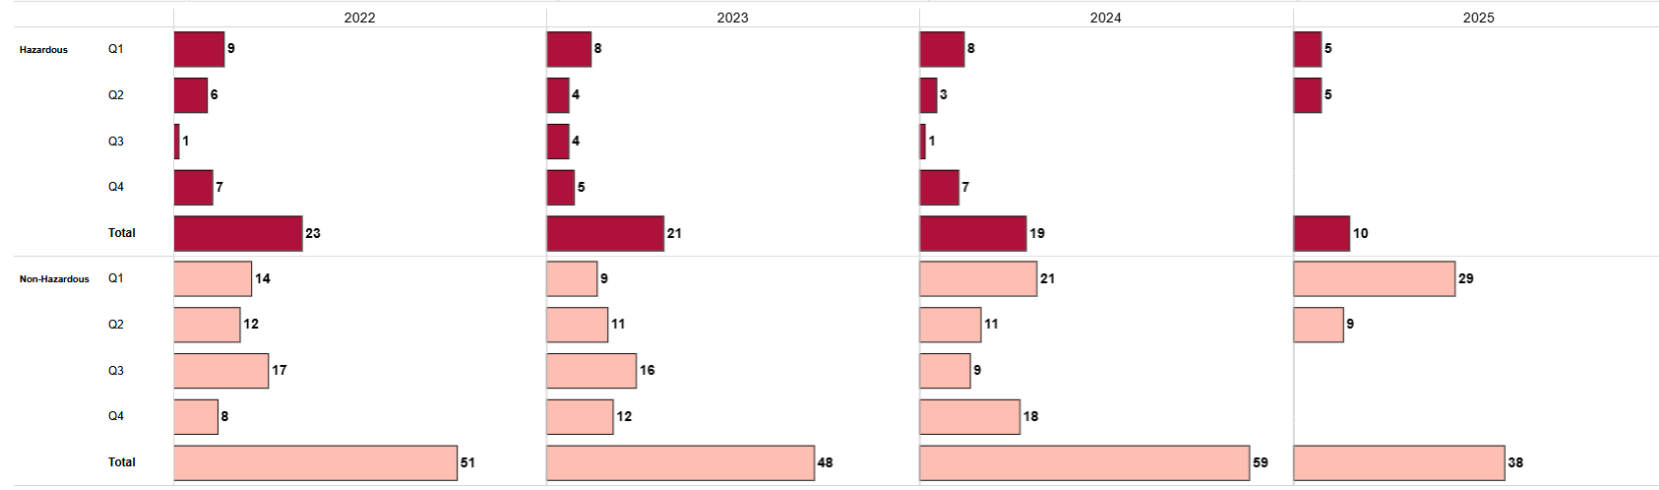
## 12” and Larger Cast Iron Main Leak Repairs – High Pressure (10 – 35 psig)

### Main Leak Repairs

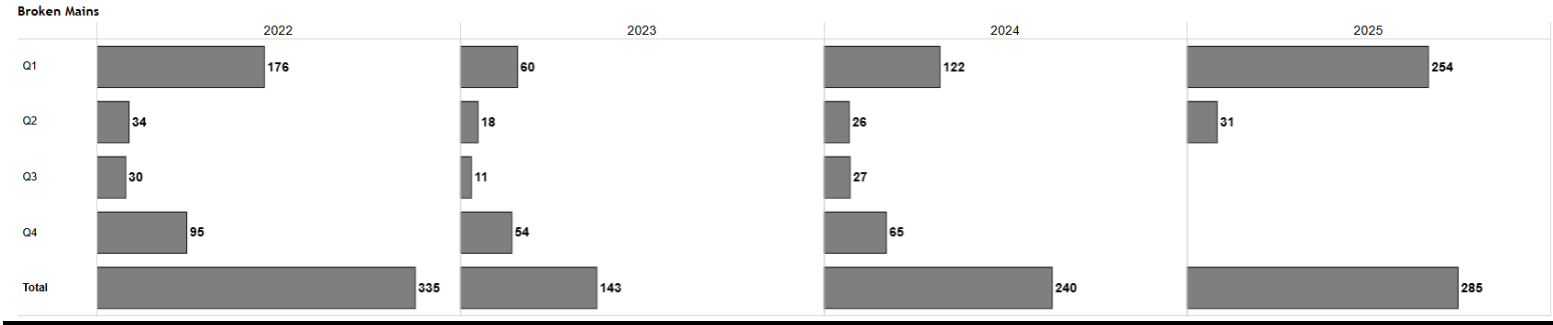
Cast Iron Broken Mains
