**Face Rock – Five Forks Inspection of Structures**

NEETRAC Project Number: 16-107

June, 2016

Principal Investigator: Joe Goldenburg, P.E.  
(GA Lic# PE033181)

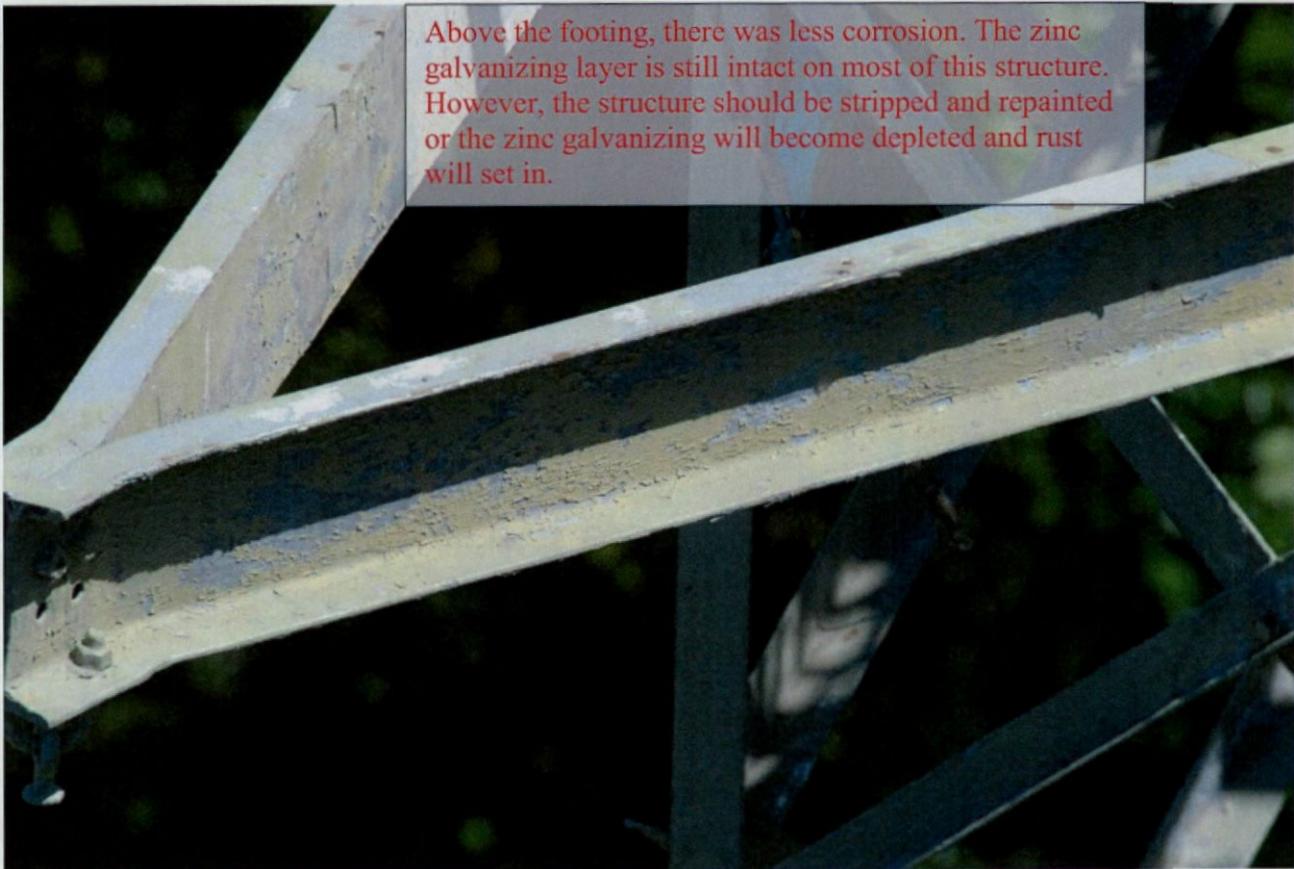
Figure 12: 3962S1518116 - Paint peeling and poor adhesion

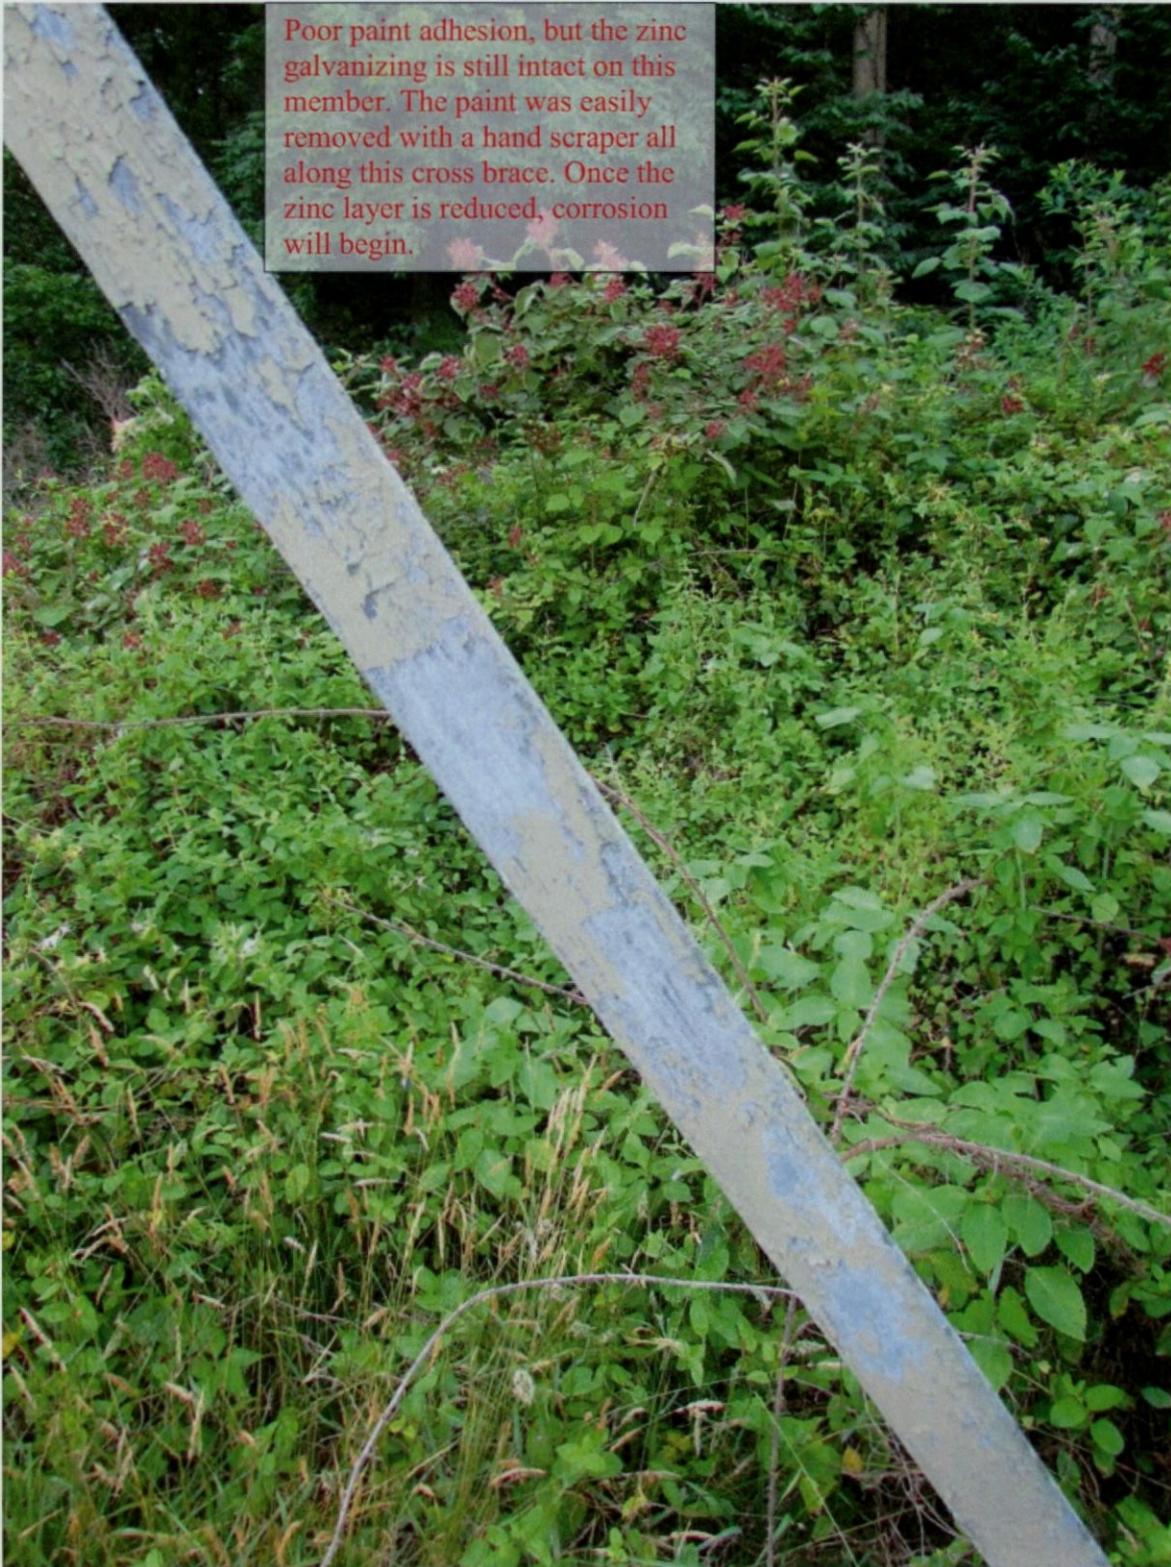
Figure 15: 3962S1518116 - Paint removed from a cross brace

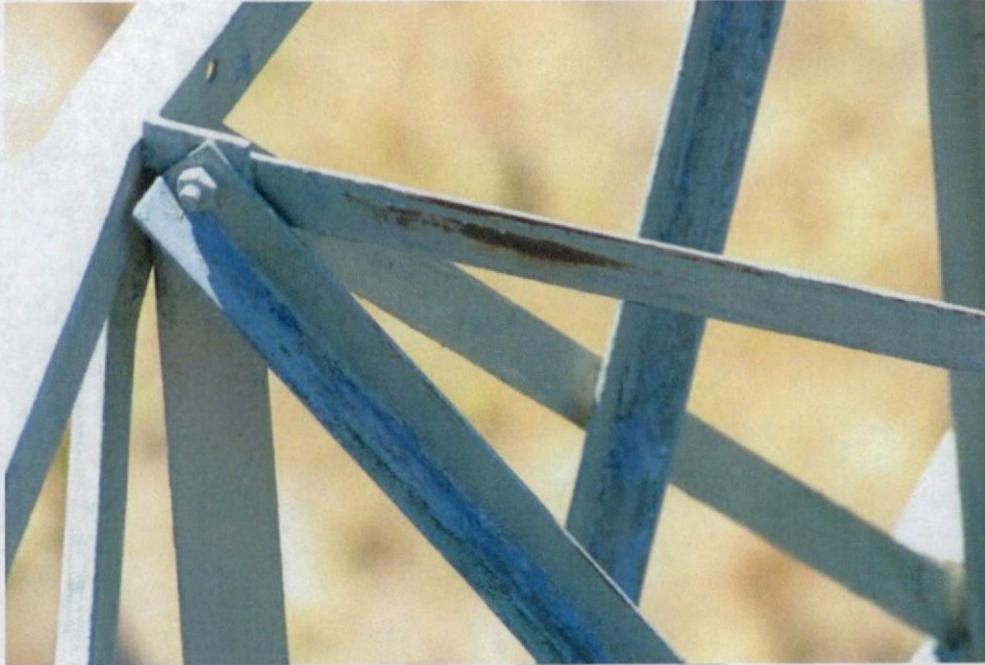
This structure exhibited poor paint adhesion and corrosion. A detailed climbing inspection is needed to determine a remediation plan and cost.

**Figure 41:** 39282S17720 - Corrosion and paint peeling on structural members

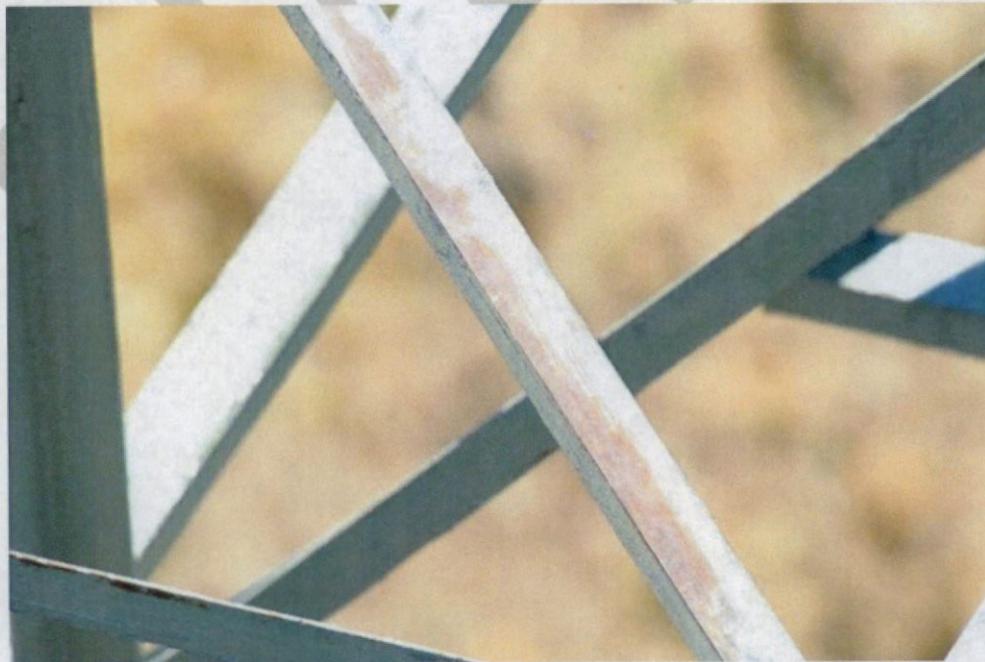
**Figure 42:** 39282S17720 - Corrosion and paint peeling on structural members

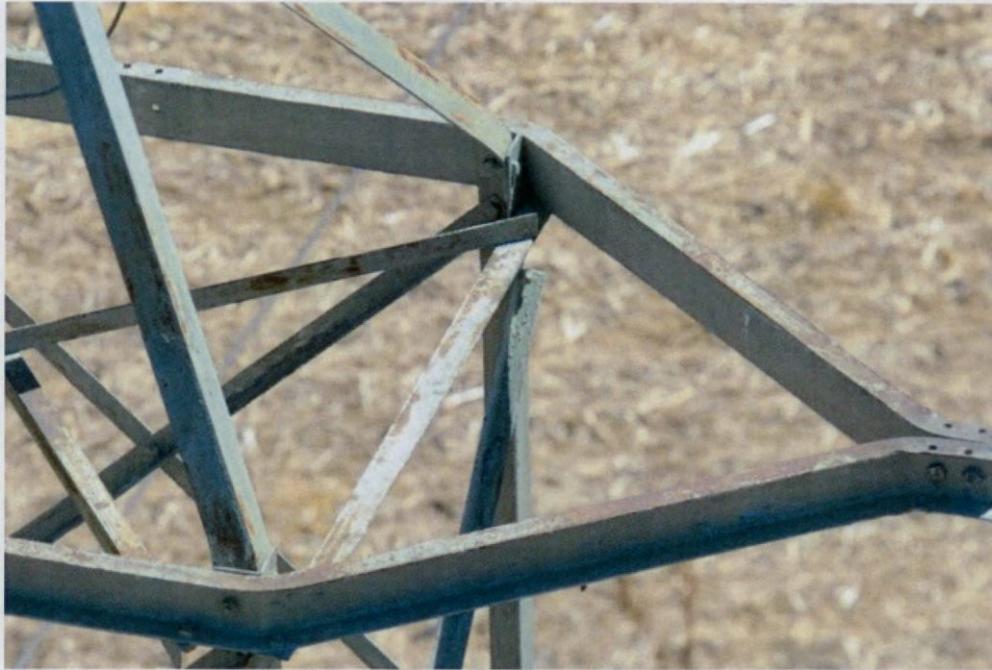
Figure 43: 39282S17720 - Corrosion and paint peeling on structural members

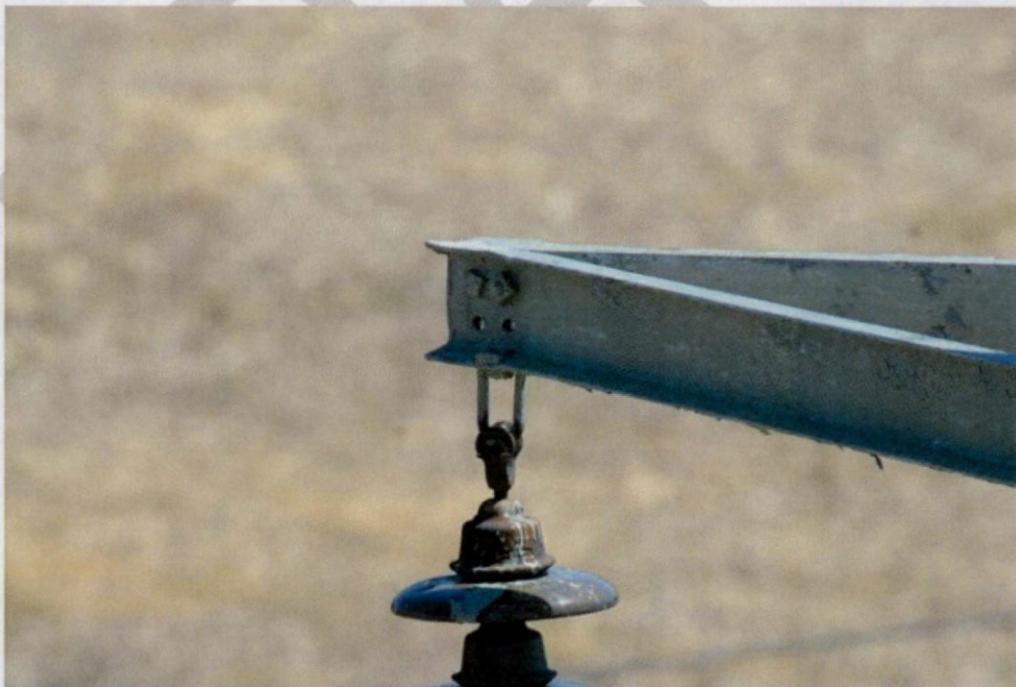
Figure 44: 39282S17720 - Corrosion and paint peeling on structural members

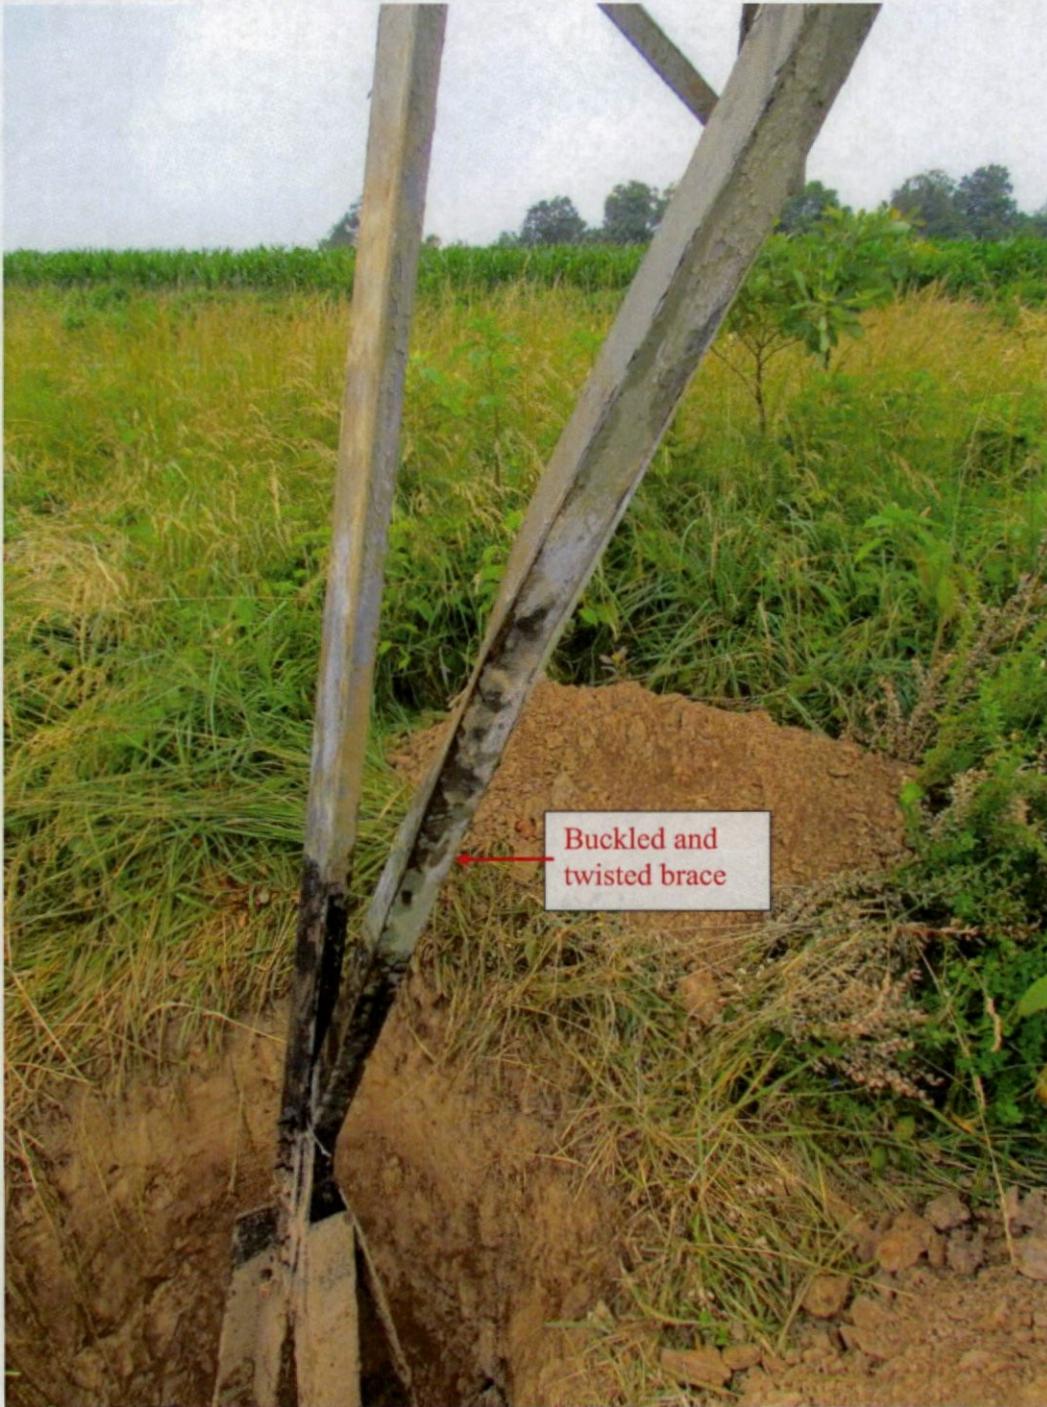
Figure 46: 39282S17720 - Close up view of the buckled and twisted brace

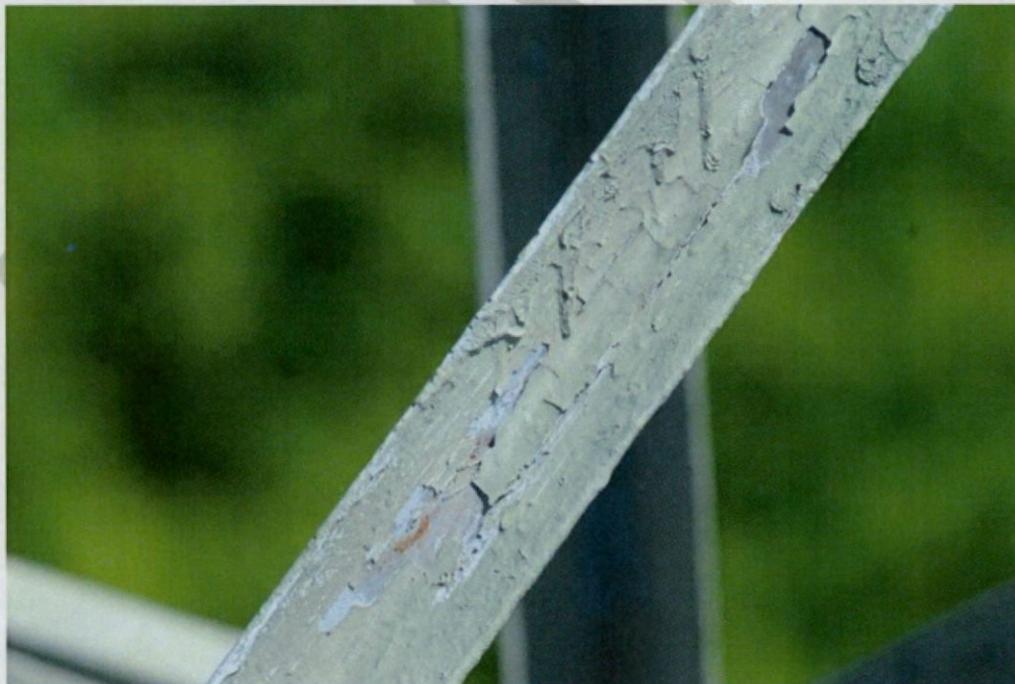
Figure 49: 39282S17720 - Peeling paint

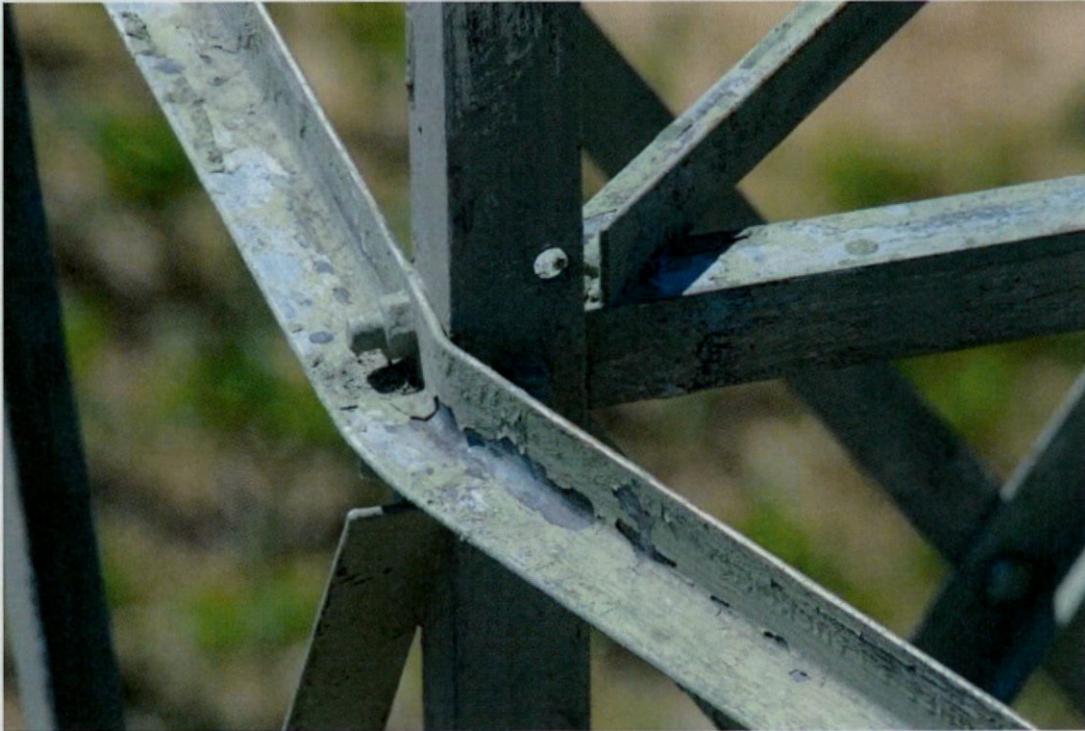
Figure 51: 39134S17433 - Peeling paint

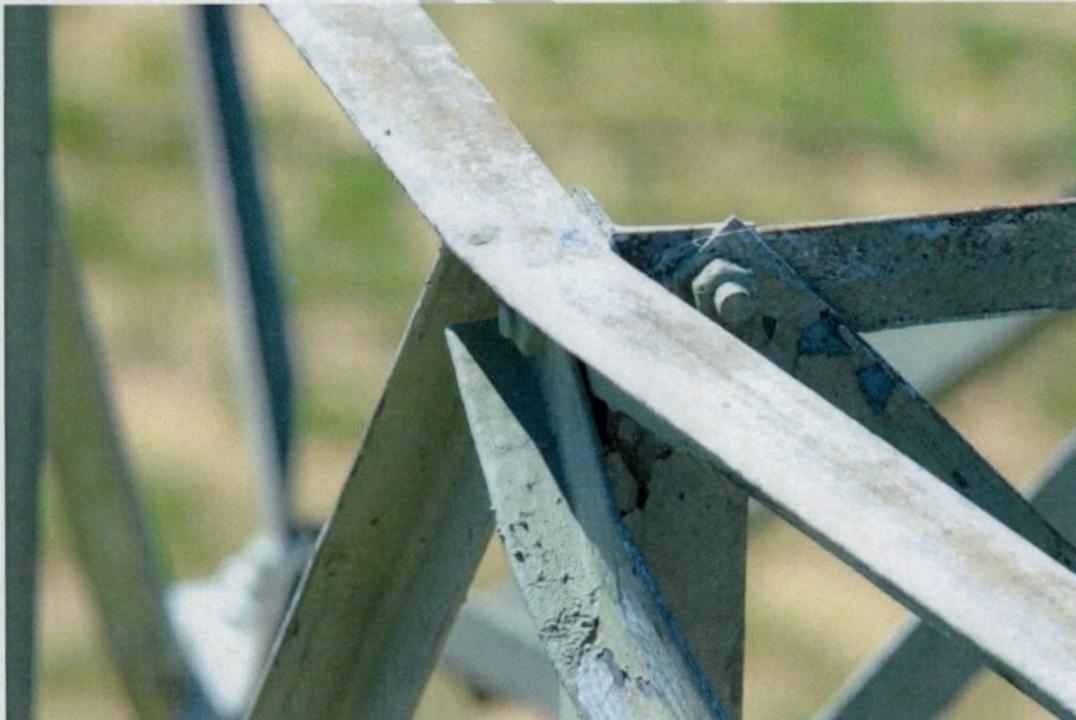
Figure 52: 39134S17433 - Peeling paint

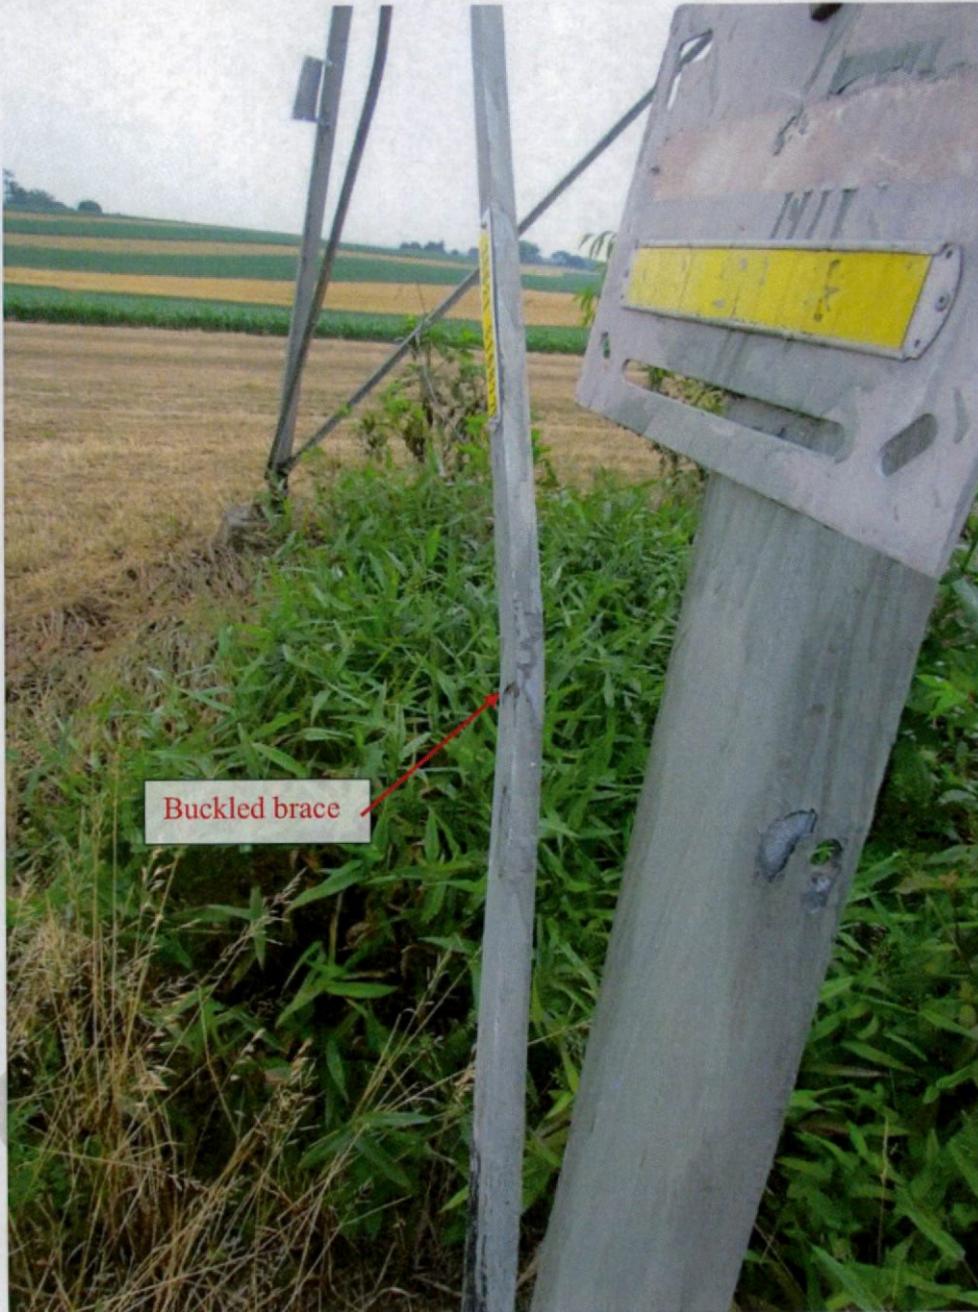
Figure 56: 38921S16877 – Buckled brace

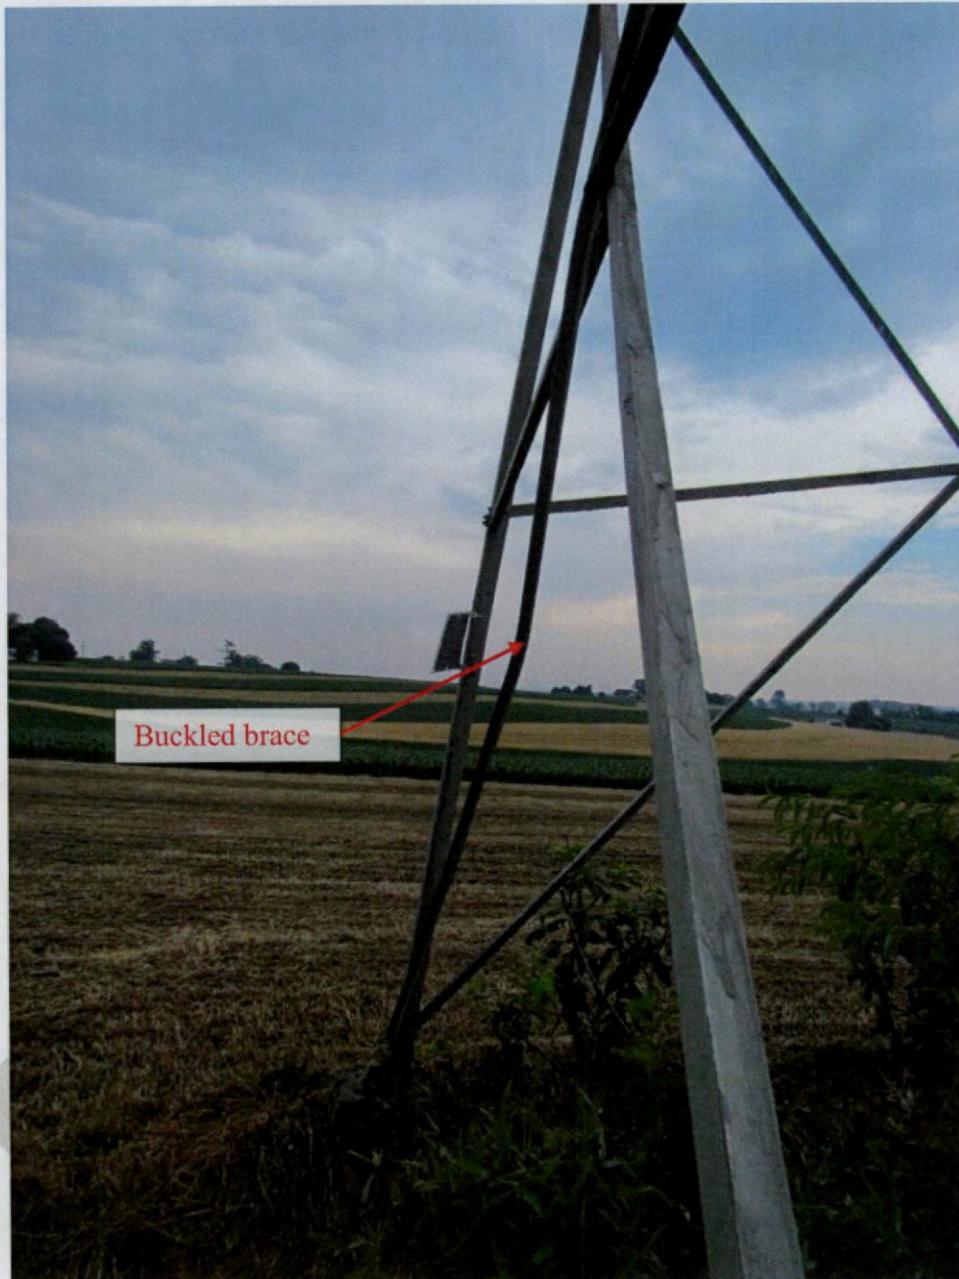
Figure 57: 38921S16877 – Buckled brace

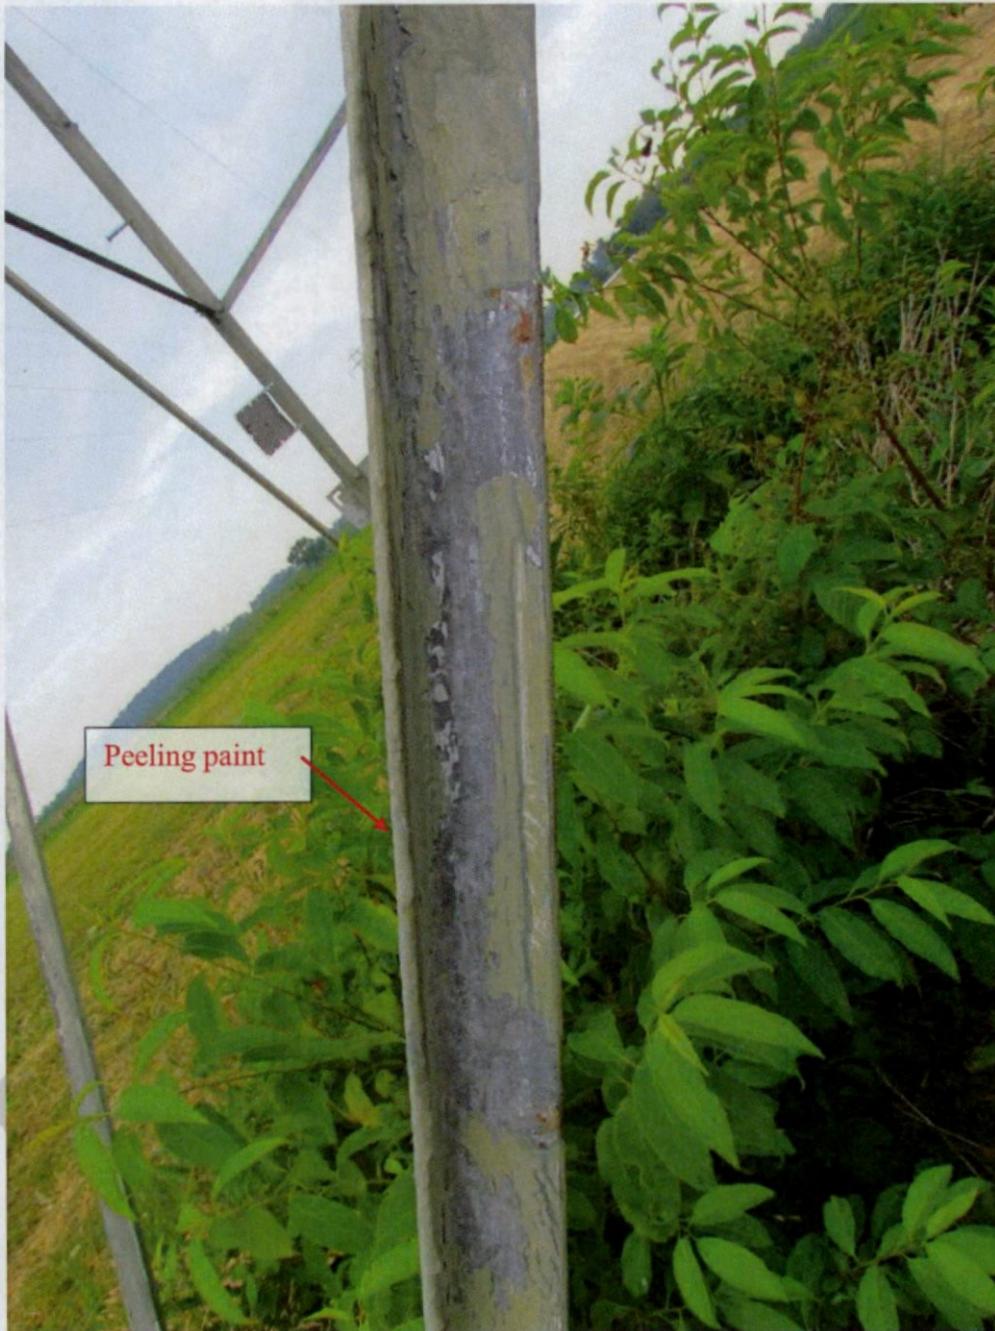
Figure 58: 38921S16877 – Peeling paint

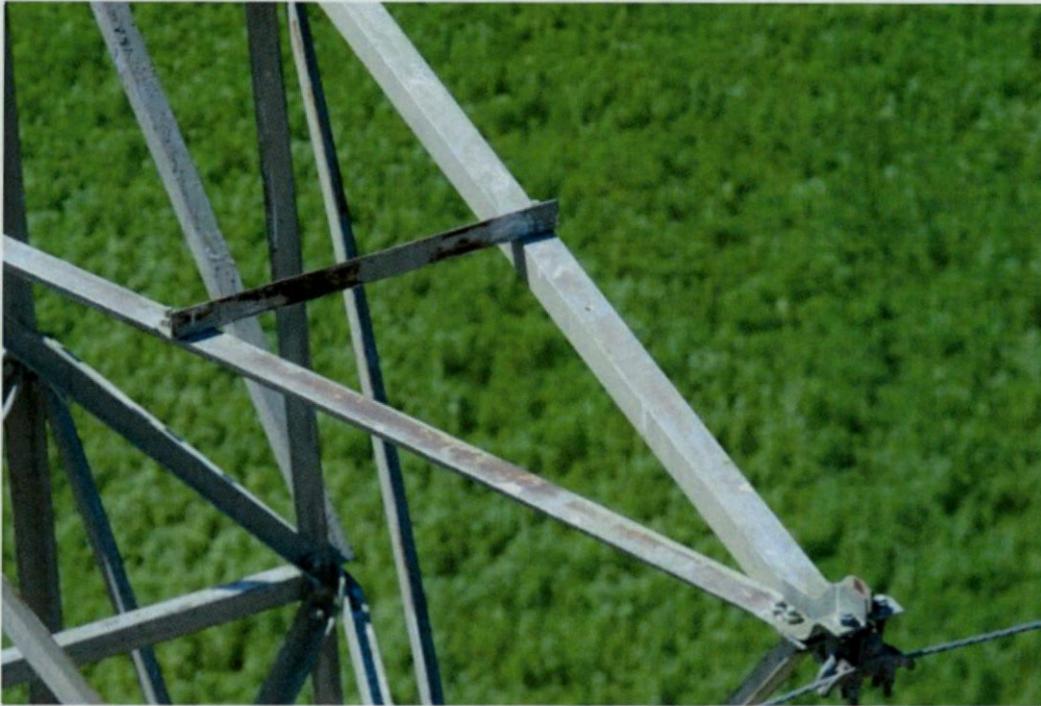
Figure 59: 38921S16877 – Corrosion on structural members

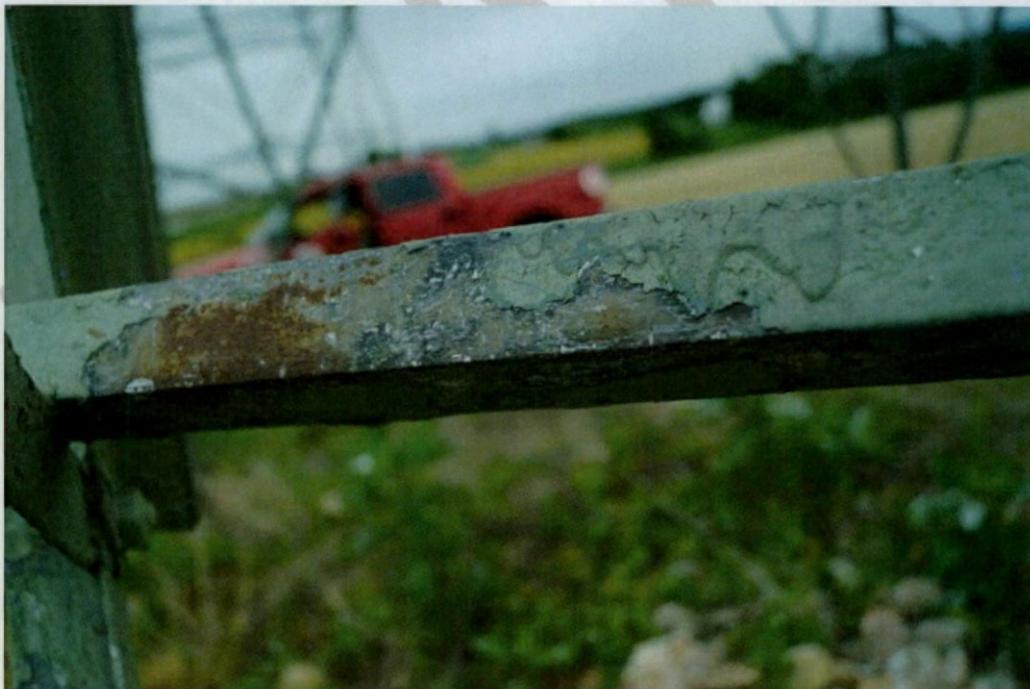
Figure 60: 38921S16877 – Corrosion and peeling paint

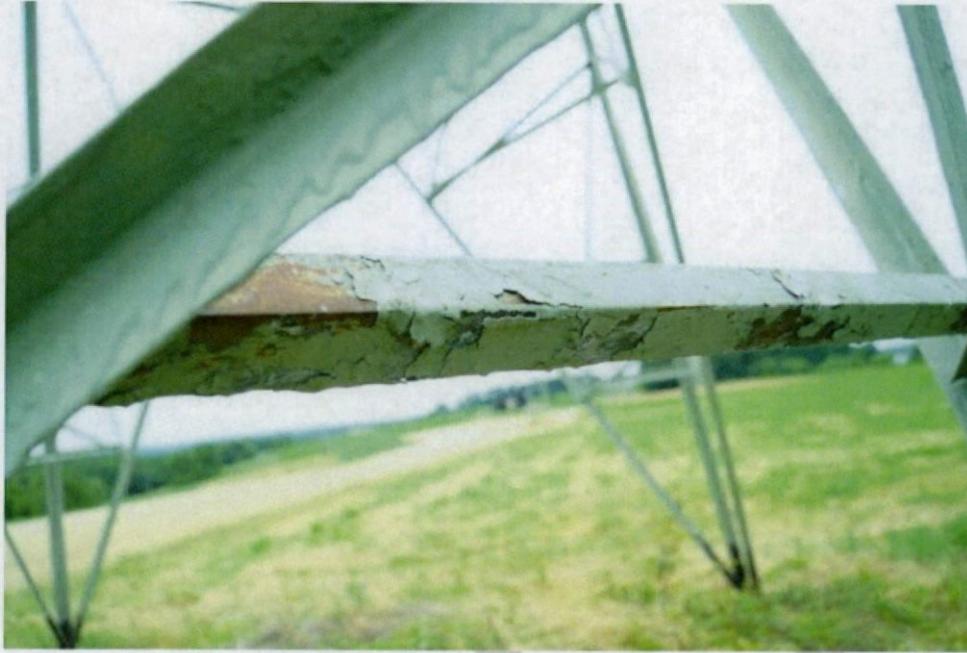
Figure 61: 38921S16877 – Corrosion and peeling paint

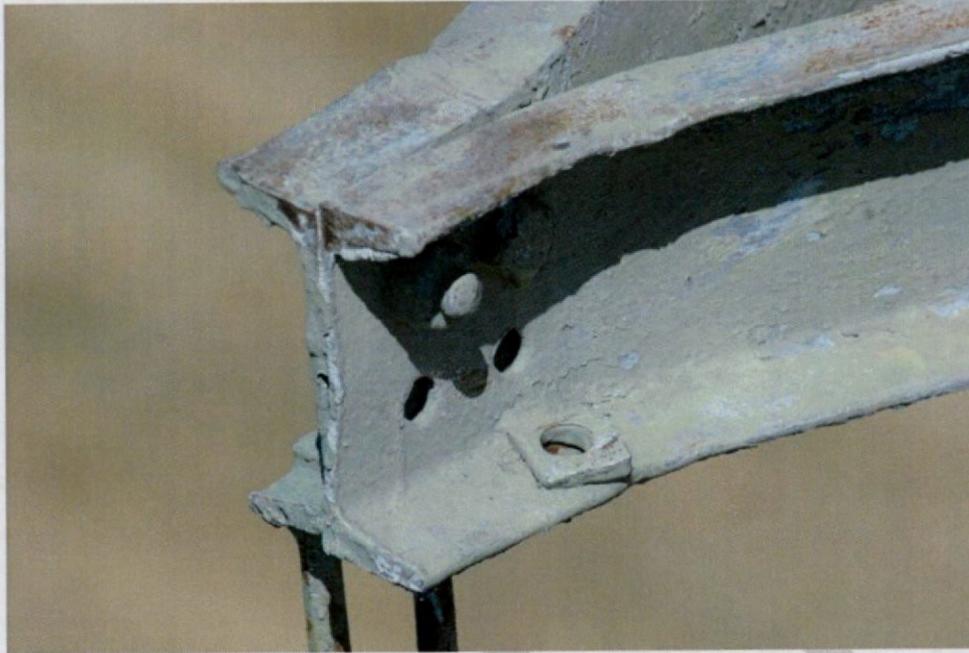
**Figure 64:** 38916S16879 - Corrosion and peeling paint.

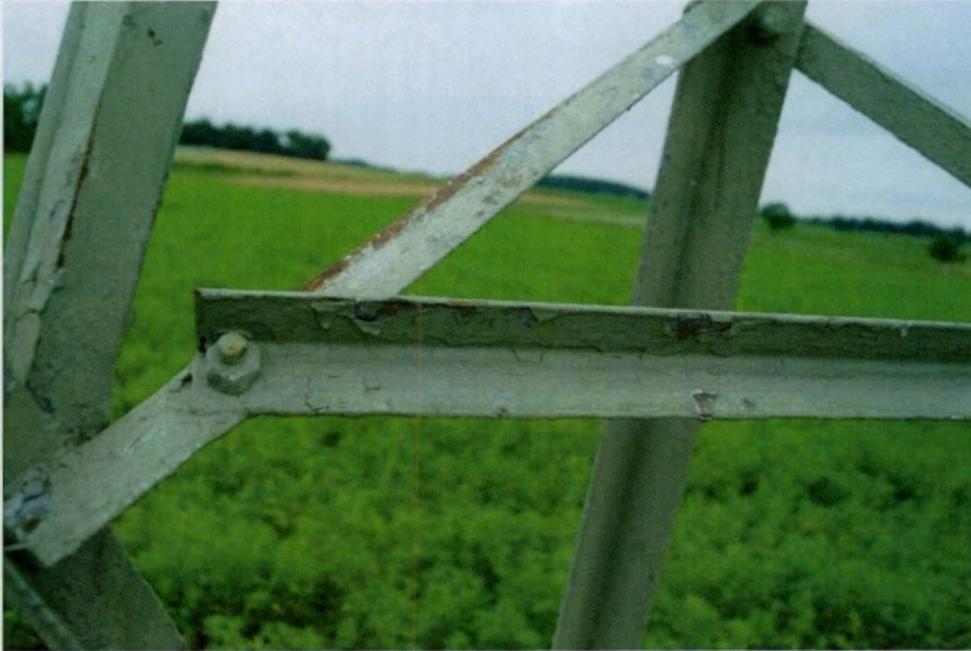
Figure 66: 38916S16879 - Peeling paint.

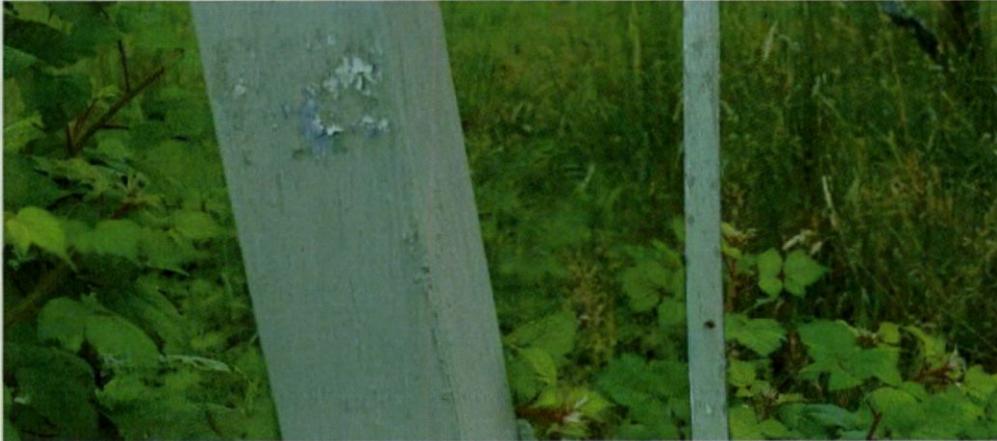
This structure exhibited some peeling paint on the lower sections, while the tops of the arms had virtually no paint on them. There was very little corrosion on this structure. The structure was in relatively good shape, but the paint needs to be removed and the structure repainted.

**Figure 68:** 38738S16387 - Paint beginning to peel on the lower portion of this structure.

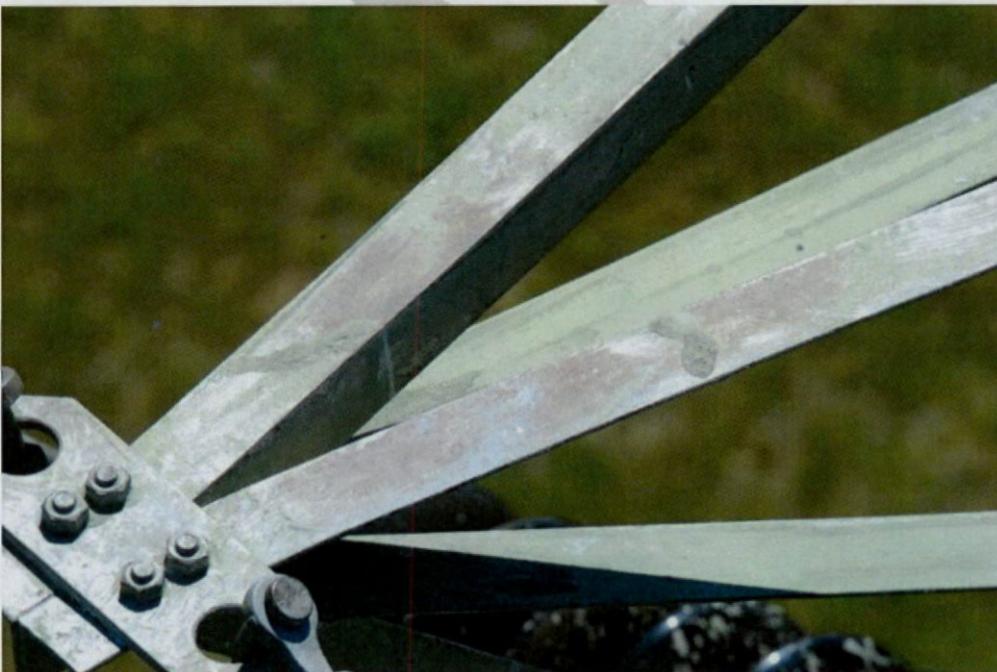
**Figure 69:** 38738S16387 - Most of the paint peeled away from the top of the structure

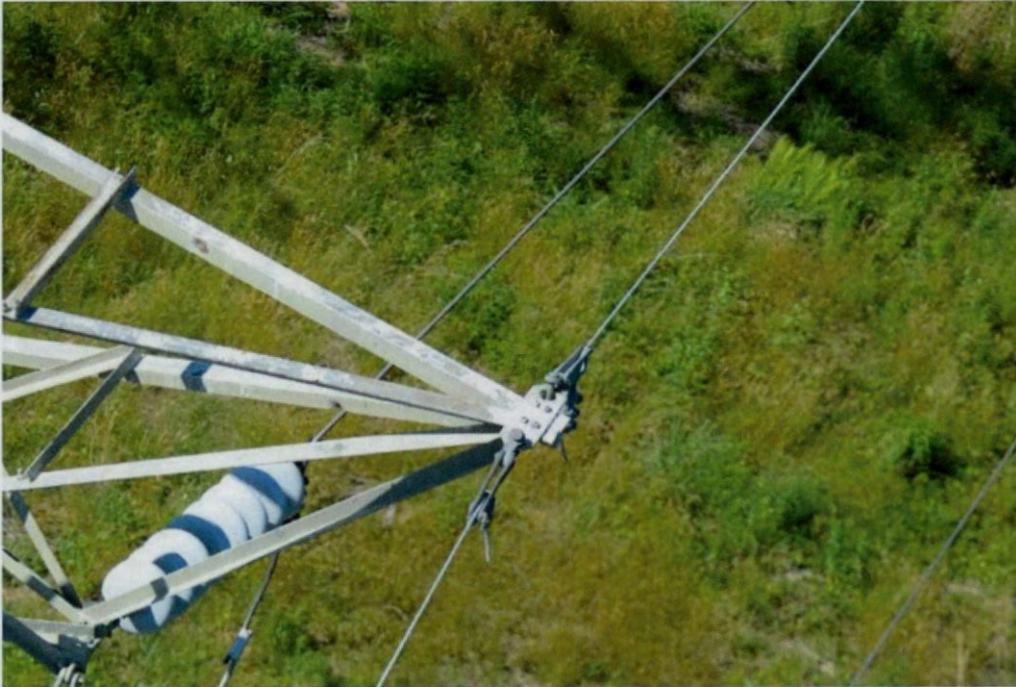
Figure 76: 38703S16287 - Top of the structure with significant amount of bird feces

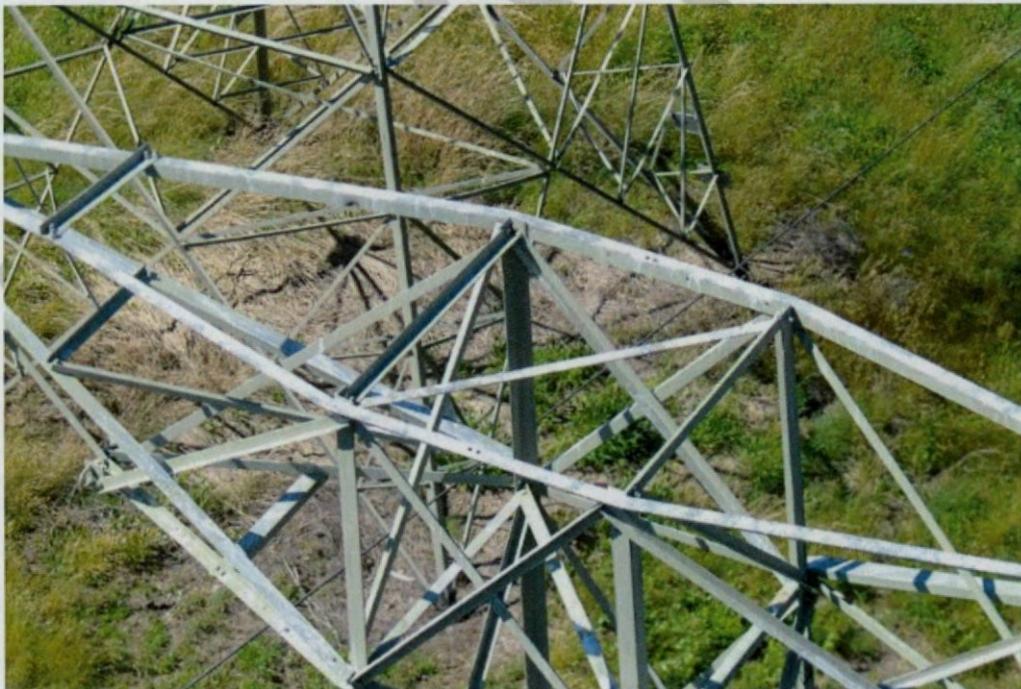
Figure 77: 38703S16287 - Top of the structure with a significant amount of bird feces

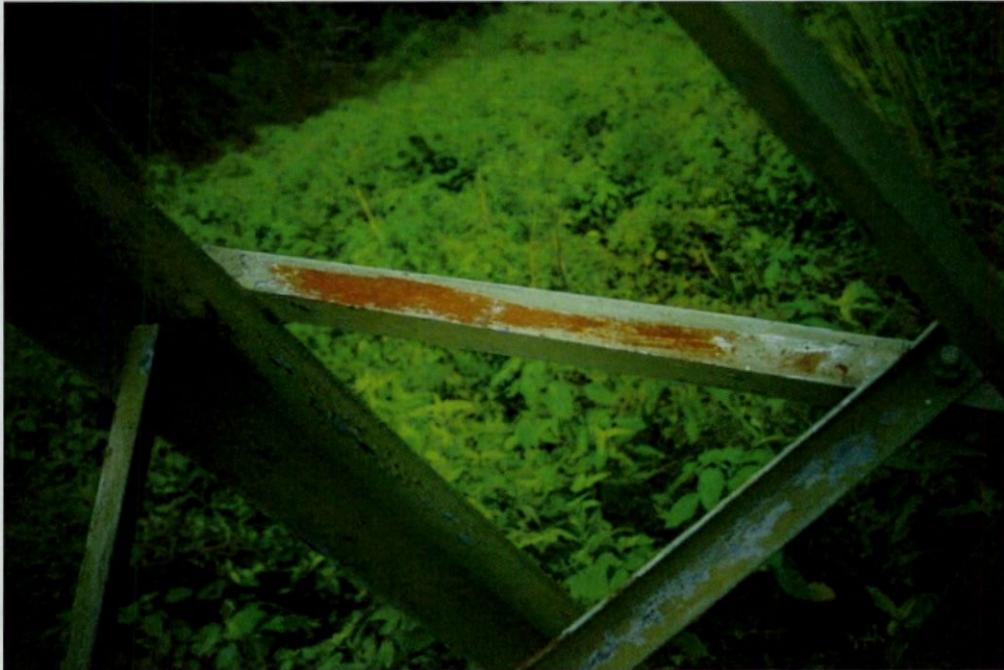
**Figure 90:** 38658S16197 - One of the few places near the ground that exhibited rust

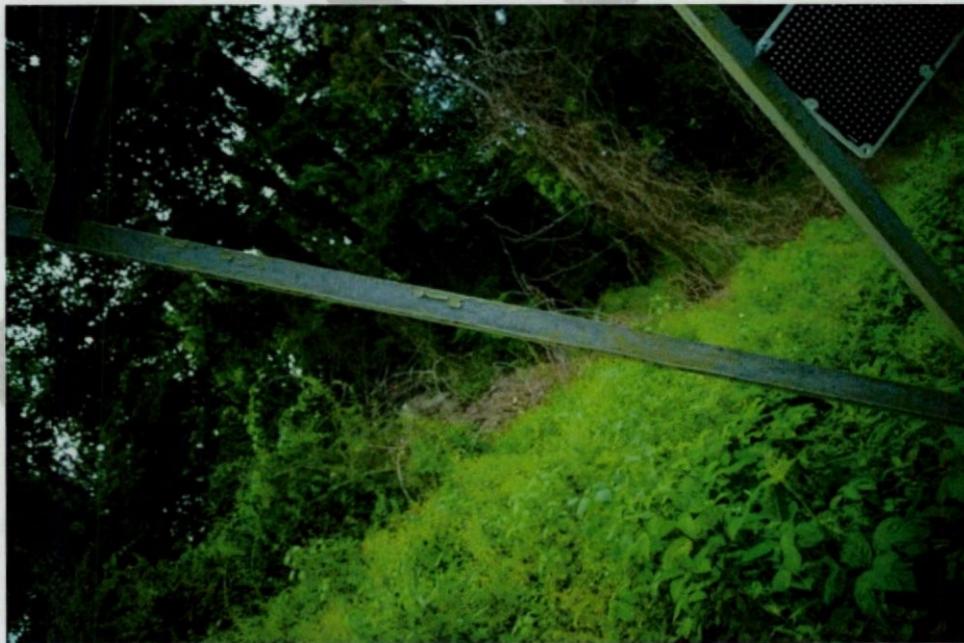
**Figure 91:** 38658S16197 - Paint was not stripped on this brace. This is the as-found condition.

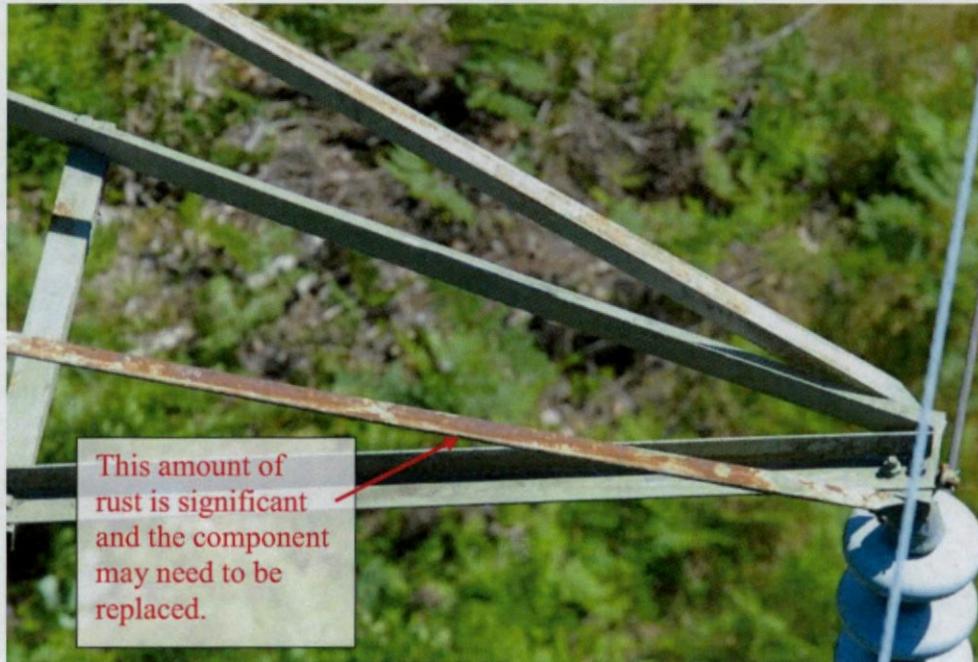
This structure exhibited significant rust and paint peeling at the top of the structure. A more detailed inspection is needed to determine the extent of the rusting at the top, as well as to determine the remediation plan and cost.

Figure 93: 38591S15995 - Top of the structure exhibited significant rust

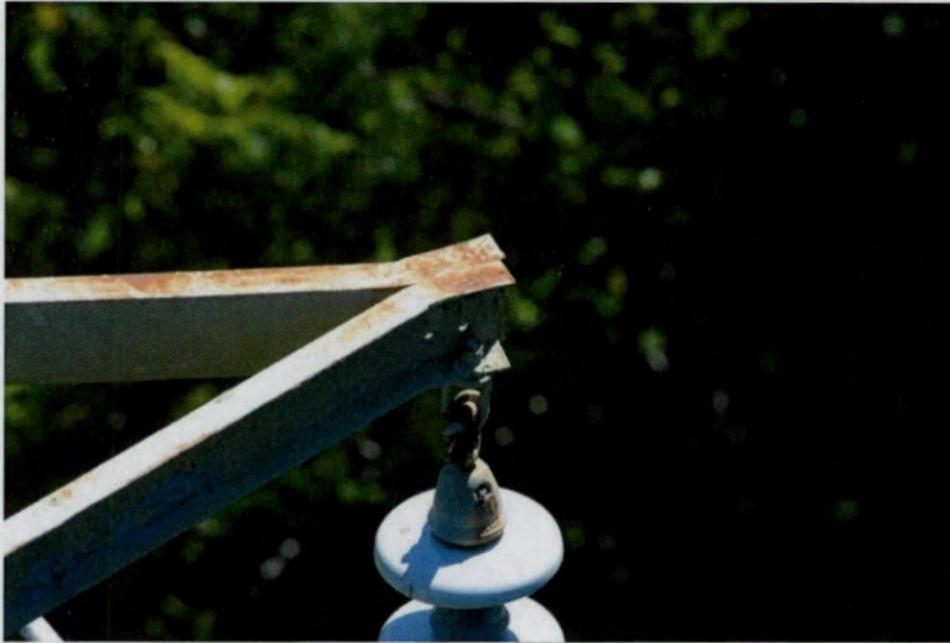
This structure exhibited significant corrosion (rusting) of many of the components at the top of the structure. The rust may be deep enough that the components need to be replaced. A detailed climbing inspection will be needed to make that determination, as well as to determine the remediation plan and cost.

Figure 95: 38586S16005 - Top of the structure showed significant rust and blistered paint

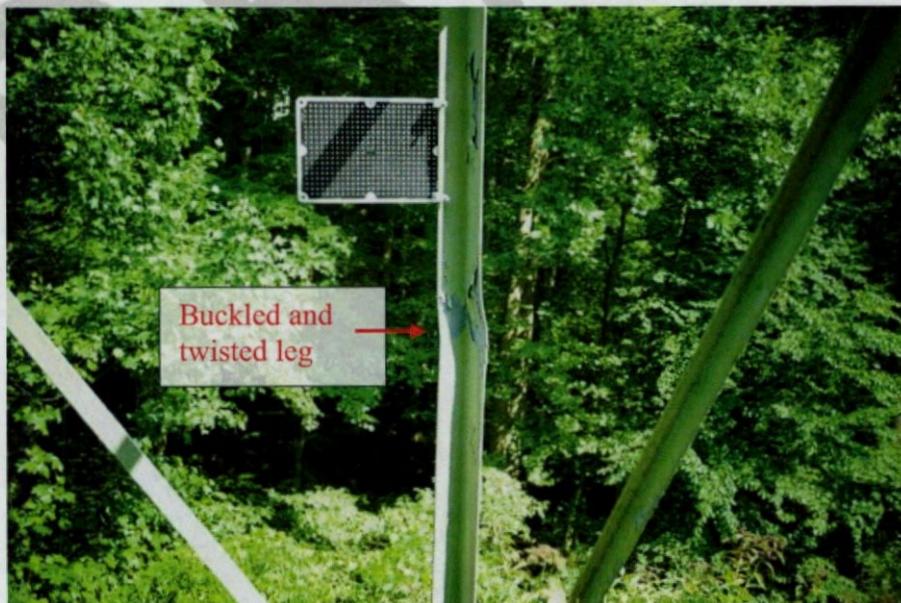
This structure requires immediate attention. One of the legs is buckled and twisted. Given the structure's location on the side of a steep hill, it does not seem reasonable that the damage could have been caused by farm equipment. More likely causes include overloading from wind or ice, as well as seismic activity or an inadequate footing. In addition, the lower portion of the structure exhibited poor paint adhesion and the top of the structure exhibited significant rust. A more detailed inspection is needed, especially of the footing and replacement will likely be the best option.

Figure 98: 38567S15943 - Buckled and twisted leg
