**Face Rock – Five Forks Inspection of Structures**

NEETRAC Project Number: 16-107

June, 2016

Principal Investigator: Joe Goldenburg, P.E.  
(GA Lic# PE033181)

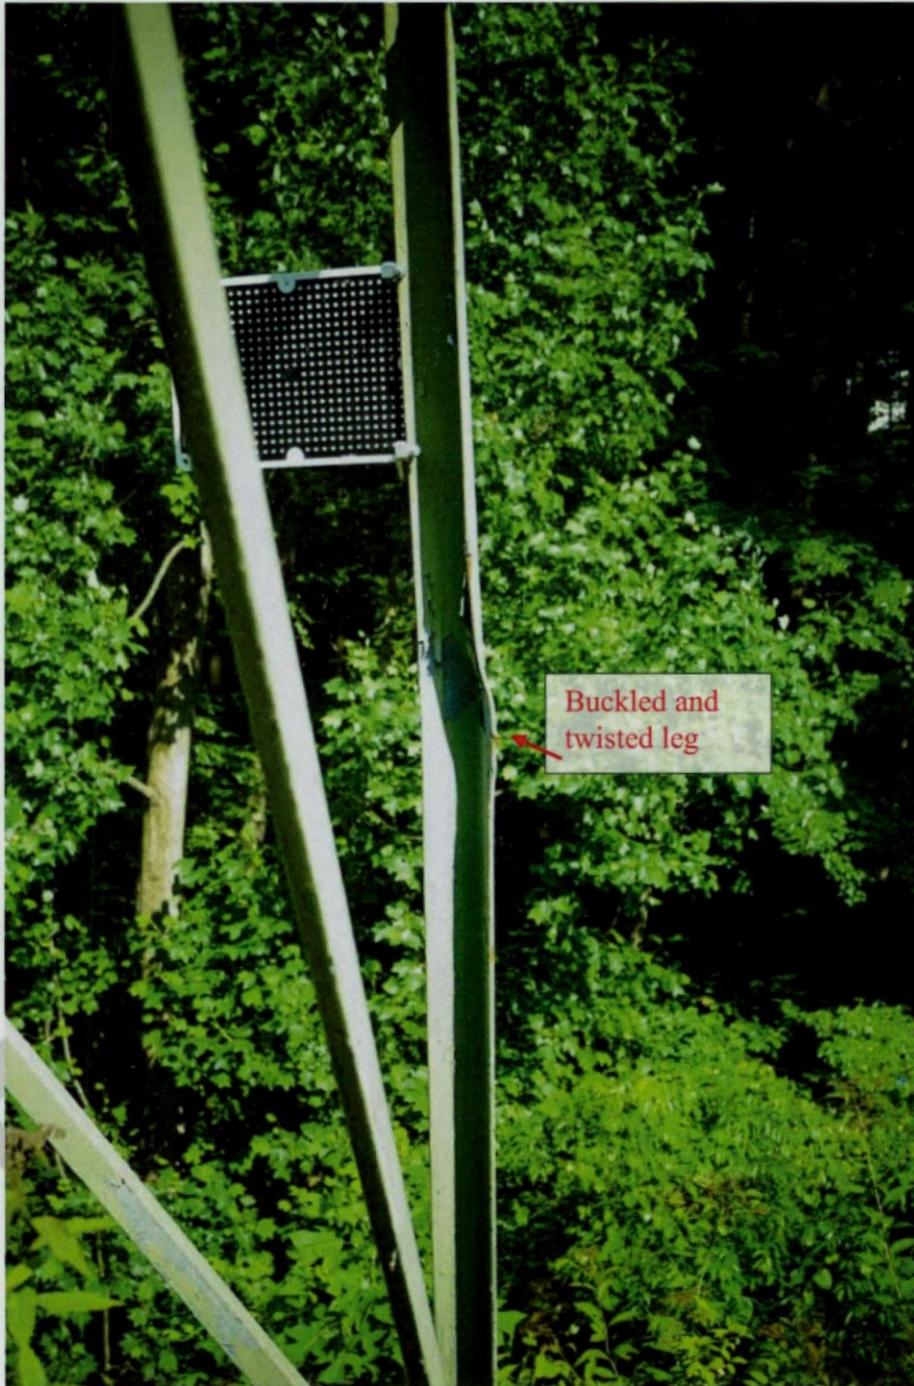
This structure requires immediate attention. One of the legs is buckled and twisted. Given the structure's location on the side of a steep hill, it does not seem reasonable that the damage could have been caused by farm equipment. More likely causes include overloading from wind or ice, as well as seismic activity or an inadequate footing. In addition, the lower portion of the structure exhibited poor paint adhesion and the top of the structure exhibited significant rust. A more detailed inspection is needed, especially of the footing and replacement will likely be the best option.

Buckled and twisted leg

Figure 99: 38567S15943 - Buckled and twisted leg

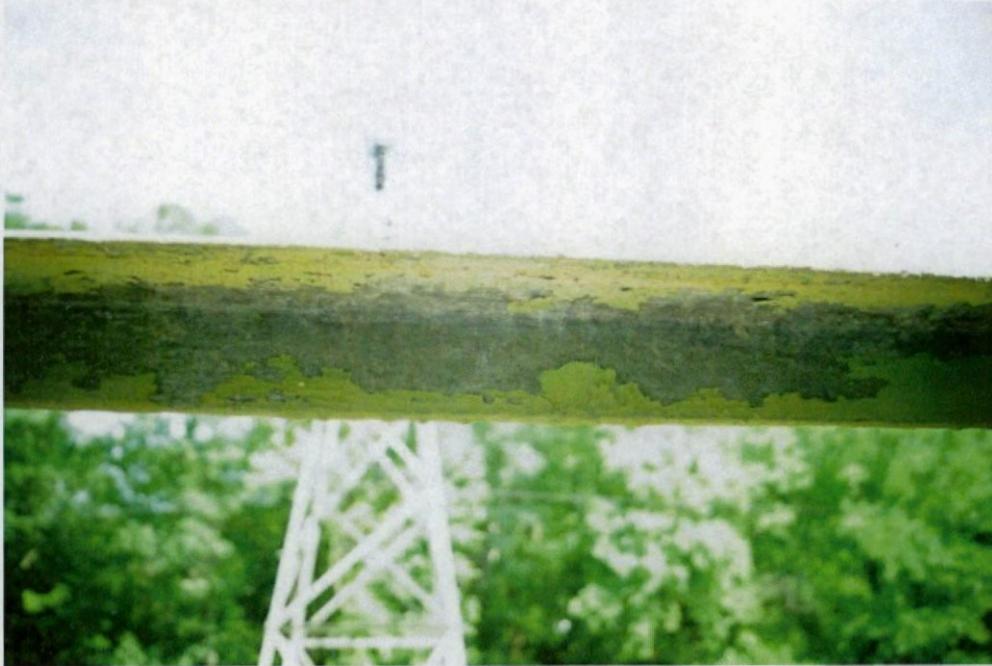
Figure 102: 38562S15945 - Paint before and after scraping

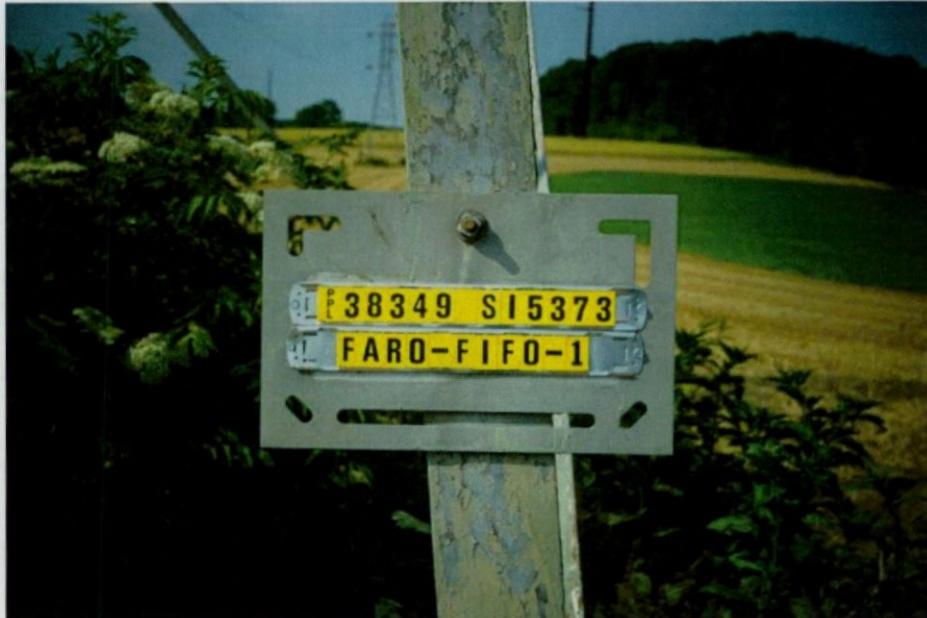
This structure exhibited poor paint adhesion and corrosion over most of the structure. Also a twisted cross brace has been reattached to the footing during a previous foundation repair. A more detailed inspection is needed to determine the remediation plan and cost.

**Figure 106:** 38349S15373 - Poor paint adhesion on this structure

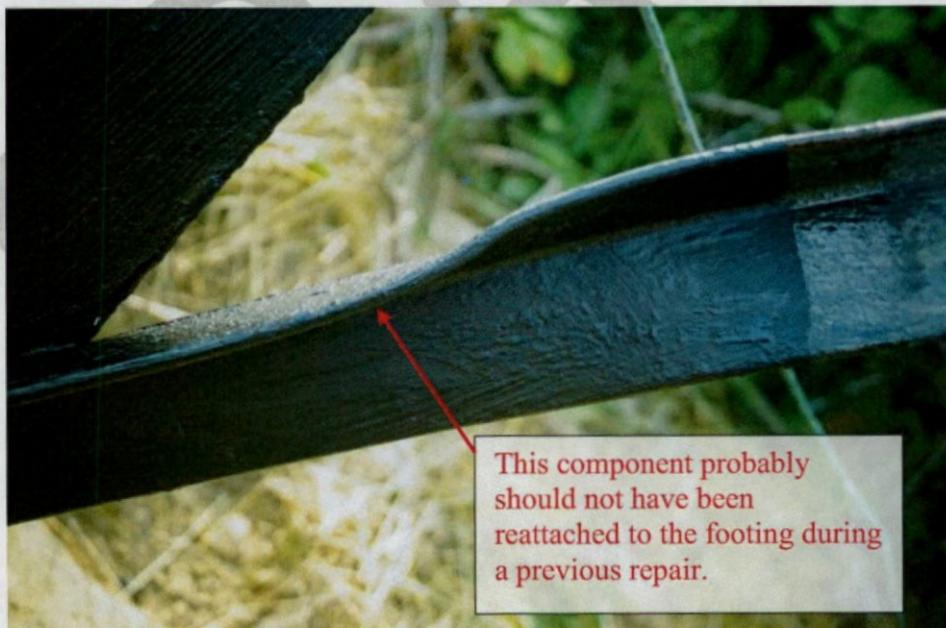
**Figure 107:** 38349S15373 - Twisted cross brace reattached to footing

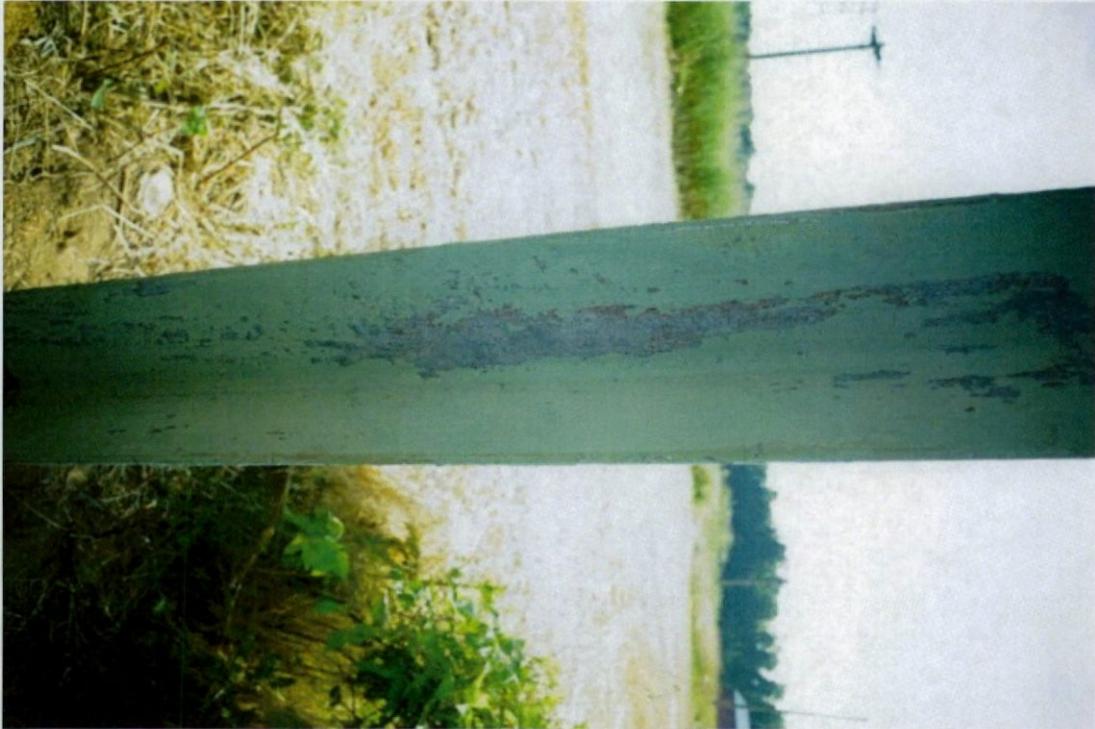
**Figure 108:** 38349S15373 - Poor paint adhesion, typical of most of the structure

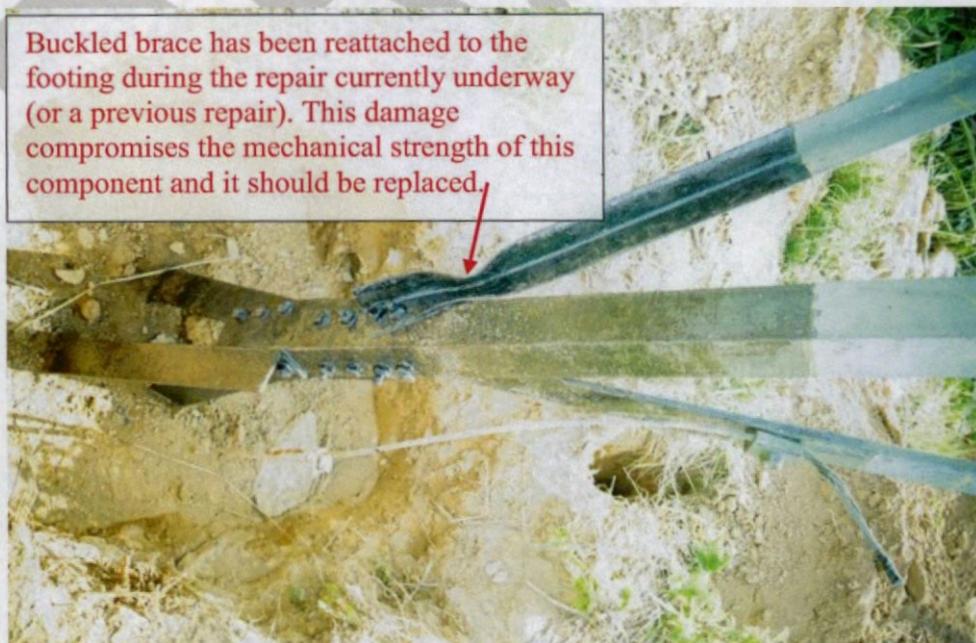
Figure 112: 38344S15375 - Damage likely caused by the footing repair

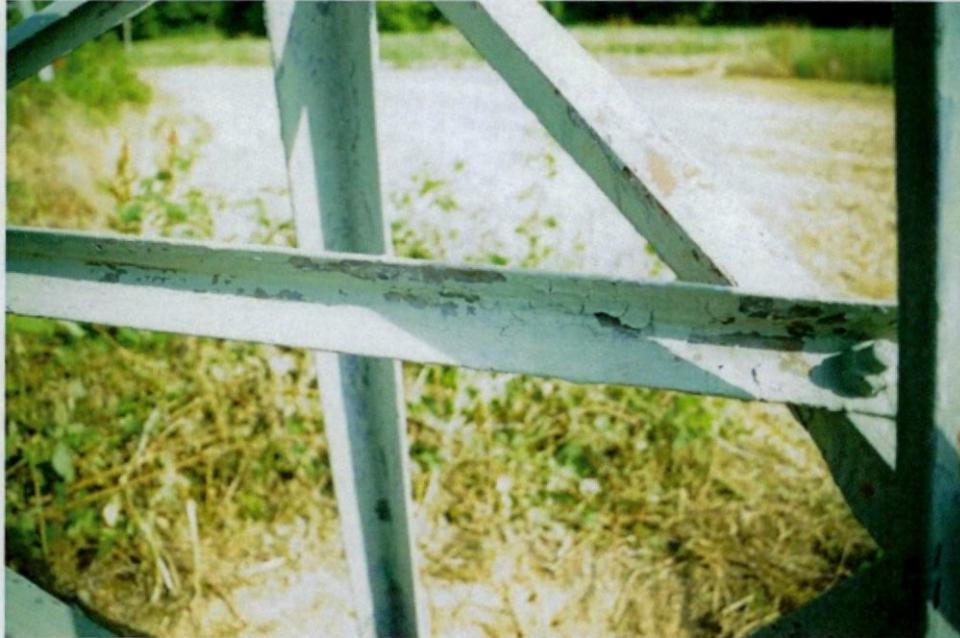
**Figure 113:** 38344S15375 - Typical poor condition of the paint on this structure

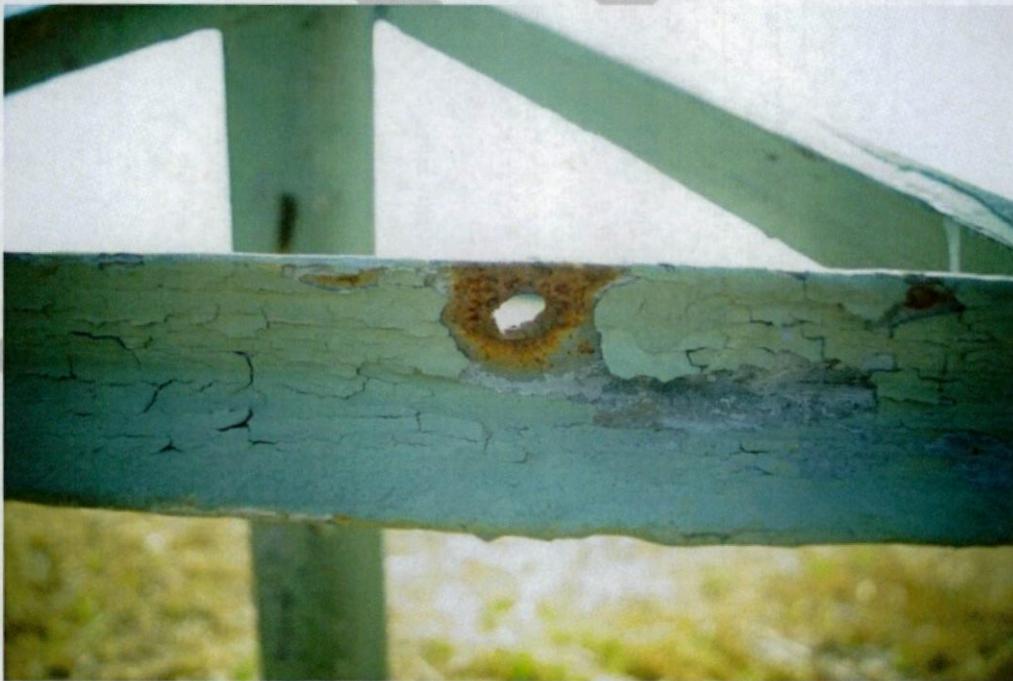
**Figure 114:** 38344S15375 - Typical condition of the paint with spot rust

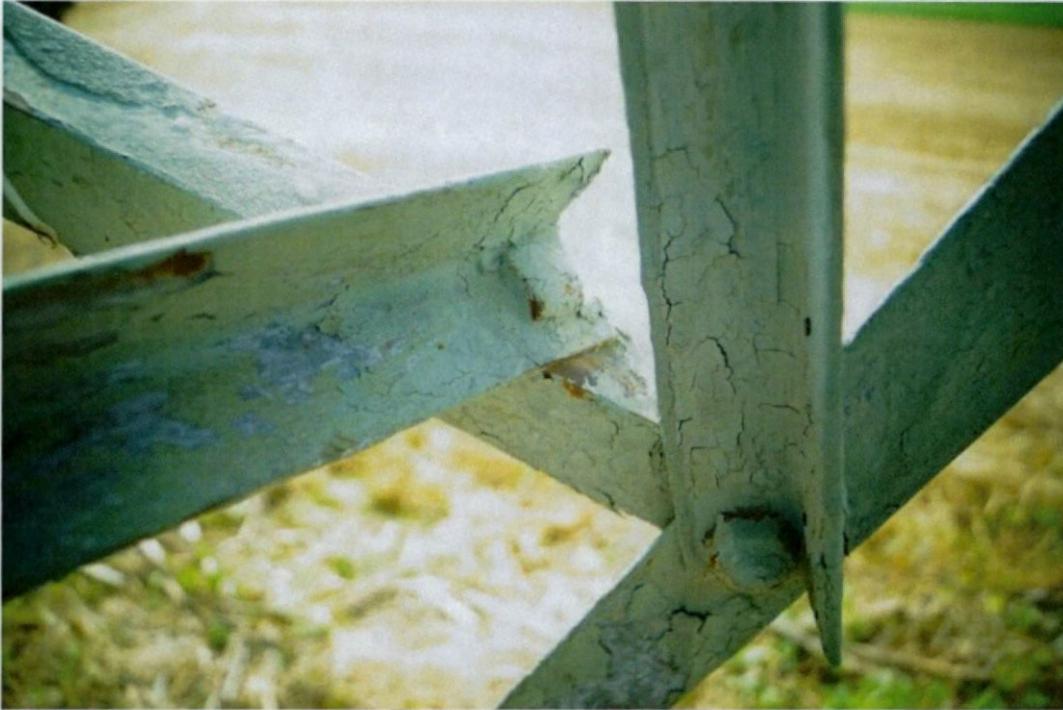
**Figure 115:** 38344S15375 - Typical condition of the paint with spot rust

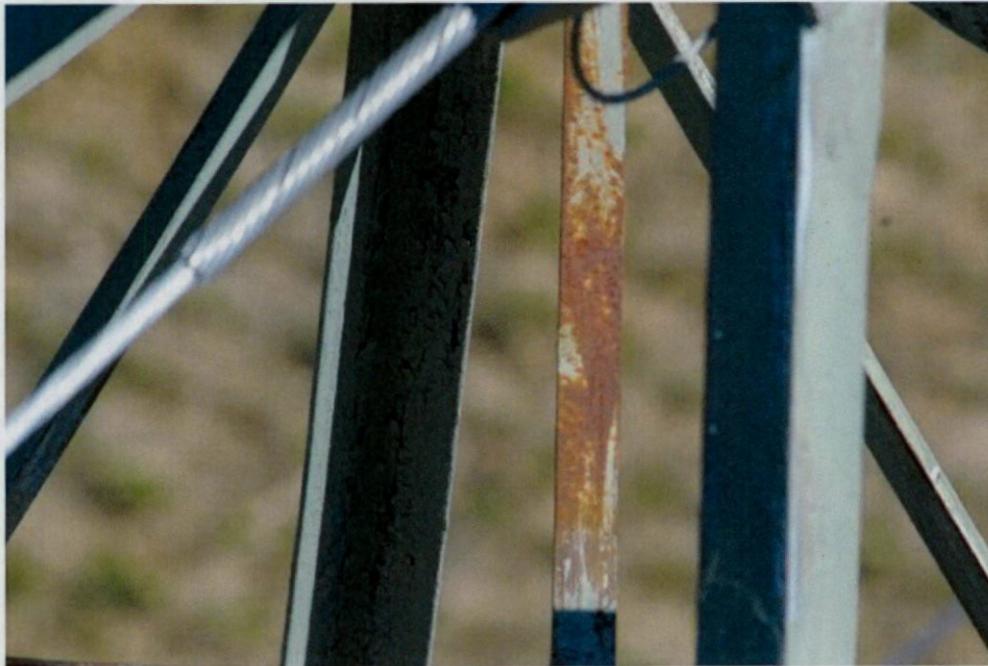
This structure exhibited poor paint adhesion and spot rust over its entire lower surface. The top of this structure exhibited significant rust and several components may need to be replaced. A more detailed inspection is needed to determine the remediation plan and cost.

**Figure 119:** 38124S14790 - Poor paint adhesion and rust typical of the upper part of this structure

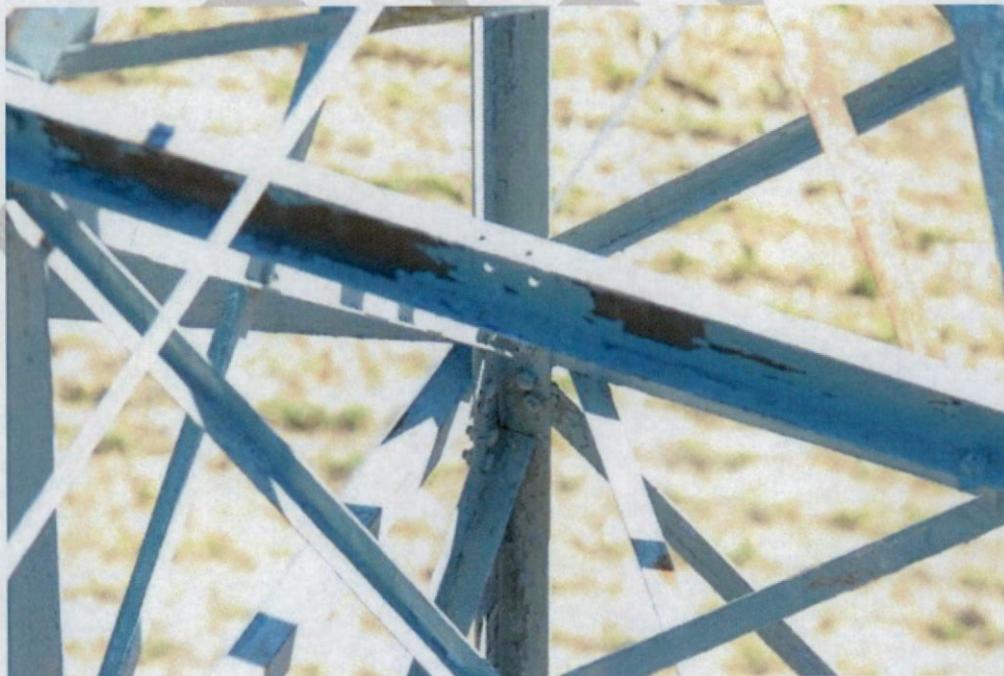
**Figure 120:** 38124S14790 - Poor paint adhesion and rust typical of the upper part of this structure

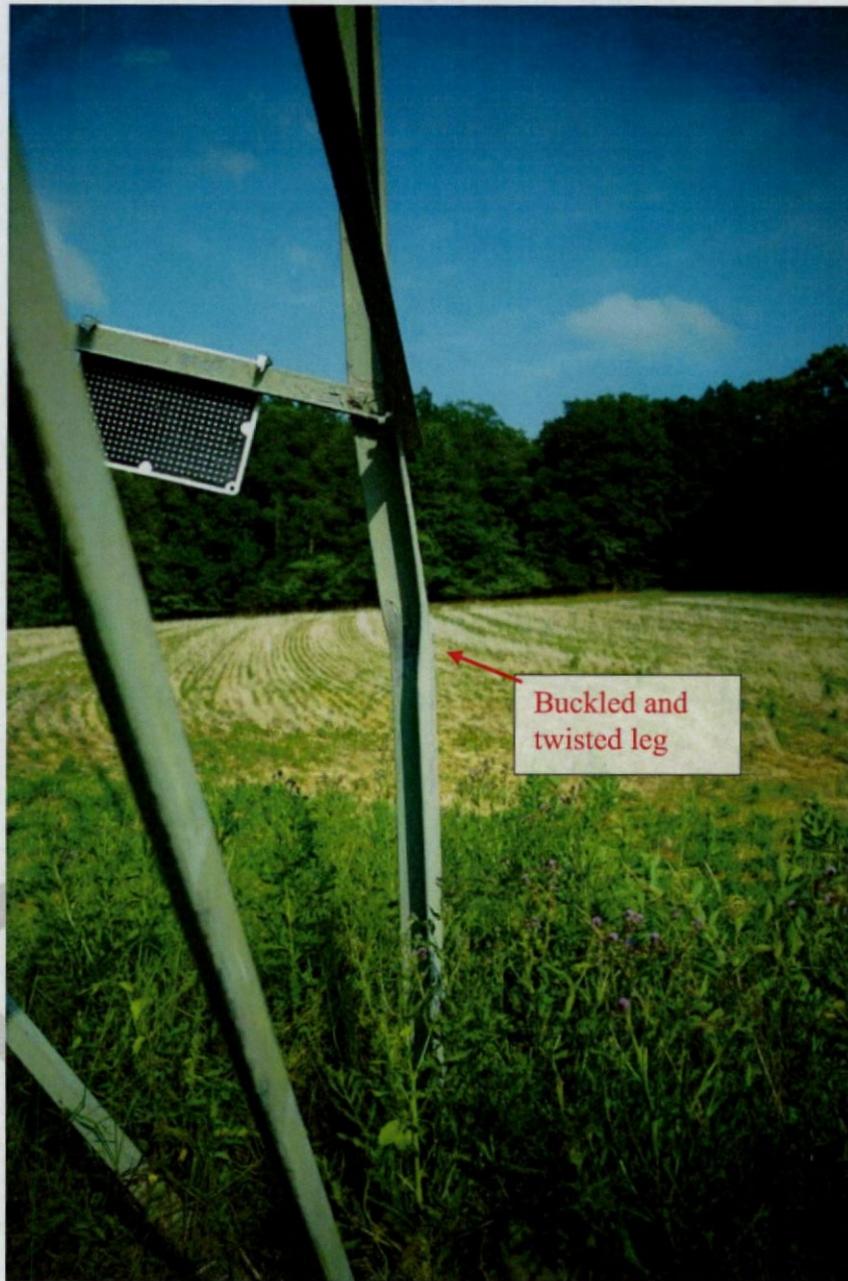
This structure exhibited a buckled leg and requires immediate action.

**Figure 121:** 38129S14788 – Buckled and twisted leg

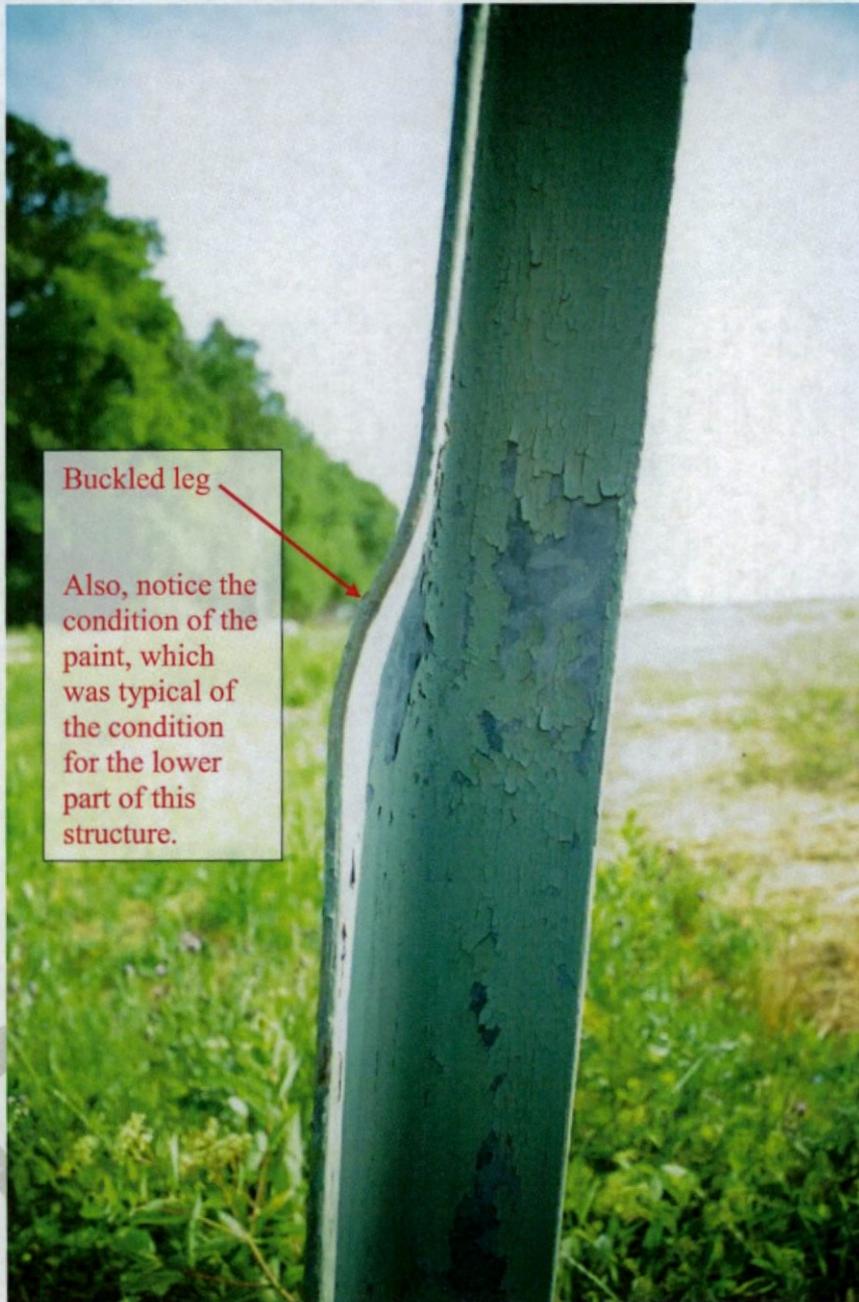
Figure 122: 38129S14788 – Buckled and twisted leg

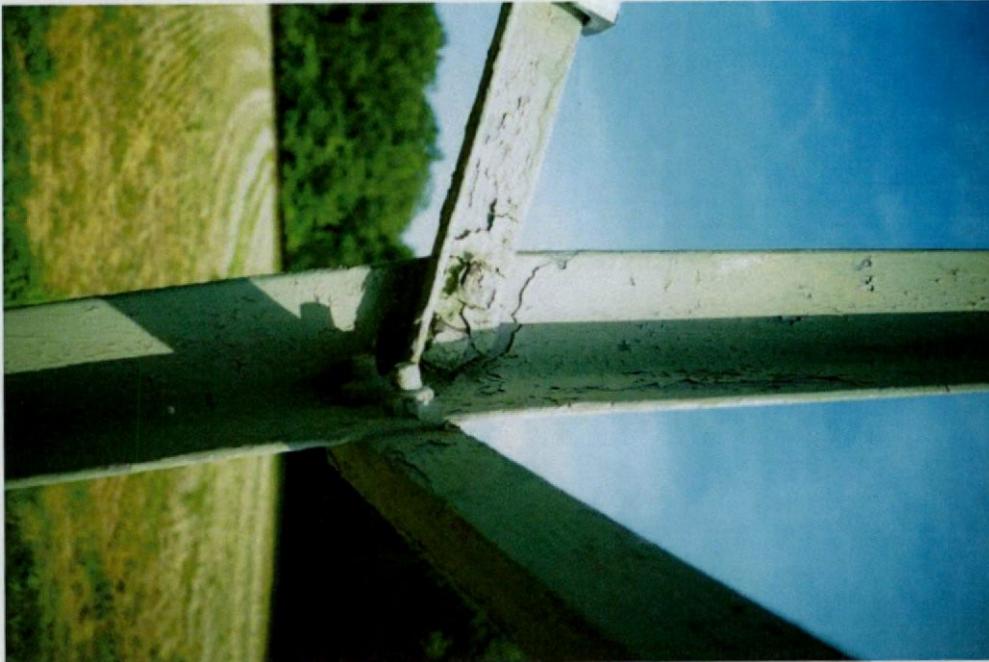
Figure 123: 38129S14788 – Poor paint adhesion typical of the lower part of this structure

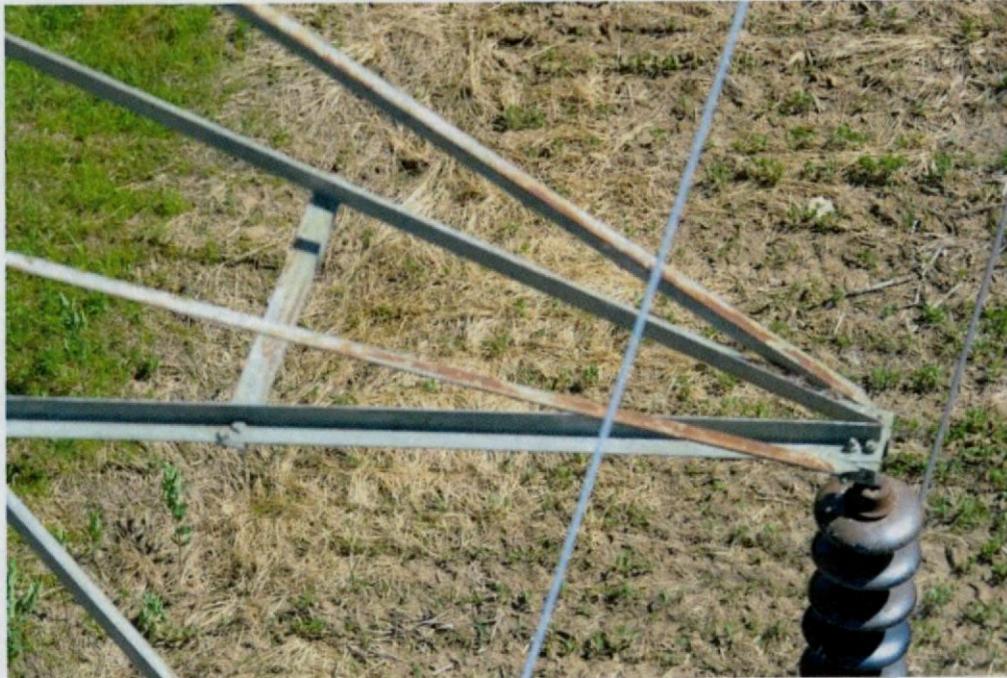
Figure 125: 38129S14788 – Poor paint adhesion and rust typical of the upper part of this structure

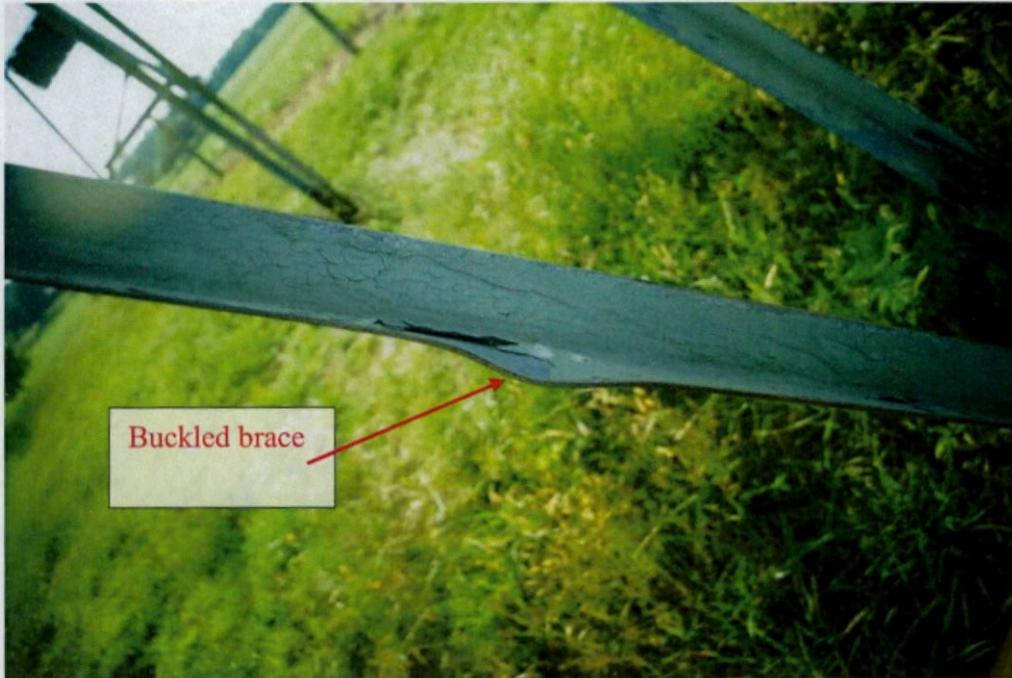
This structure exhibited a damaged brace. The lower portion exhibited poor paint adhesion and spot rust, while the top portion exhibited poor paint adhesion and more significant rust. A more thorough inspection is needed to determine a remediation plan and cost.

Buckled brace

Figure 128: 38005S14453 - Buckled brace

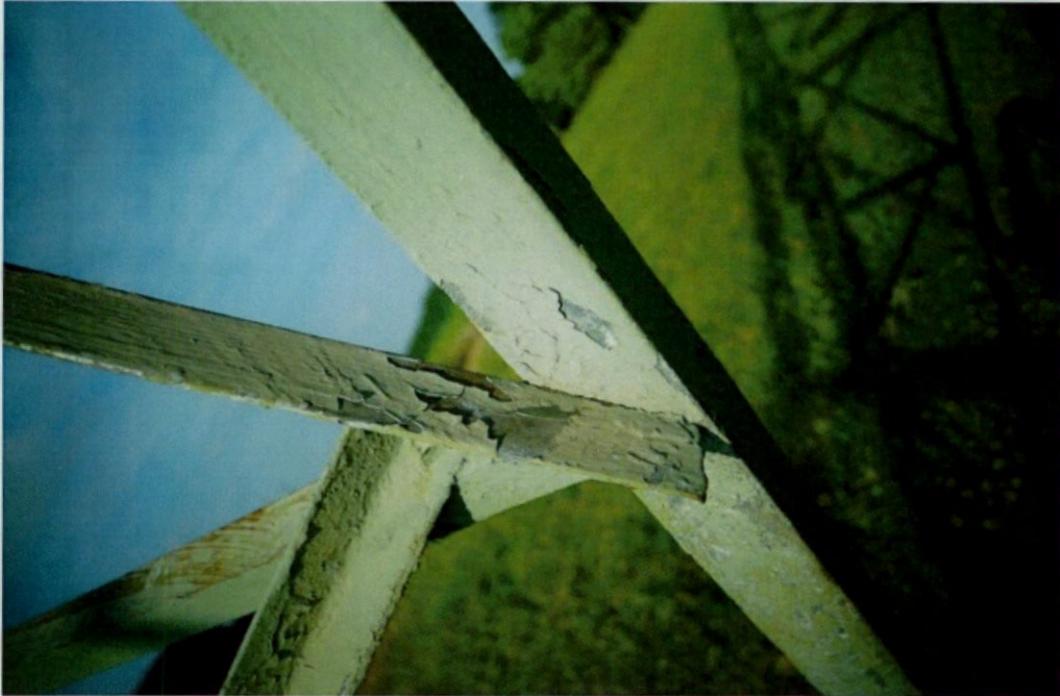
**Figure 130:** 38005S14453 - Typical poor paint adhesion of the lower portion of this structure

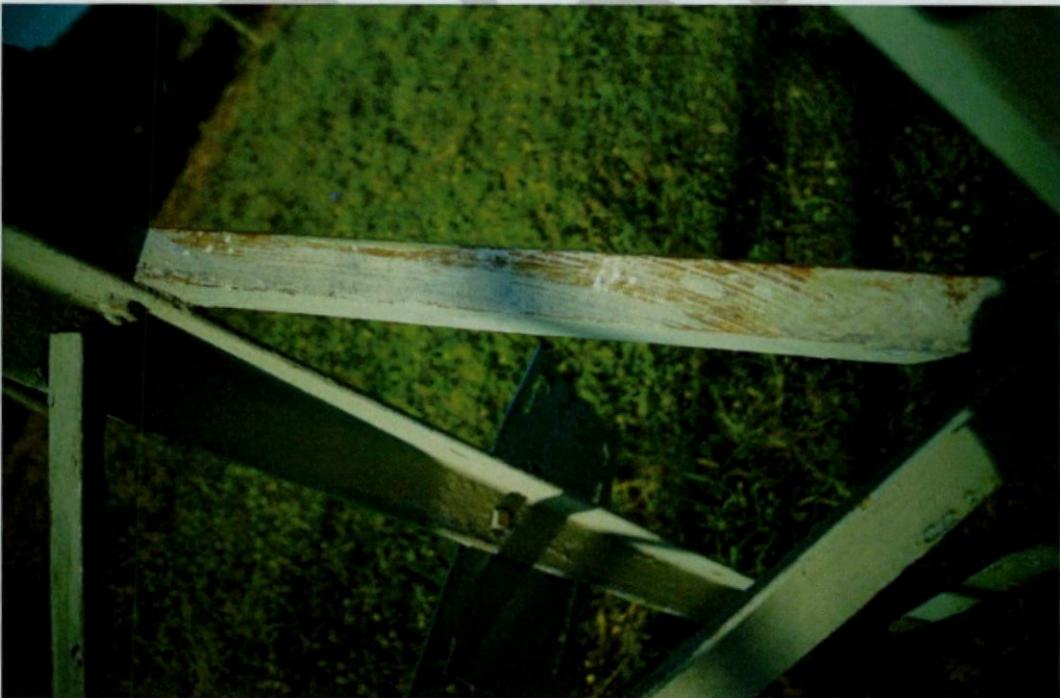
**Figure 131:** 38005S14453 - Typical poor paint adhesion with spot rust, typical of the lower portion of this structure

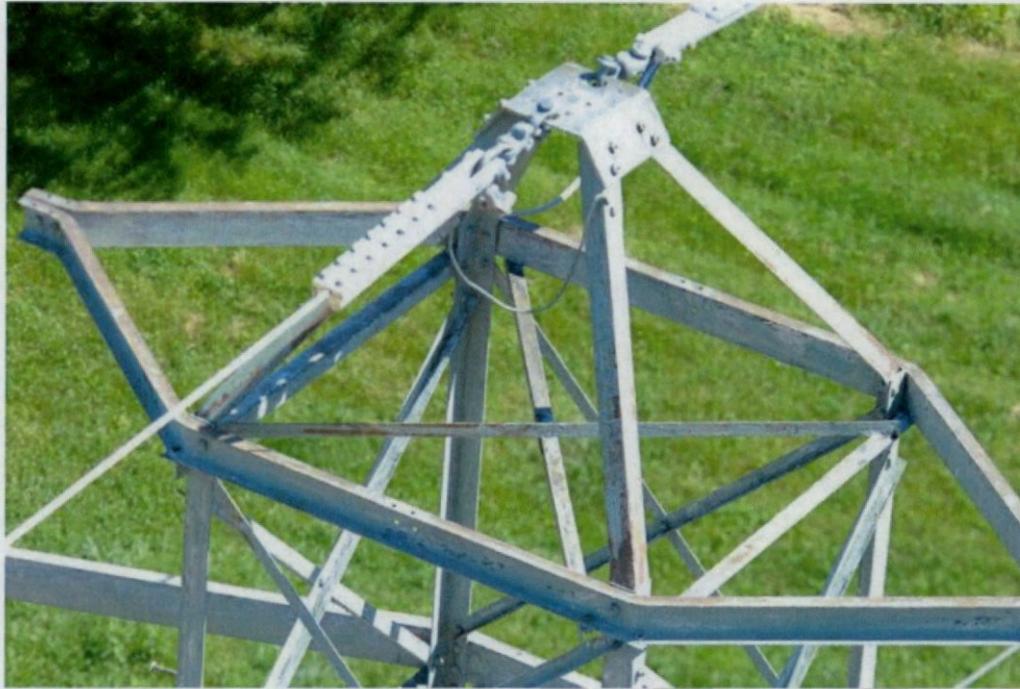
**Figure 132:** 38005S14453 - Poor paint adhesion and corrosion typical of the upper portion of this structure

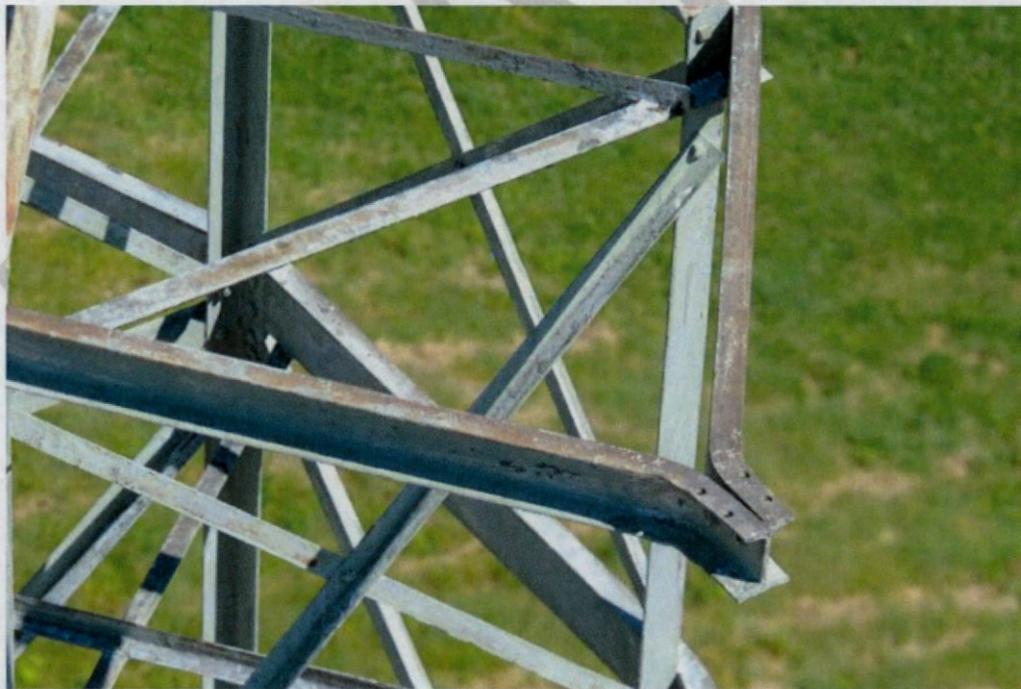
**Figure 133:** 38005S14453 - Poor paint adhesion and corrosion typical of the upper portion of this structure

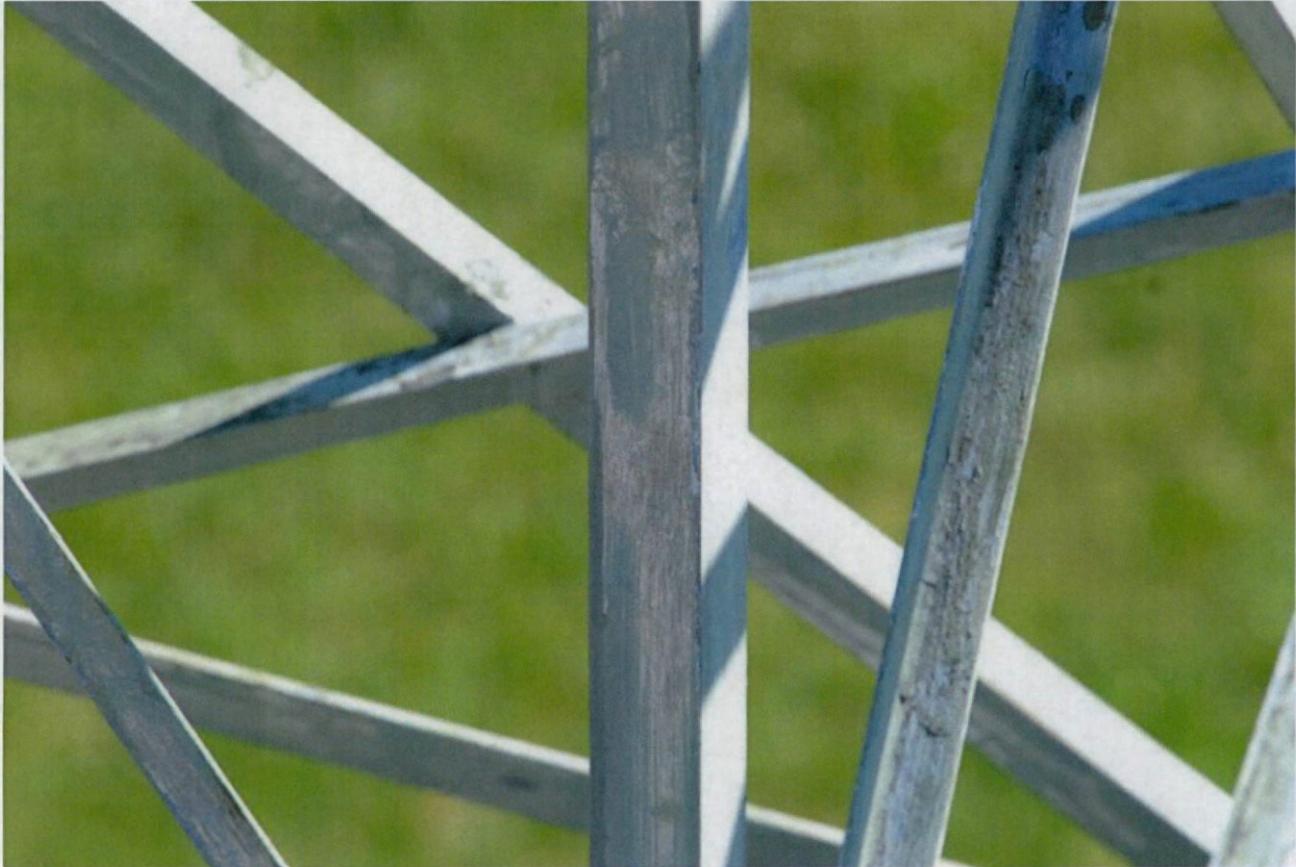
**Figure 136:** 38010S14451 - Poor paint adhesion typical of the entire structure
