PENNSYLVANIA TURNPIKE COMMISSION
In Depth Inspection Report
Bridge No. WB-206 - Milepost 12.6

BRIDGE INSPECTION REPORT

IN-DEPTH INSPECTION REPORT
OF
VEHICULAR WEARING SURFACE, EXPANSION DAMS
AND
UNDERLYING SUPPORTING ELEMENTS
HOMEWOOD BRIDGE
AT
HOMEWOOD BOROUGH, PENNSYLVANIA

HOMEWOOD BRIDGE INSPECTION REPORT

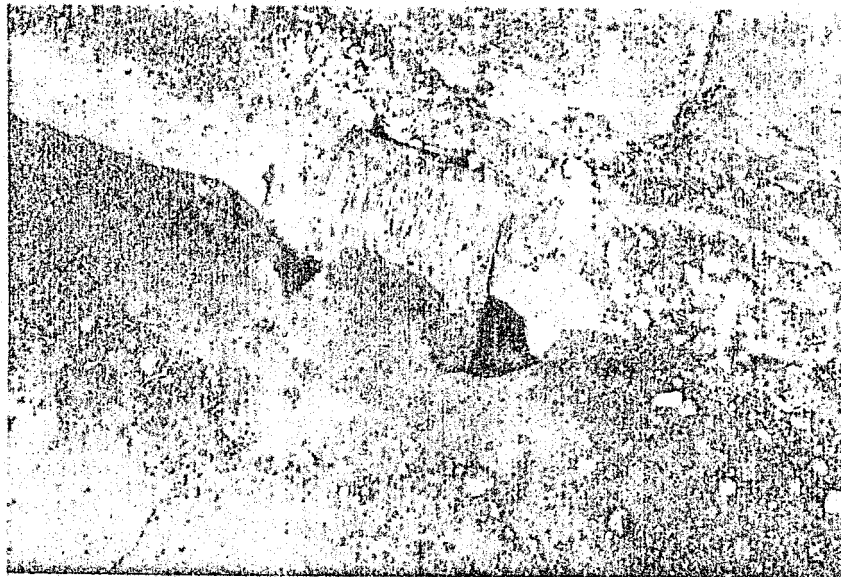
PHOTO 30

East curb of expansion dam over Pier 12
