RE: Ronald and Sheila Derian vs. Pennsylvania American Water Company
Docket # c-2023-3041252

Included please find Exhibits 1 thru 7 to be entered concerning the above case # c-2023-3041252.

G:\Projects\41000\41370 Travelers - Derian Property\Docs\Report.docx

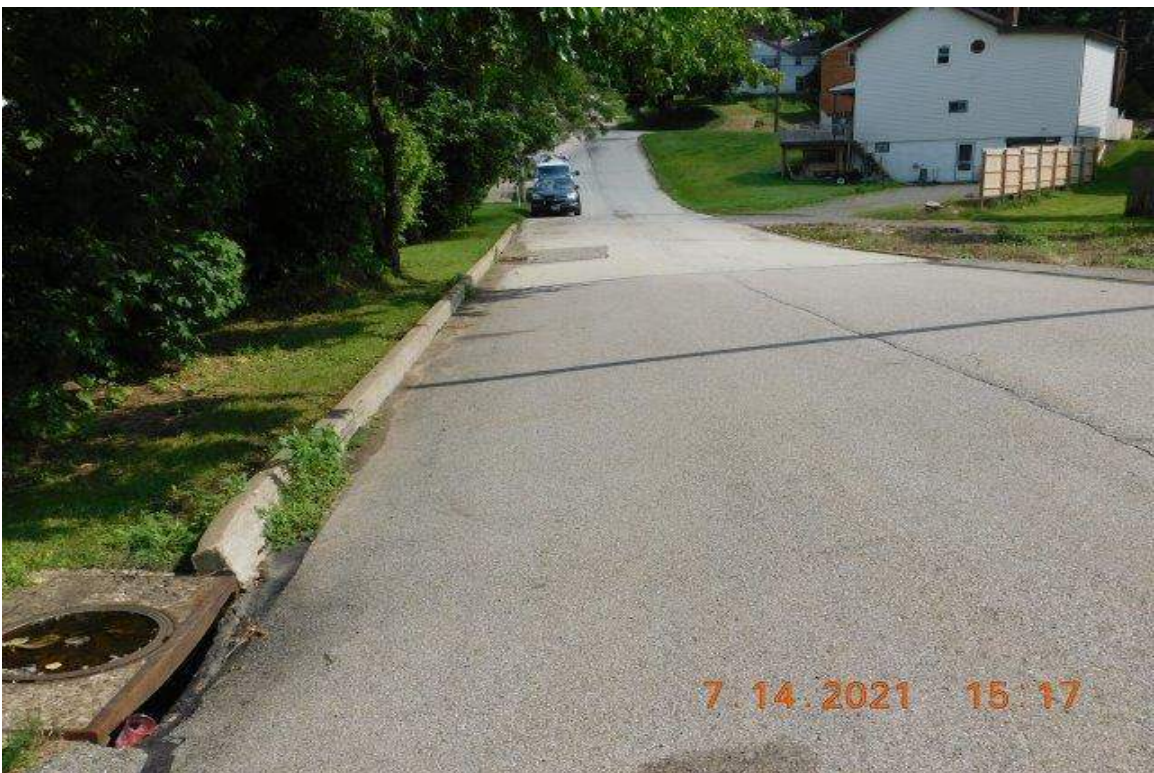
Photo 1 shows the Derian property looking east from the intersection of E. Miller Avenue and Hill Street. Photos 2 and 3 show Hill Street looking southeast. The water main break occurred in the area of the dark pavement patch in the center background of Photo 3. Photos 4, 5, and 6 show the south portion of the Derian property, the area where runoff from the water main break reportedly flowed. Photo 7 shows the upper retaining wall in the rear (south) limit of the left (east) yard. Photo 8 shows E. Miller Avenue looking east from Hill Street, while Photo 9 shows the dwelling front (north) wall.

PHOTO 2 - HILL STREET LOOKING SOUTHEAST FROM EAST MILLER AVENUE

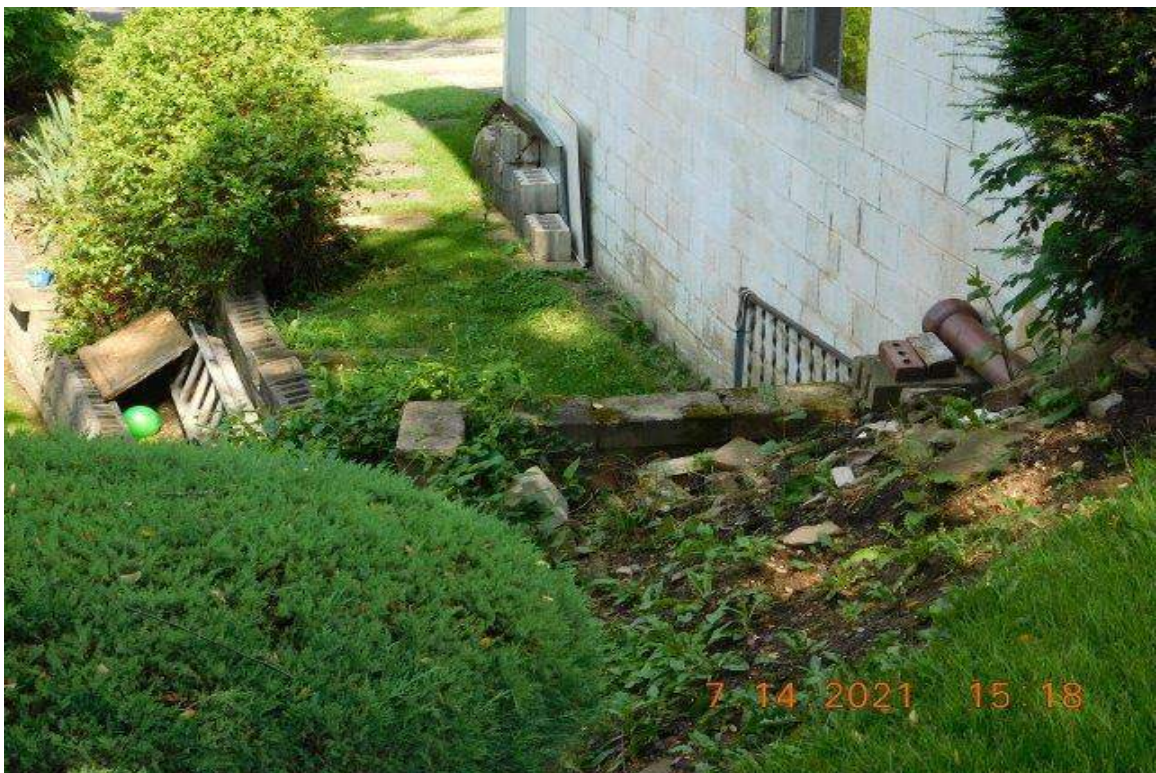
PHOTO 6 - LEFT (EAST) REAR (SOUTH) LIMIT OF DERIAN PROPERTY

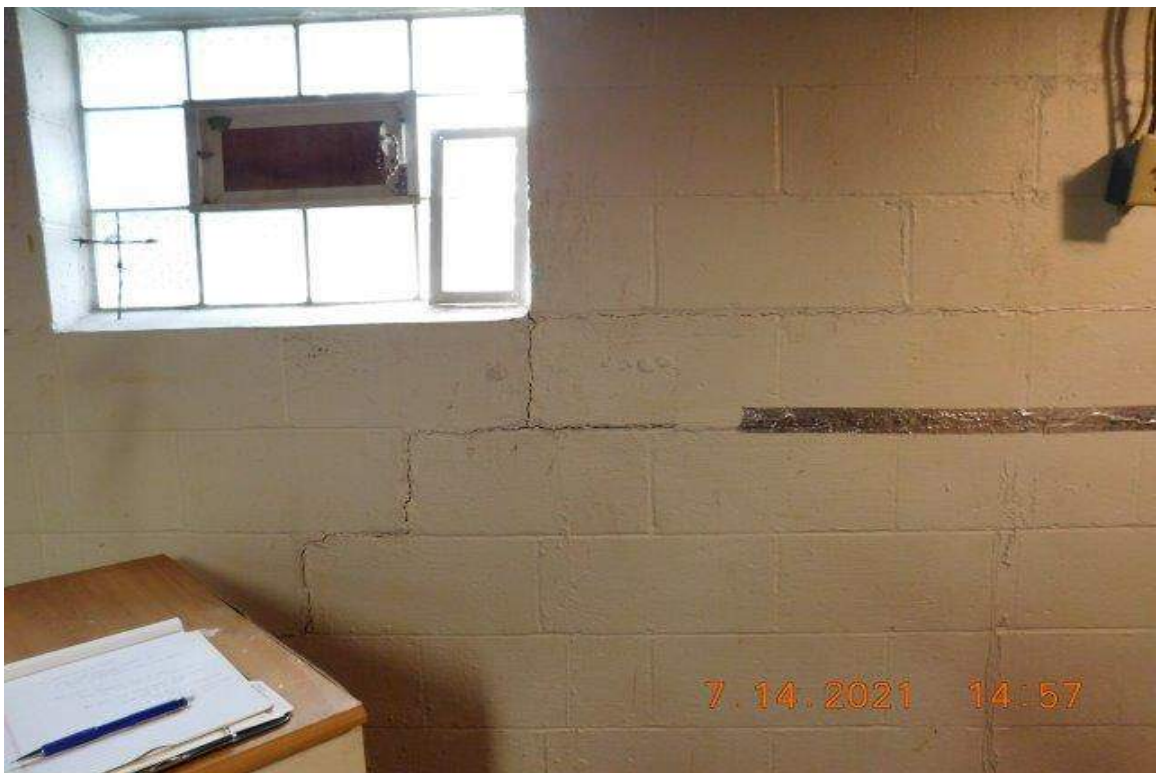
Interior Photo 10 shows the right (west) rear corner of the basement. Photo 11 shows the basement right wall right of Photo 10. Photos 12, 13, and 14 show a step crack in the blockwork mortar joints below the basement right wall rear window, reportedly repaired by Mr. Derian after the water main break in 2020. As noted in those photos, flexible caulking was installed in these cracks. However, the cracks have since recurred. Photos 15, 16, and 17 show horizontal cracks in the basement right wall blockwork mortar joints three courses and four courses below the top of the wall, some of which were covered with metallic paint. Photos 18 and 19 show the basement right wall front window and horizontal and step cracks in the blockwork mortar joints below the window opening. Photo 20 shows the basement right front corner and significant staining as well as areas where the paint has

PHOTO 12 - ANOTHER VIEW OF AREA ON PHOTO 10

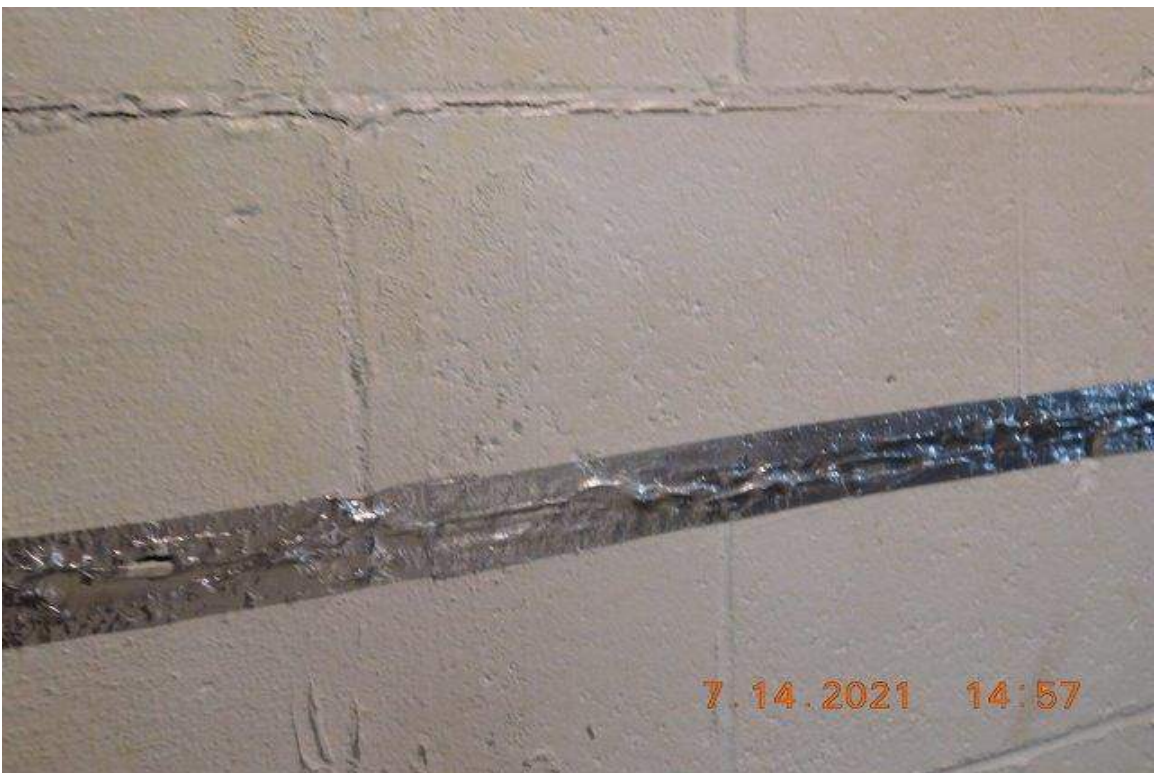
PHOTO 16 - AREA RIGHT OF PHOTO 15

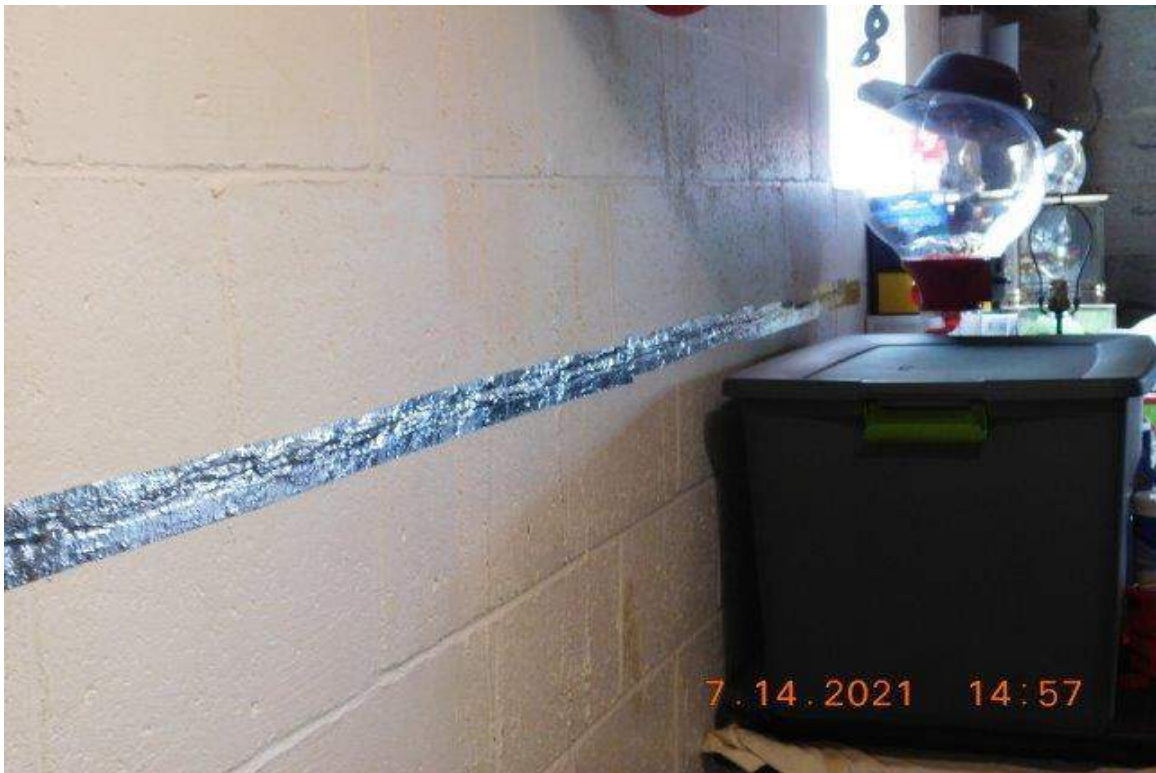
PHOTO 17 - AREA RIGHT OF PHOTO 16

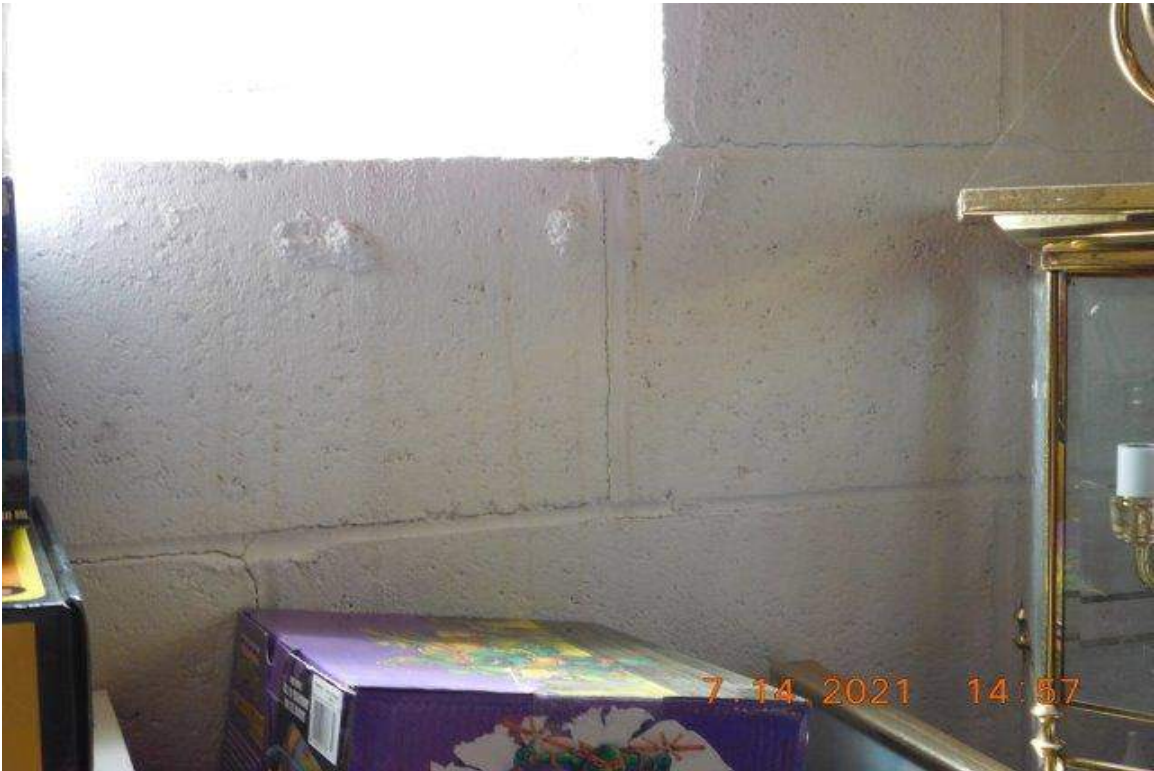
PHOTO 19 - AREA RIGHT OF PHOTO 18

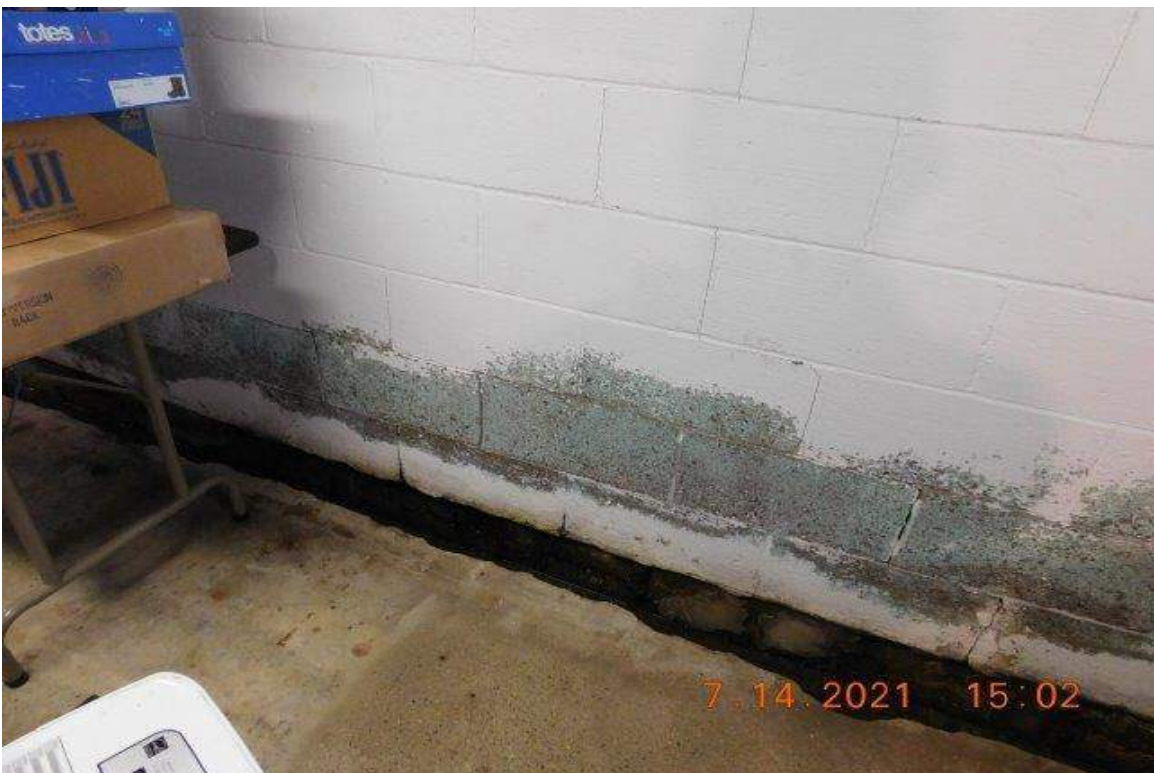
PHOTO 30 - ANOTHER VIEW OF AREA ON PHOTO 29

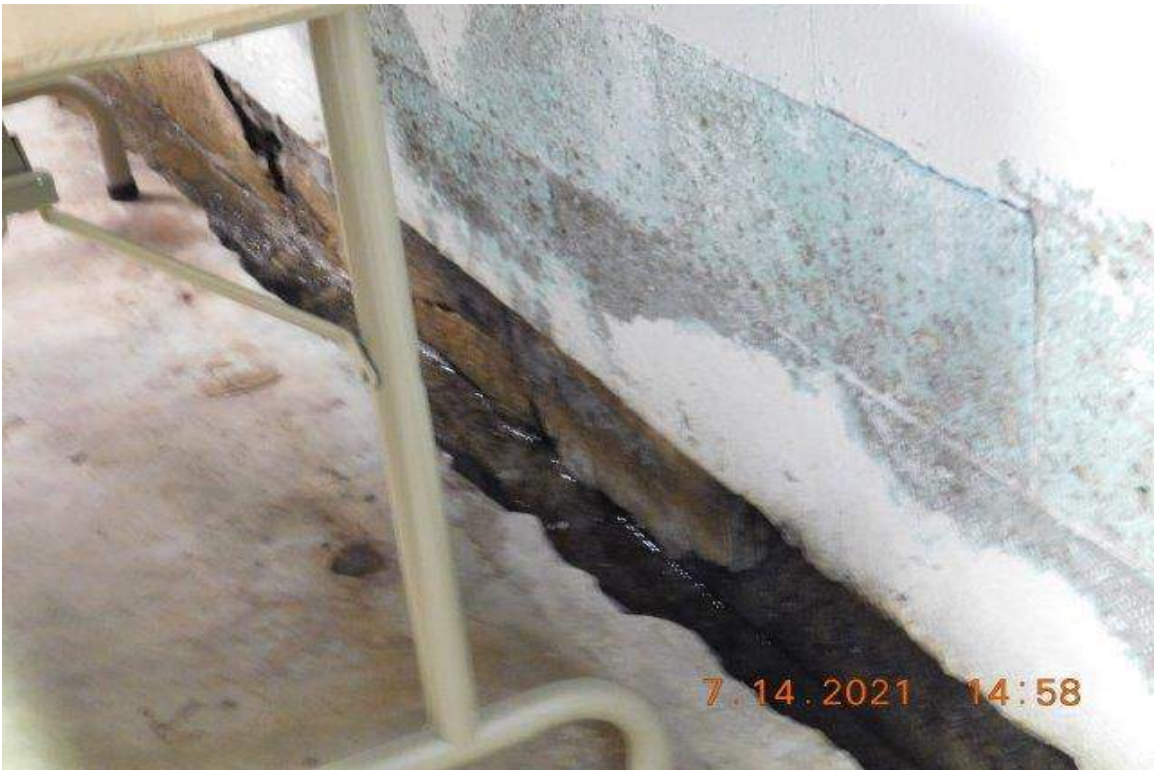
PHOTO 32 - AREA LEFT OF PHOTO 31

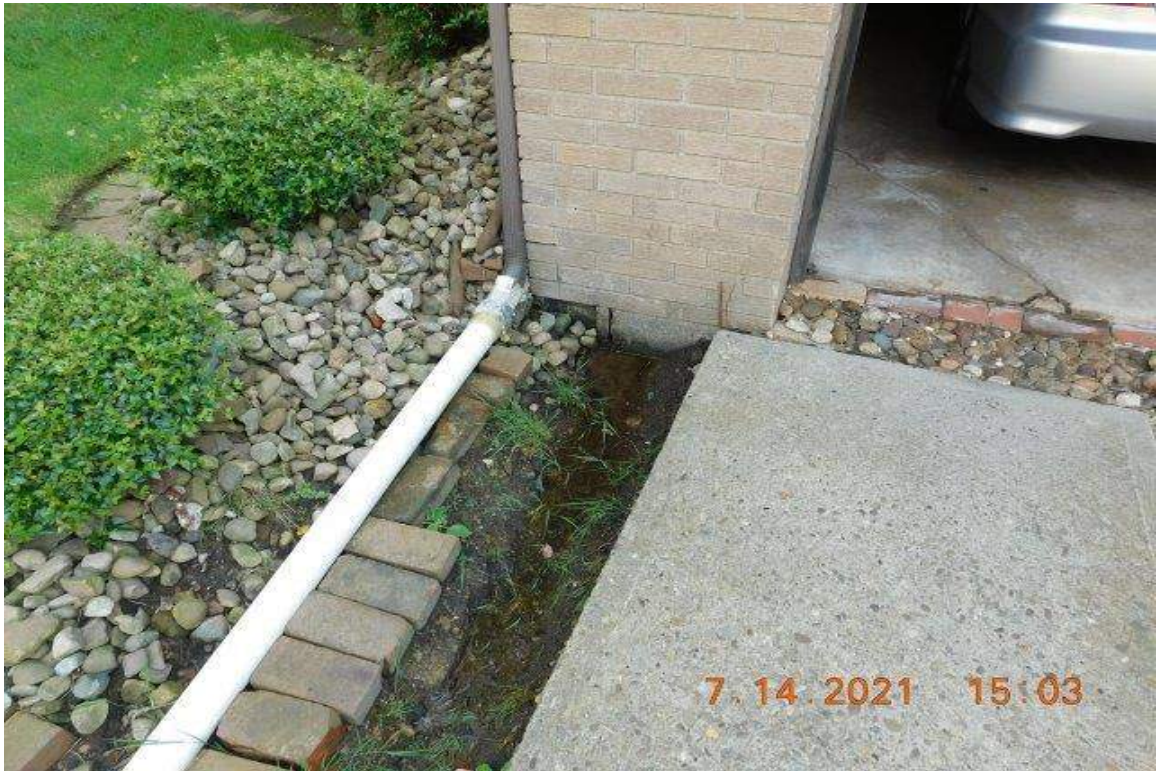
PHOTO 41 - LEFT FRONT CORNER OF GARAGE

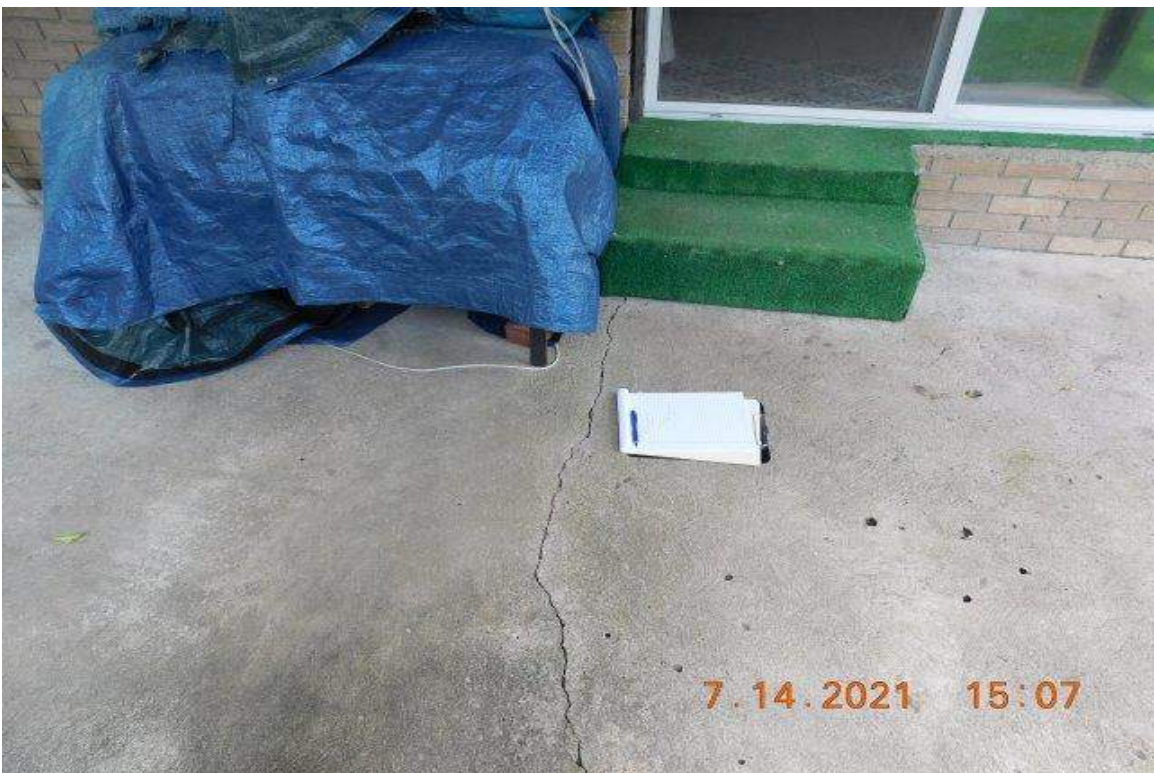
PHOTO 46 - AREA TO FRONT OF PHOTO 44

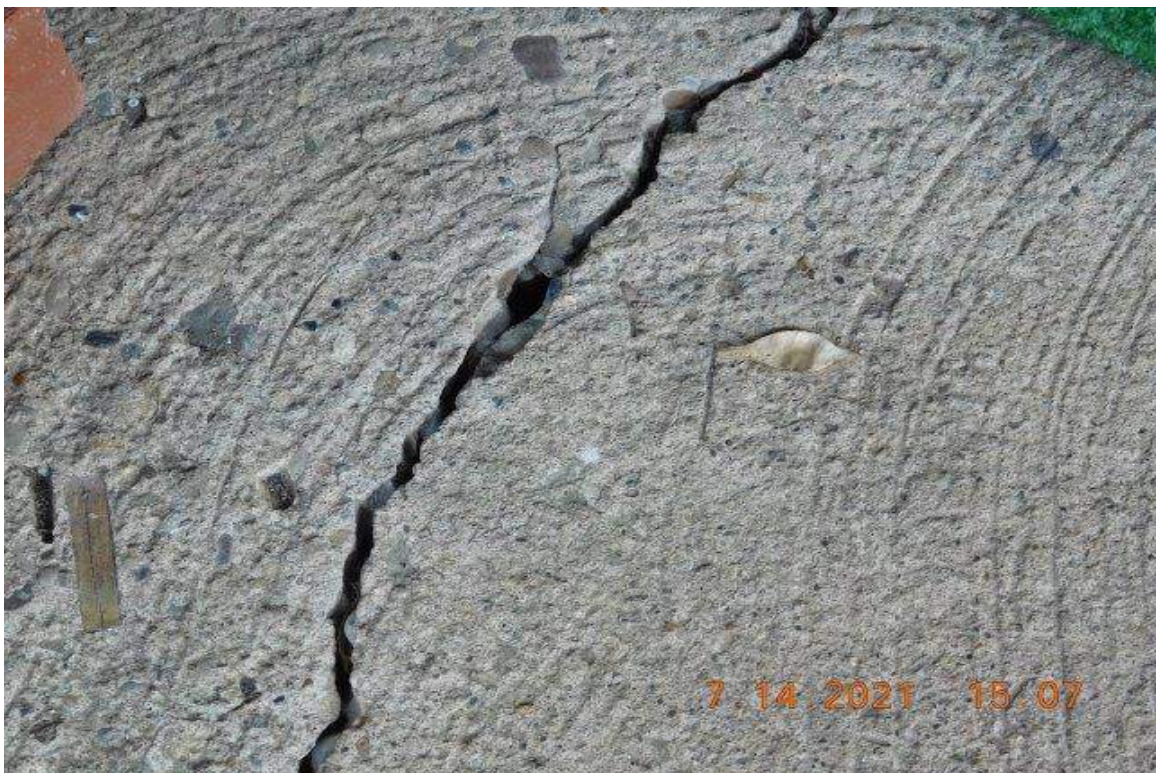
PHOTO 48 - AREA TO FRONT OF PHOTO 47

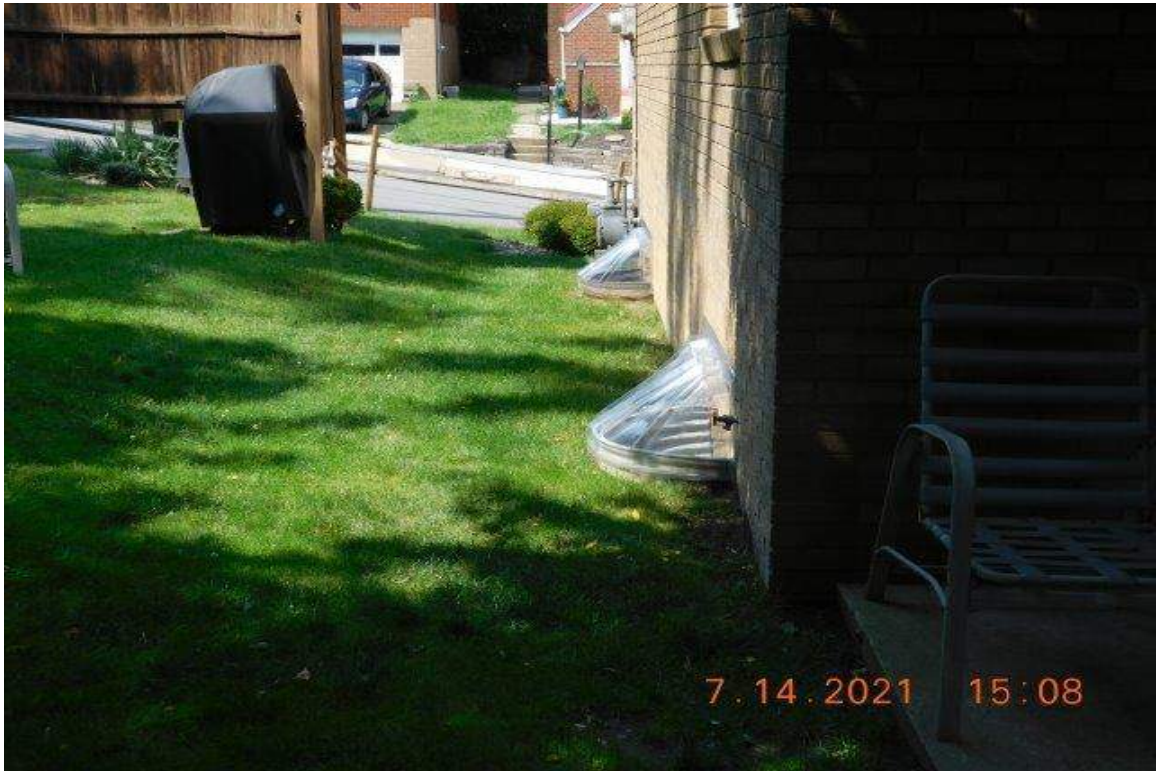
Photo 49 shows the dwelling right wall looking north.

PHOTO 49 - DWELLING RIGHT WALL LOOKING NORTH

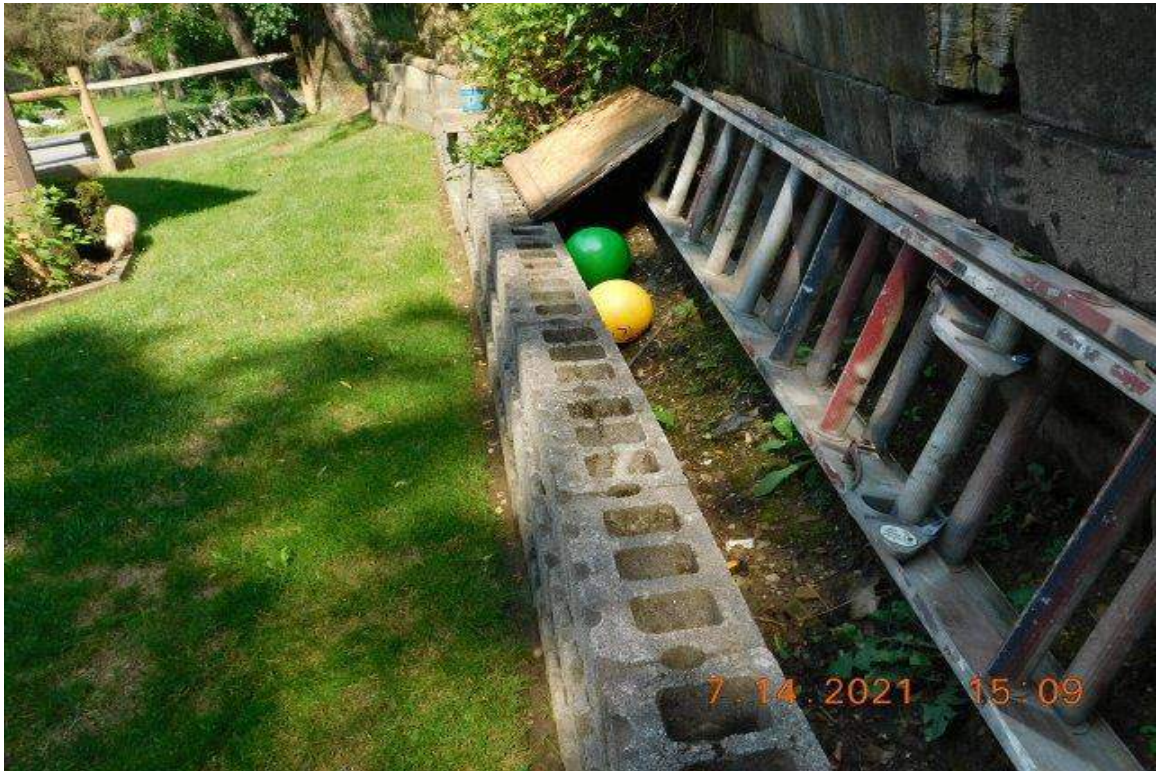
Photo 54 shows the left yard three-course-high retaining wall looking south. Photos 55 thru 58 show the two-tiered block retaining wall in the rear portion of the left yard. The upper wall includes occasional wooden perpendicular support members. Although both of these walls exhibit minor rotation, it does not appear that these walls experienced significant erosion or silt deposition behind them due to the runoff water. Therefore, this rotation pre-dated the water main break.

PHOTO 55 - AREA ON PHOTO 54 LOOKING NORTH

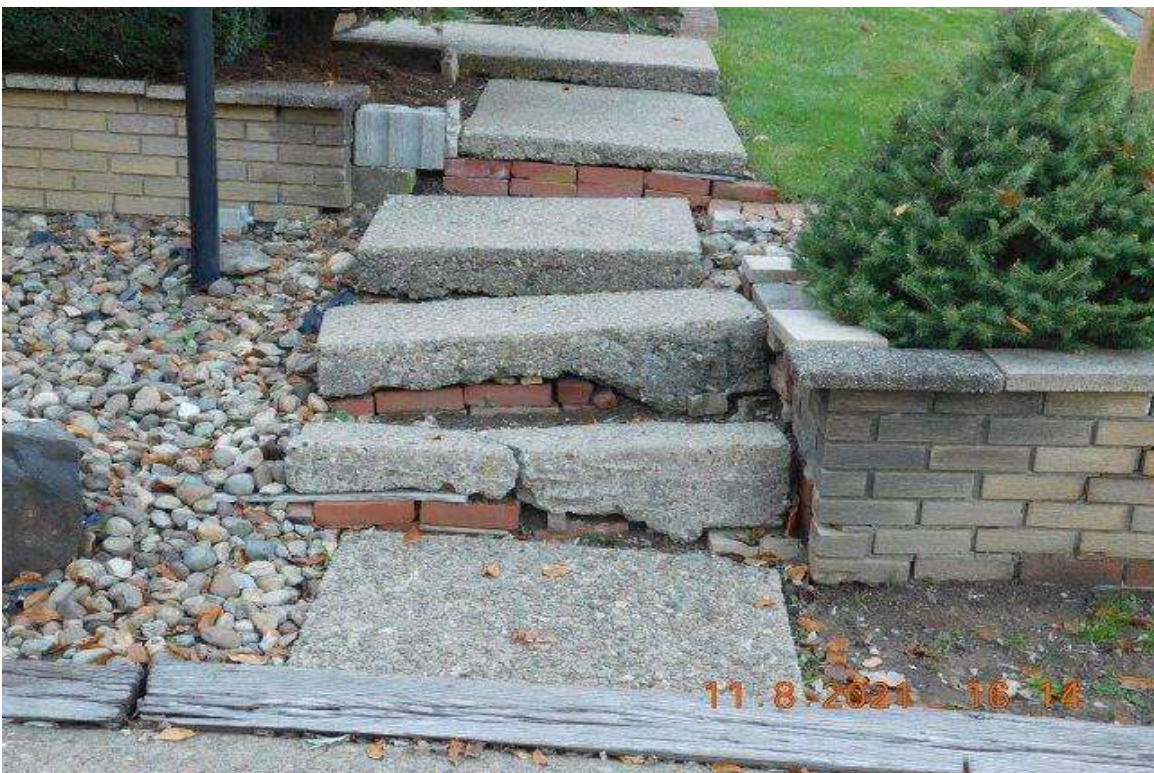
Photo 1 shows the Derian driveway looking north while Photo 2 shows a crack in the east side slab that Mrs. Derian claims is new (IGSV). Photos 3 thru 8 show the front (north) yard sidewalk and steps, which are uneven throughout. Photo 9 shows the blocks and slabs supporting the front stoop, which are not uniformly distributed. Mrs. Derian alleges that all of the unevenness is recent (IGSV).

PHOTO 3 - FRONT (NORTH) YARD SIDEWALK LOOKING NORTHWEST

PHOTO 4 - ANOTHER VIEW OF AREA ON PHOTO 3

PHOTO 5 - CLOSE-UP OF AREA ON PHOTO 4

PHOTO 6 - SIDEWALK WEST OF PHOTO 5

PHOTO 7 - CLOSE-UP OF AREA ON PHOTO 6

PHOTO 8 - CLOSE-UP OF AREA ON PHOTO 7

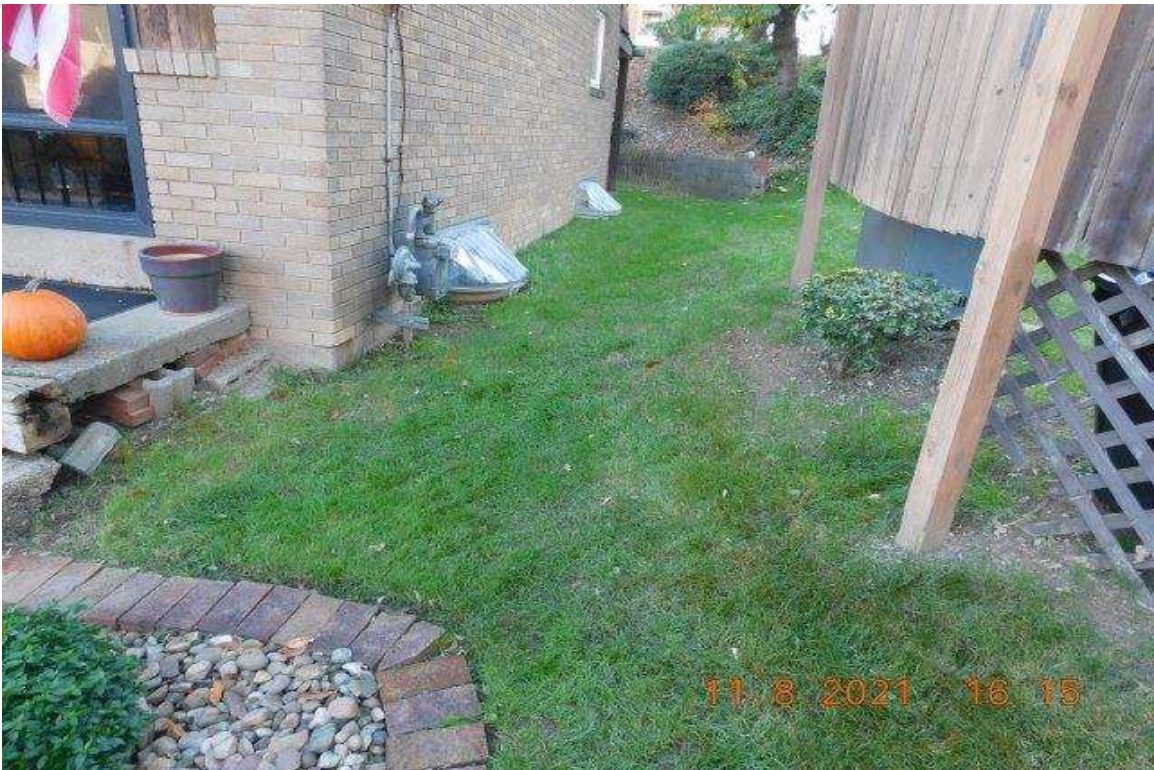
Photos 10, 11, and 12 show the Derian right (west) side yard. Mrs. Derian identified this as one of the areas that have become uneven recently due to “subsidence”. It should be noted that when I compared photos taken for my July 22, 2021, report the area appears to be the same. However, the grass was more lush in July than it was in November. It is my opinion that the areas of alleged subsidence are the paths that the Derians follow when walking through the yard. Since the grass is thinner and the ground is wetter in the Fall of the year, the paths are getting slightly more compressed when being walked on, creating the shallow depressed area.

PHOTO 10 - RIGHT (WEST) SIDE YARD

PHOTO 11 - CLOSE-UP OF AREA ON PHOTO 12

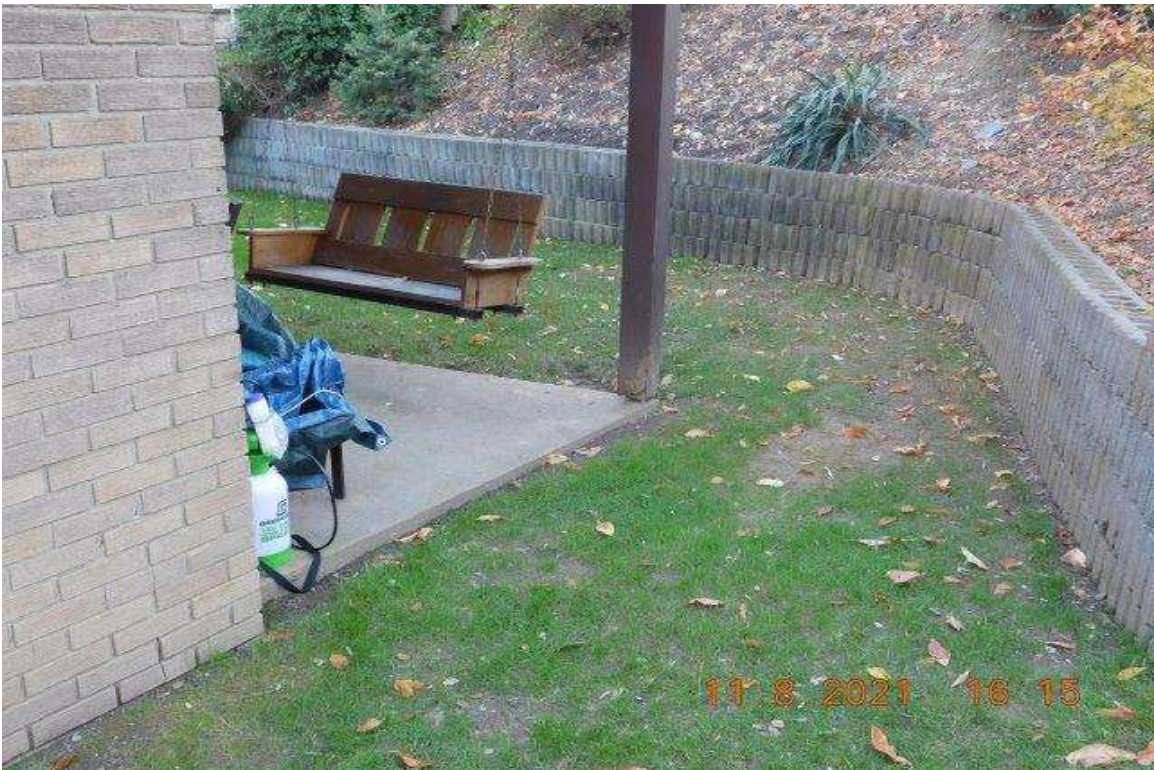
Photos 12, 13, and 14 show the significantly rotted bases of the posts supporting the porch roof. Photos 15, 16, and 17 show the roof of the porch which is very deteriorated in some areas and previously repaired in others. Photos 18 thru 21 show the crack in the rear patio slab, which does not appear to have changed since my July 14, 2021, inspection.

PHOTO 12 - AREA SOUTH OF PHOTO 13

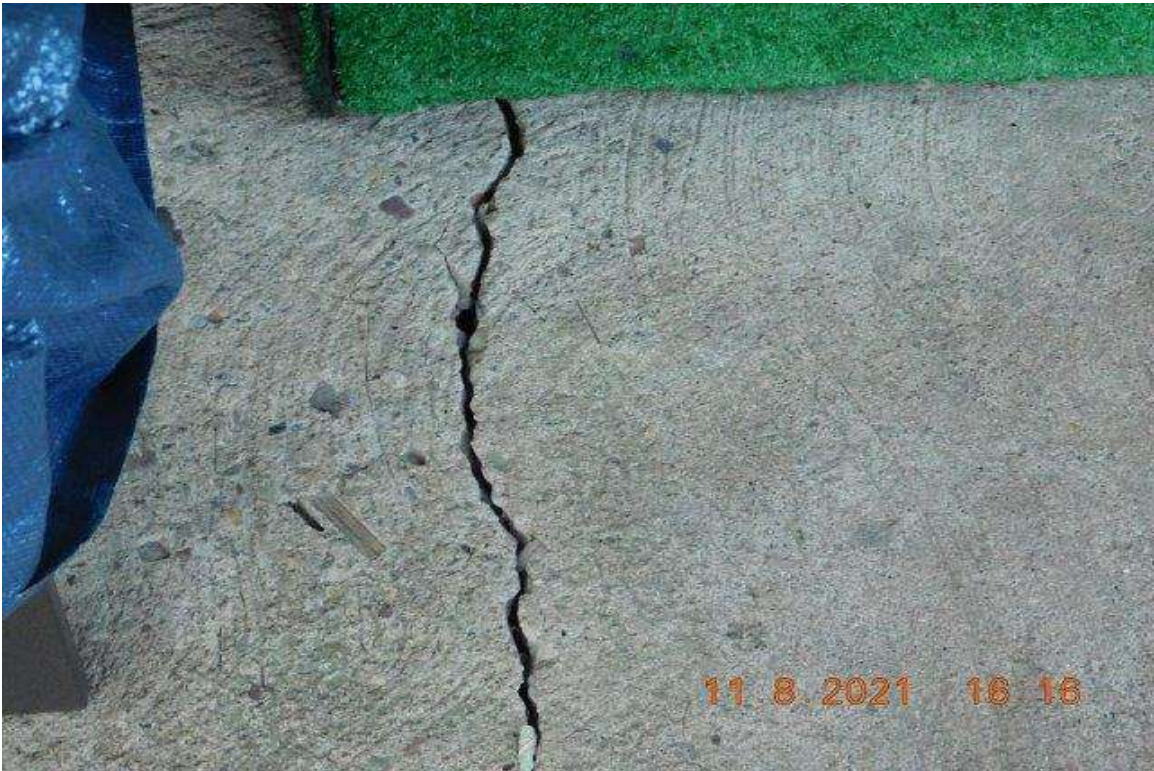
PHOTO 21 - AREA NORTH OF PHOTO 20

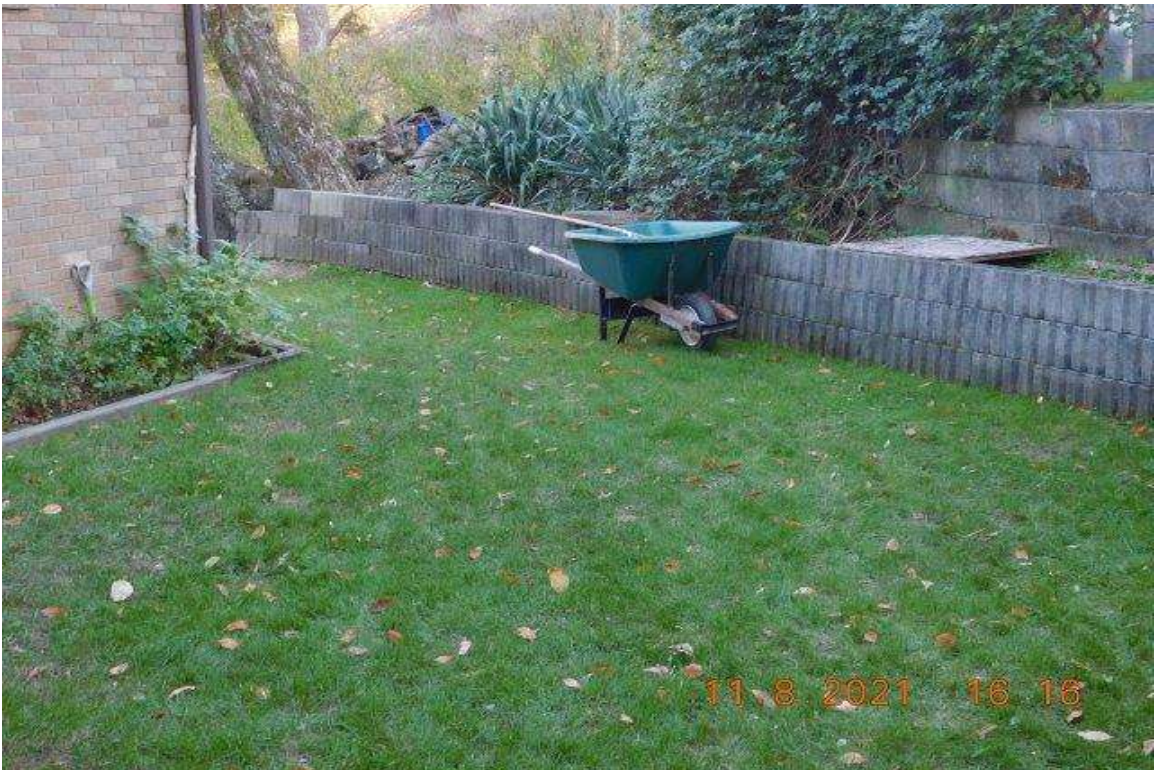
Photos 22, 23, and 24 show the left portion of the rear yard, the second area identified by Mrs. Derian as having become uneven recently due to “subsidence”. This area was not reviewed during my July

PHOTO 22 - EAST PORTION OF REAR YARD LOOKING EAST

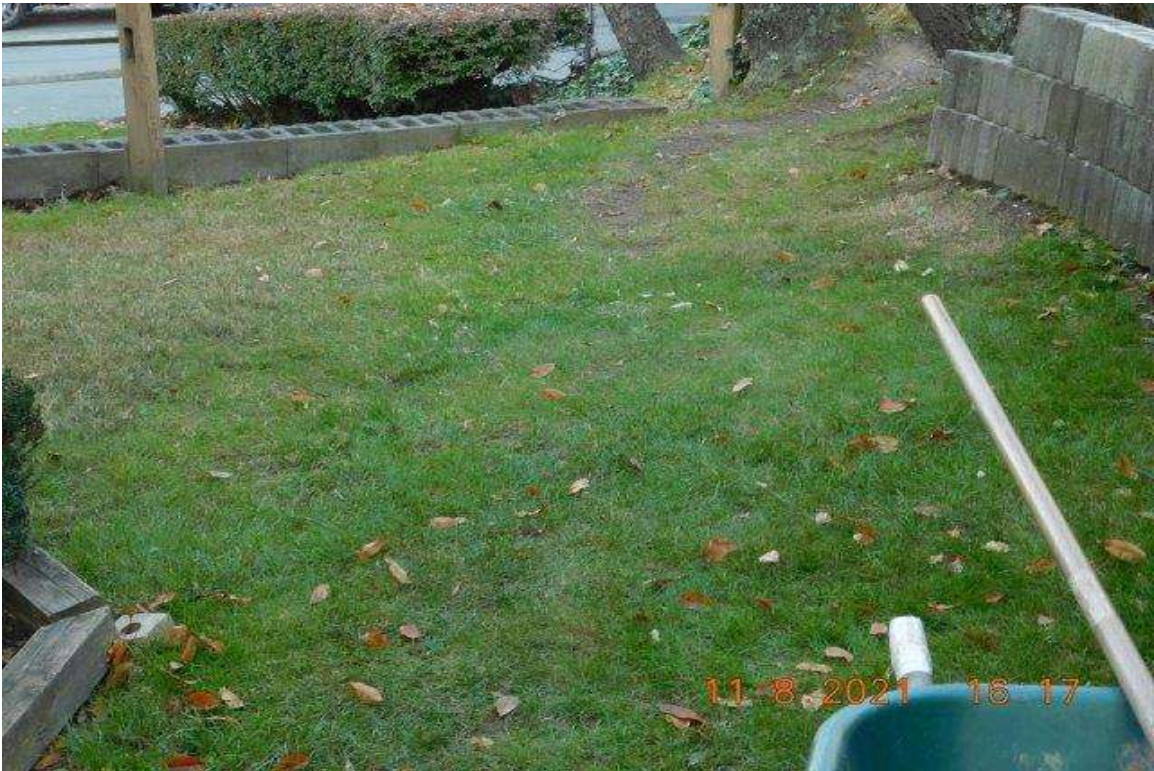
Photos 25 and 26 show the Derian left (east) side yard. Mrs. Derian identified this as the third area that has become uneven recently due to subsidence. It should be noted that when I compared photos taken for my July 22, 2021, report, the area's condition appears to be the same. However, the grass was more lush in July than it was in November. It is again my opinion that the areas of alleged subsidence are the paths that the Derians follow. Since the grass is thinner and the ground is wetter in the Fall, the paths are getting slightly more compressed when being walked on, creating the shallow depressed area.

PHOTO 25 - LEFT (EAST) SIDE YARD LOOKING NORTHEAST

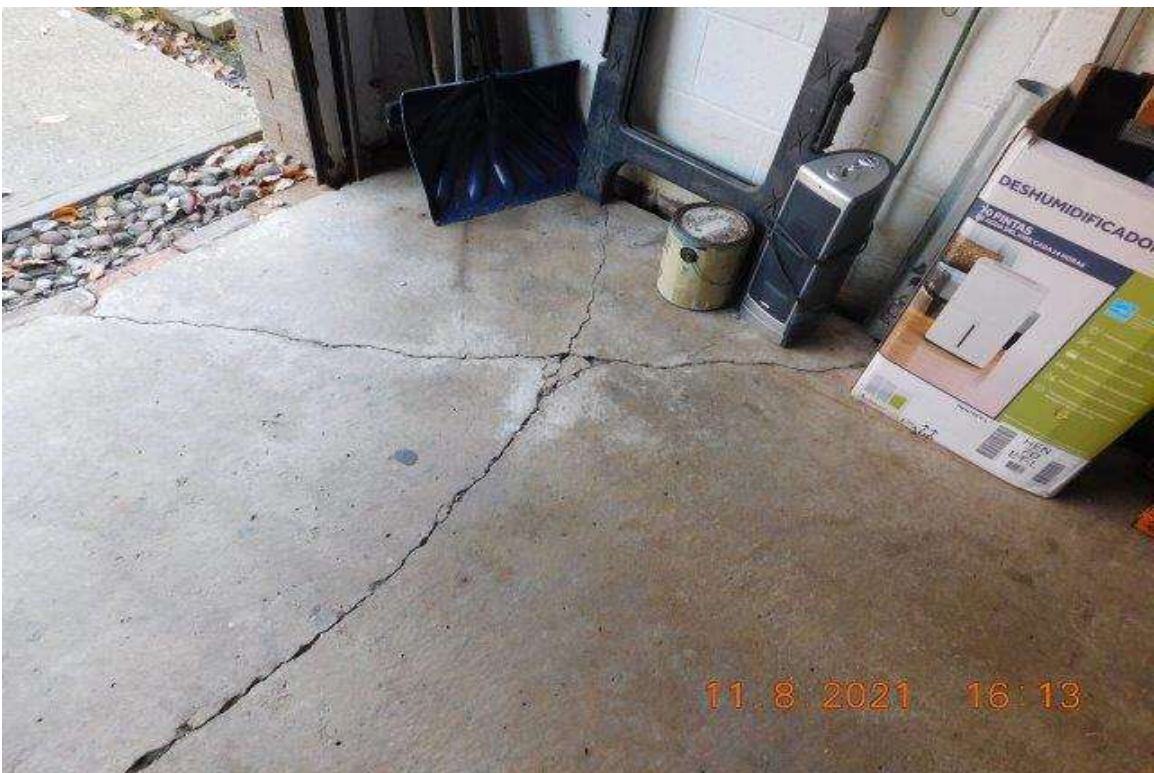
Photos 38, 39, and 40 show cracks in the garage floor slab, which Mrs. Derian opined are new. As noted in the photos, the cracks exhibit rounded and polished edges indicating that they are not new.

PHOTO 40 - AREA EAST OF PHOTO 39
