-----  
Bureau of Investigation |  
and Enforcement |  
v. |  
Philadelphia Gas Works, |  
In Person Evidentiary |  
-----

Docket No.:  
C-2024-3052277

Thursday, October 16, 2025  
Commencing at 9:59 a.m.

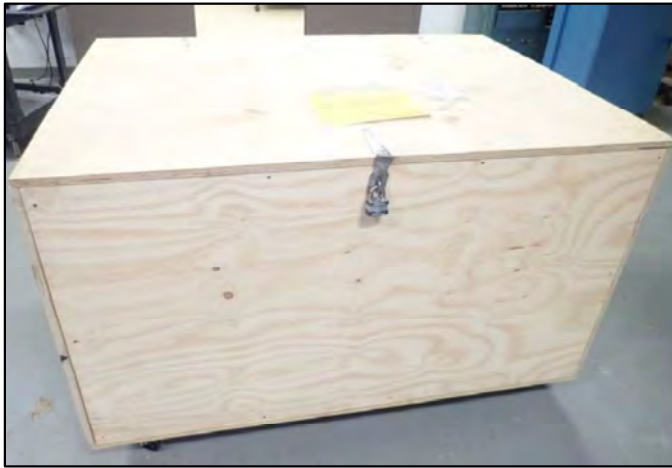
Photo No. 1 (W-6491-D-005.JPG – cropped)

The subject pipe section and corresponding pipe segment were supplied inside a padlocked wooden crate whereby a key was provided to gain access (**Photo No. 1**). Two pipe sections were contained inside the crate and were identified as **ITEM A** and **ITEM B** (**Photo Nos. 2 – 3**). The pipe sections and corresponding cut/removed samples were returned to the respective crate and locked at the end of each work day, except for the samples that were shipped to an independent testing laboratory while maintaining chain of custody, which were eventually returned to the respective crate upon completion of mechanical testing and chemical analysis as per the March 7, 2022 protocol. As noted above, **ITEM B** was reserved for sampling should **ITEM A** not have sufficient length for testing per the protocol. The following testing was performed on **ITEM A** only.

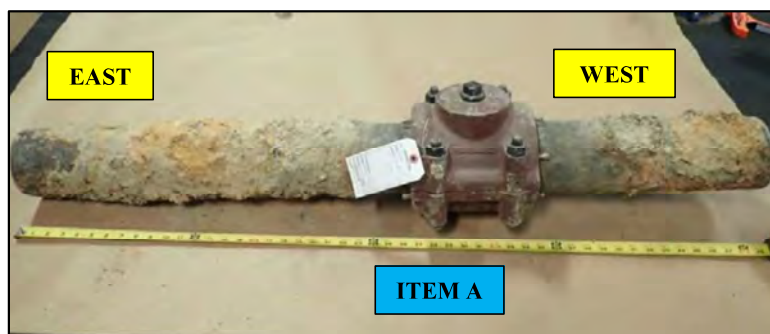
Photo No. 4 (W-6491-D-064.JPG – cropped)

**ITEM A** consisted of a 49-inch long, 4-inch diameter cast iron pipe with a metal pipe repair clamp (Dresser® Style 80 Repair Clamp) located in the approximate middle of the pipe section (**Photo Nos. 4 – 5**). A paper tag attached to the pipe section was marked “*DATE: 12/1/2021; LOCATION: 815 Jackson Street; DESCRIPTION: 4" CIOC gas main.*” Handwritten markings found on the surface of the clamp identified the TOP of the pipe and North (N), South (S), East (E), and West (W) directions denoting orientation as installed in the ground. It was understood that during the investigation process PGW workers installed a repair clamp across the breach, which was attributed to the reported incident, to secure the damaged region.

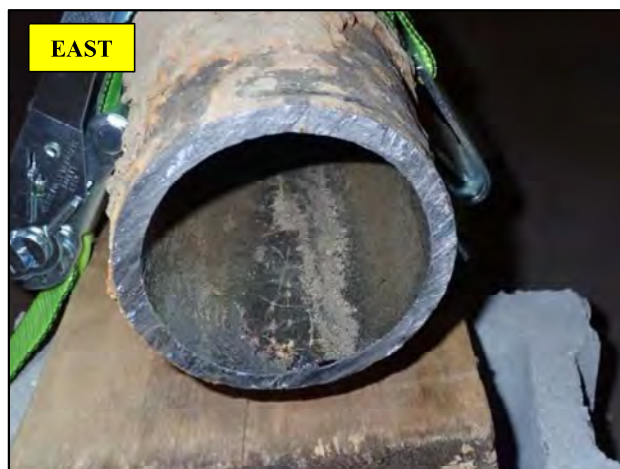
Photo No. 6 (W-6491-076.JPG)

Both the EAST and WEST ends exhibited circumferential cuts (**Photo Nos. 6 – 7**, respectively). Visual examination of the EAST and WEST ends of **ITEM A** revealed the presence of darkened regions along cut surfaces, suggesting graphitization, which reduces the effective wall thickness by corrosion process. Due to the roughness of the cut surfaces and the fact that the breach did not occur at these ends, these ends were not ground planar for further examination. However, it may be noted that visual examination of the cut surfaces of both ends showed notably sized porosity and voids, which formed at the time of manufacturing (**Photo Nos. 8 – 9**).

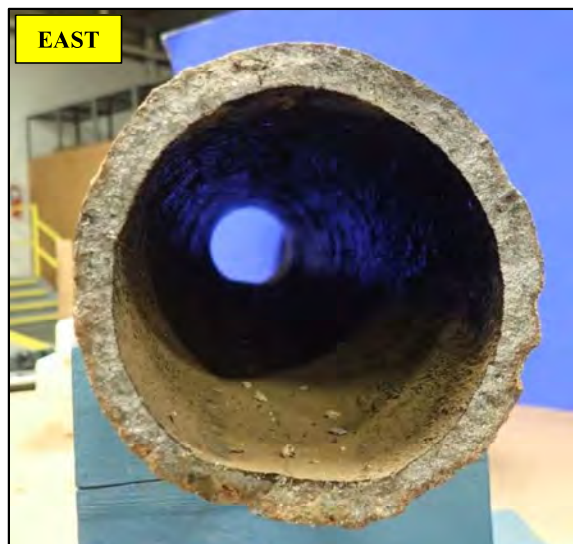
Photo No. 13 (W-6491-D-167.JPG – cropped)

Both mating fracture surfaces of **ITEM A** were visually examined in the as-received, or uncleaned, condition. The mating fracture surfaces were mirror images of each other (**Photo Nos. 13 – 14**). The BOTTOM of the cast iron main exhibited a darkened surface that spanned more than half the wall thickness. However, preliminary inspection of the mating fracture surfaces did not reveal the presence of a darkened region spanning the thickness of the wall, which would have suggested a pre-

existing leak prior to the reported incident. In order to further examine the fracture topography, microstructure, mechanical properties, and chemical composition, samples had to be cut/removed.

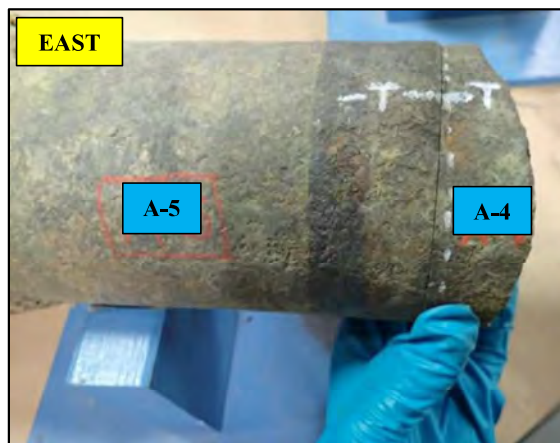
Photo No. 17 (W-6491-D-233.JPG – cropped)

The ring sections identified above were subsequently dry cut using a horizontal band saw (**Photo Nos. 17 – 18**).

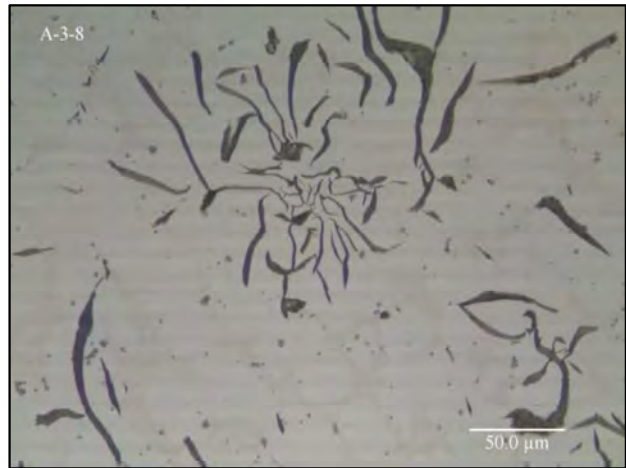
The microspecimens were then examined via Light Optical Microscopy (LOM) in both the unetched and etched conditions. The bulk microstructure of the pipe consisted of a mixture of Type C distribution of graphite (superimposed flake sizes, random orientation) with Type B (Rosette flake graphite), flake size 3-4, in a Pearlite matrix (**Photo Nos. 50 – 53**). Type C graphite, also referred to as Kish graphite, is typical for pit cast iron pipes due to the inherent slow cooling rates. Kish graphite greatly reduces the mechanical properties of cast iron and produces a rough surface finish upon machining.

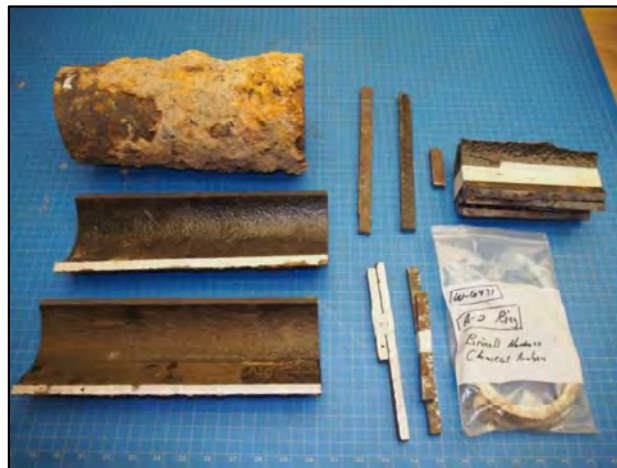
Photo No. 55 (W-6491-F-002.JPG)

As part of the mechanical testing and chemical analysis, **ITEM A-2** and **ITEM A-5** were submitted to AEIS for testing by an independent testing facility (**ATTACHMENT G** – Hardness, Ring, Talbot Strip Test Report, Chemical Analysis, and associated Chain of Custody Form).<sup>3</sup> Hardness testing was performed as per the appropriate ASTM standards (see below) while the Ring and Talbot Strip Testing was performed as per ASA Specification A-21.3 “*Cast Iron Pit Cast Pipe for Gas*” (**ATTACHMENT H**). The samples from the mechanical testing were documented and photographed after being returned from AEIS (**Photo No. 55**).

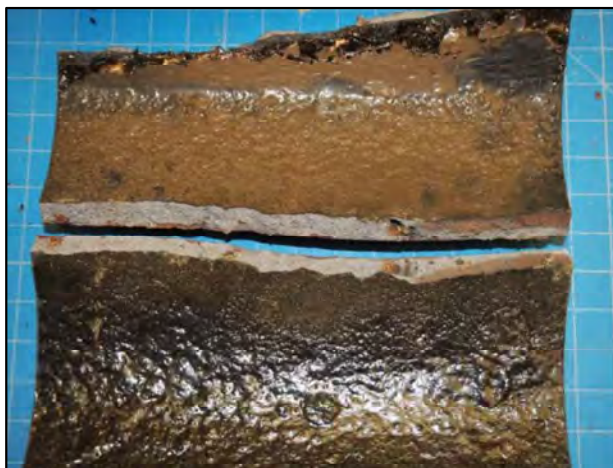
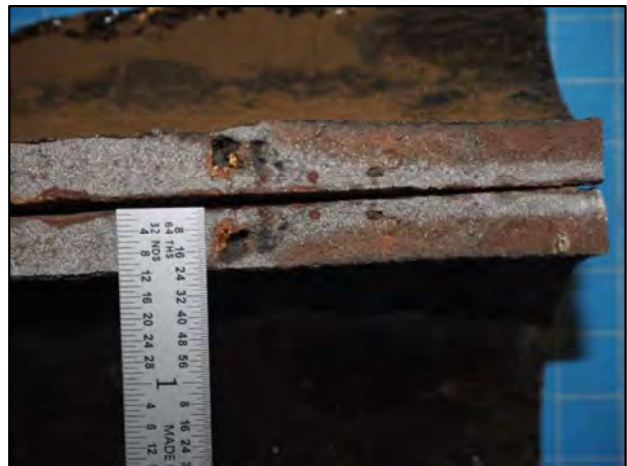
The calculated values from the ring testing indicated that the Modulus of Rupture was **NOT** acceptable or in compliance with the requirements of ASA Specification A-21.3 but the Secant Modulus of Elasticity was considered to be acceptable and in compliance with the requirements of ASA Specification A-21.3.

Examination of the induced fracture surfaces of the Ring Test Sample revealed varying degrees of graphitization and casting voids, similar to that of previously examined and above described ring samples from the cast iron main (**Photo Nos. 58 – 65**).

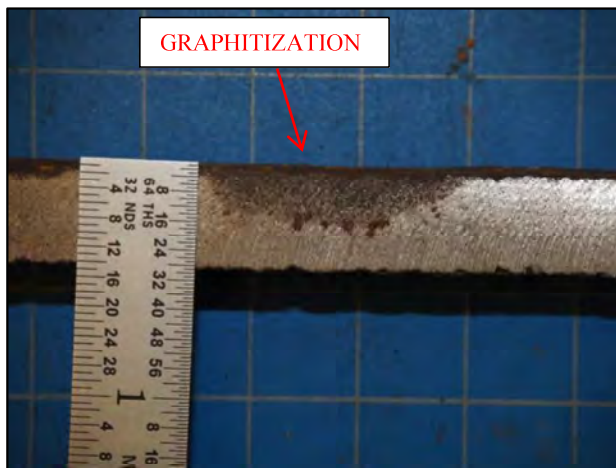
The Modulus of Rupture values of both Talbot strip specimens were **NOT** acceptable (less than 30,000 psi minimum while the Secant Modulus of Elasticity for one of the Talbot strip specimens (No. 2) met the requirement of 10,000,000 psi maximum, respectively).

Examination of the Talbot strip samples after testing revealed a reduction in effective wall thickness due to graphitization (**Photo Nos. 66 – 69**). In addition to the presence of graphitization in the cross-sections of the specimens, the low values may also be attributed to the presence of steadite phase in the microstructure, as observed in the microspecimens prepared from the cast iron main.

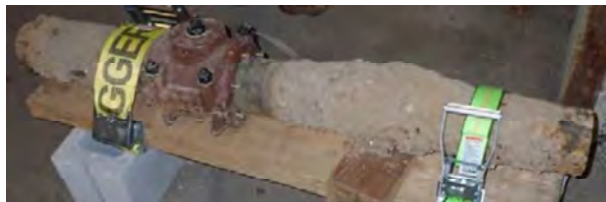
Photo No. 1 (ITEM A)

- A. 49-inch long 4-inch diameter cast iron pipe with pipe clamp spanning fracture location
- B. 47-inch long 4-inch diameter cast iron pipe with service tap

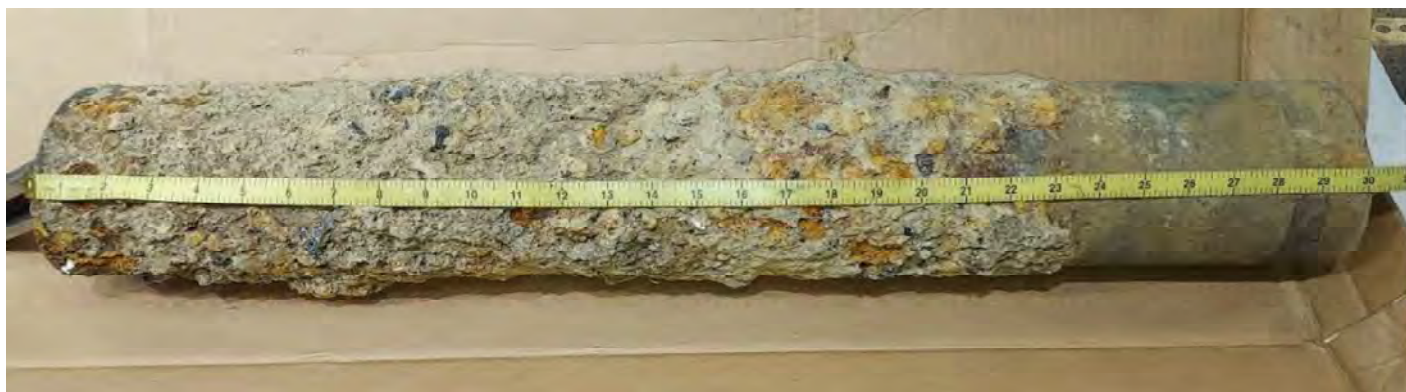
**Figure No. 1 Water Main As Received**

Rockwell hardness was measured on the submitted pipe with the following values were obtained. The hardness test results conform to the specified limit of AWWA C106.

A ring, 6 inches in length, was cut from the submitted pipe. This ring was subjected to a compression test to determine the modulus of rupture. The modulus of rupture of the submitted pipe does not conform to the required minimum of AWWA C106.

| <b>Ring Test</b> | | |
|---|---|---|
| Modulus of Rupture, psi | <b>25,700</b> | <b>40,000 Min.</b> |

The chemical analysis and modulus of rupture of the submitted water main **does not conform** to the specified minimum requirement per AWWA C106.

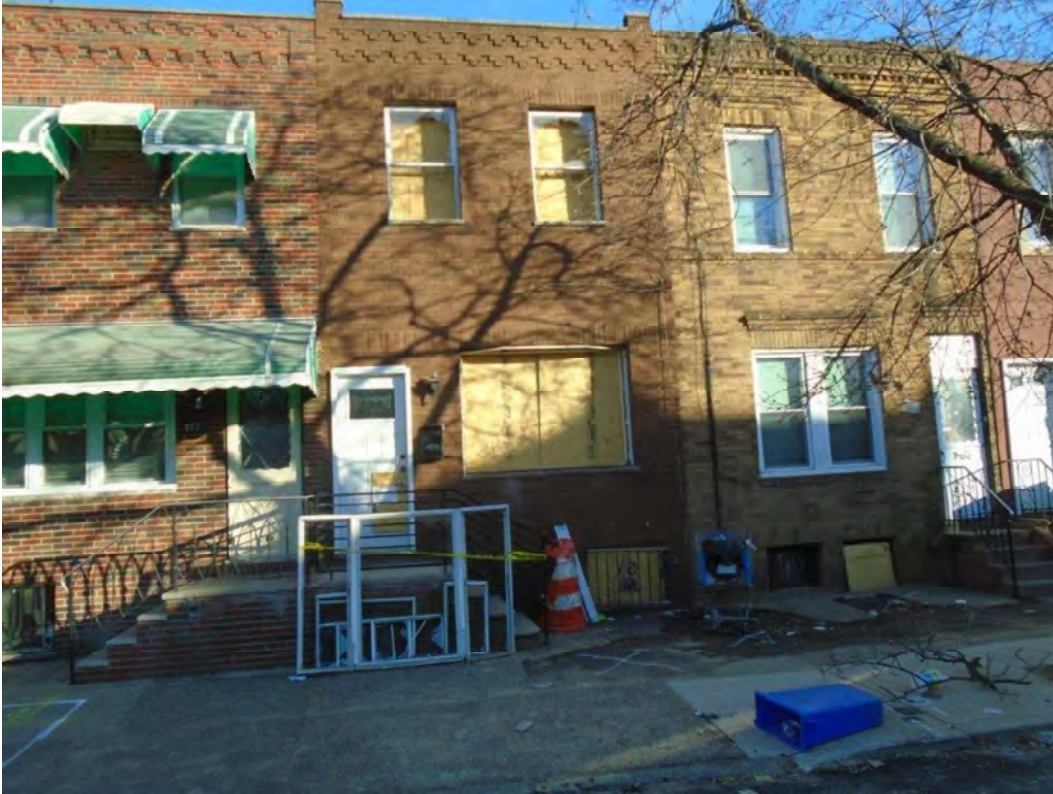
The subject structure is a two-story, three-bedroom rowhome located in the middle of the row (refer to photograph 1). There is also a full unfinished basement where all utilities were located. The exterior is brick and the interior support system is frame. The house is approximately 14' in width and approximately 40' in length. This dwelling reportedly was built in 1925 and is therefore approximately 97 years old. The dwelling was owner occupied at the time of this incident and protected by single station battery operated smoke detectors.

Photograph #1: Front view of 815 Jackson Street.

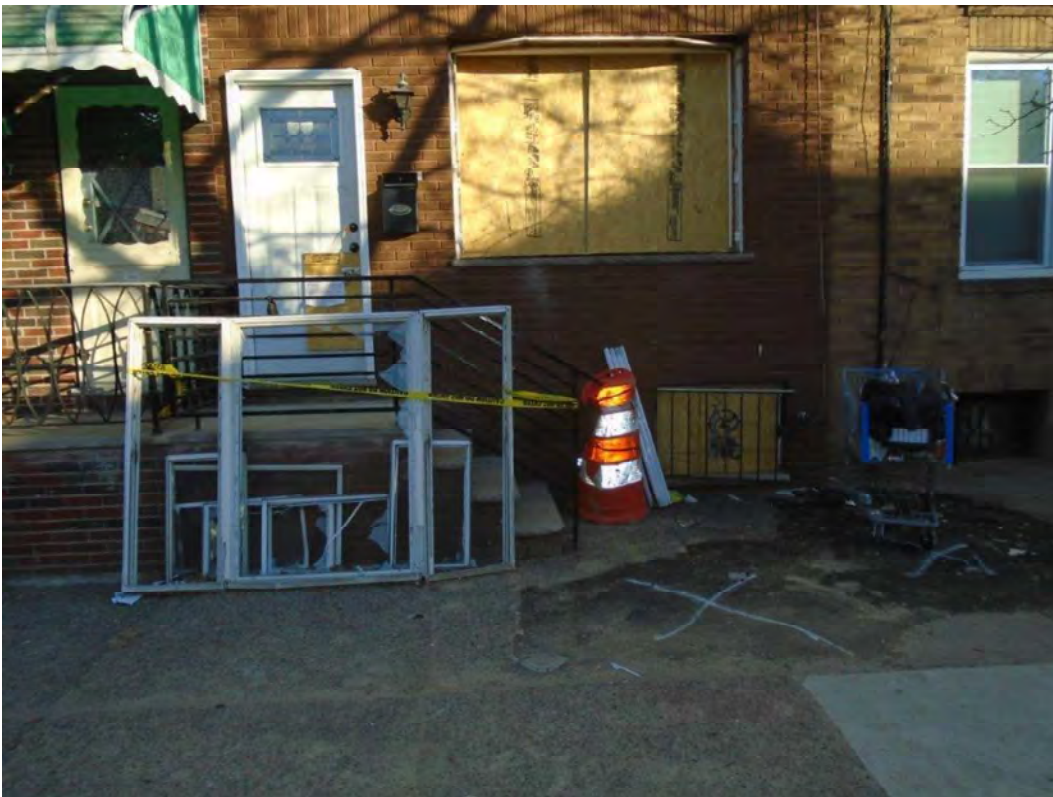
Photograph #2: Front view of 815 Jackson Street.

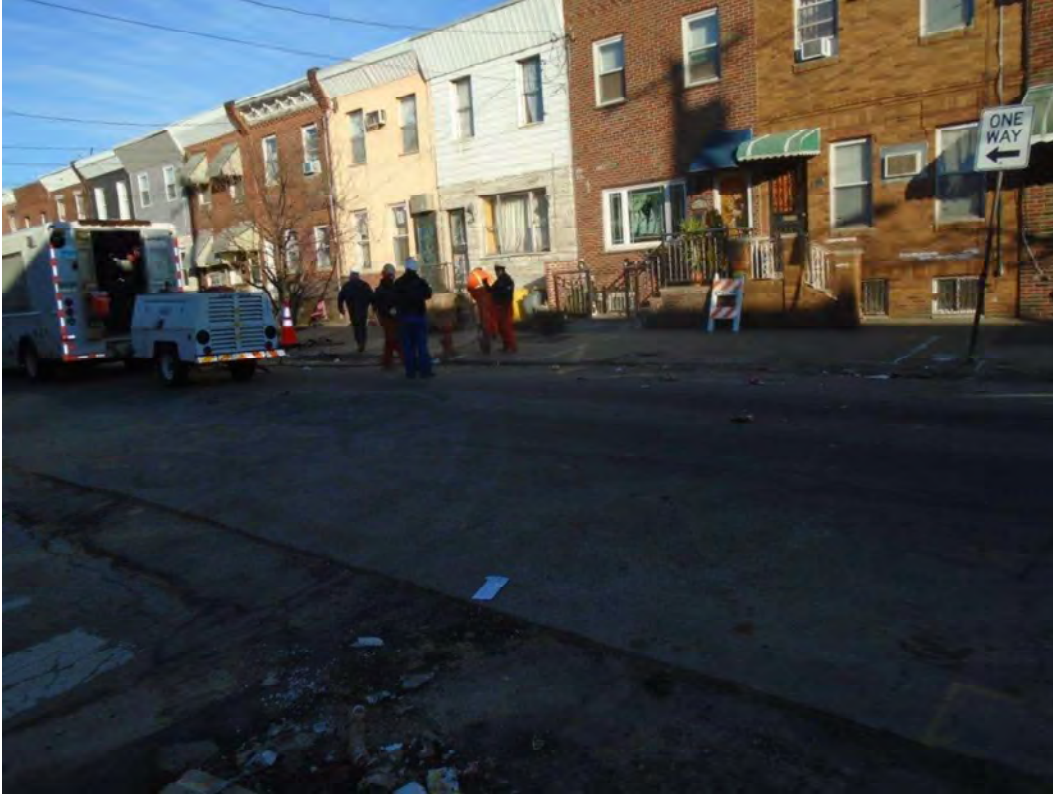
Photograph #3: 800 block of Jackson Street.

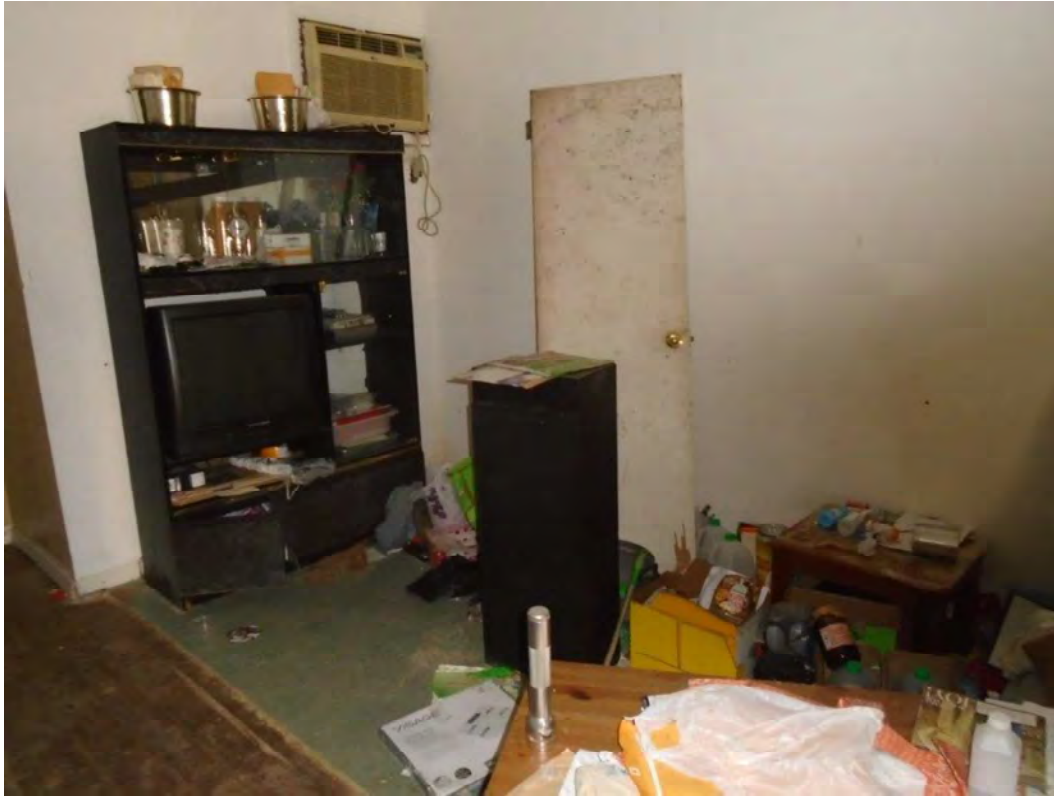
Photograph #7: Living room.

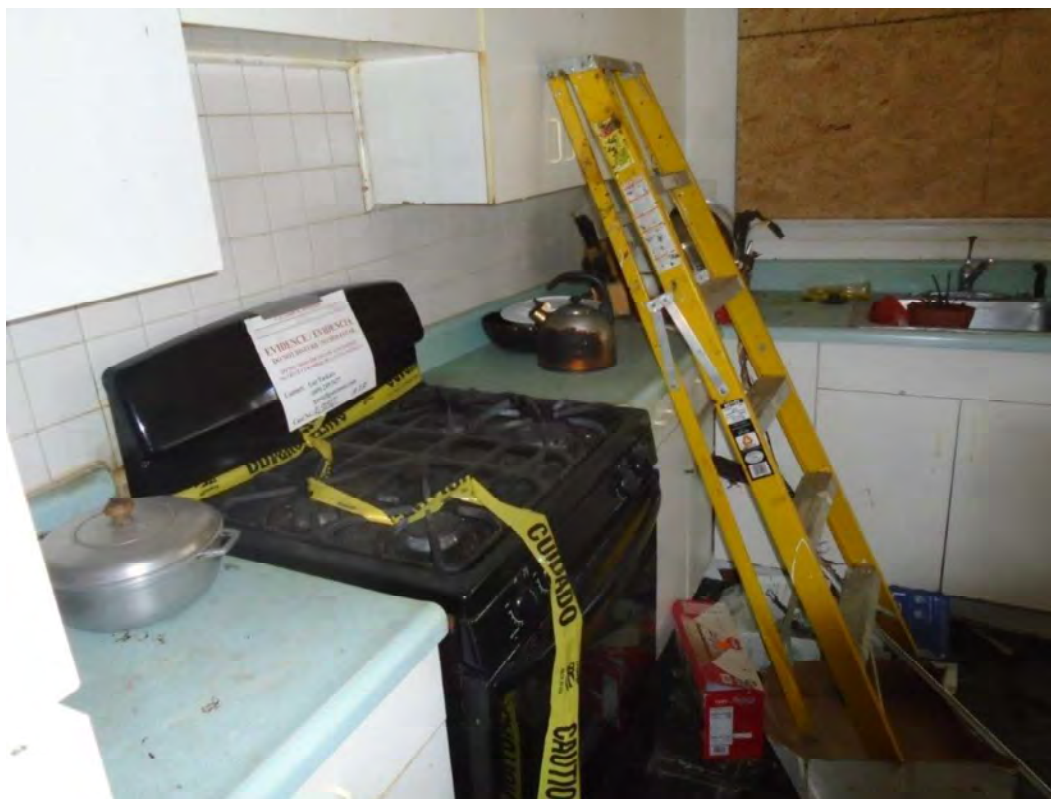
Photograph #9: Kitchen.

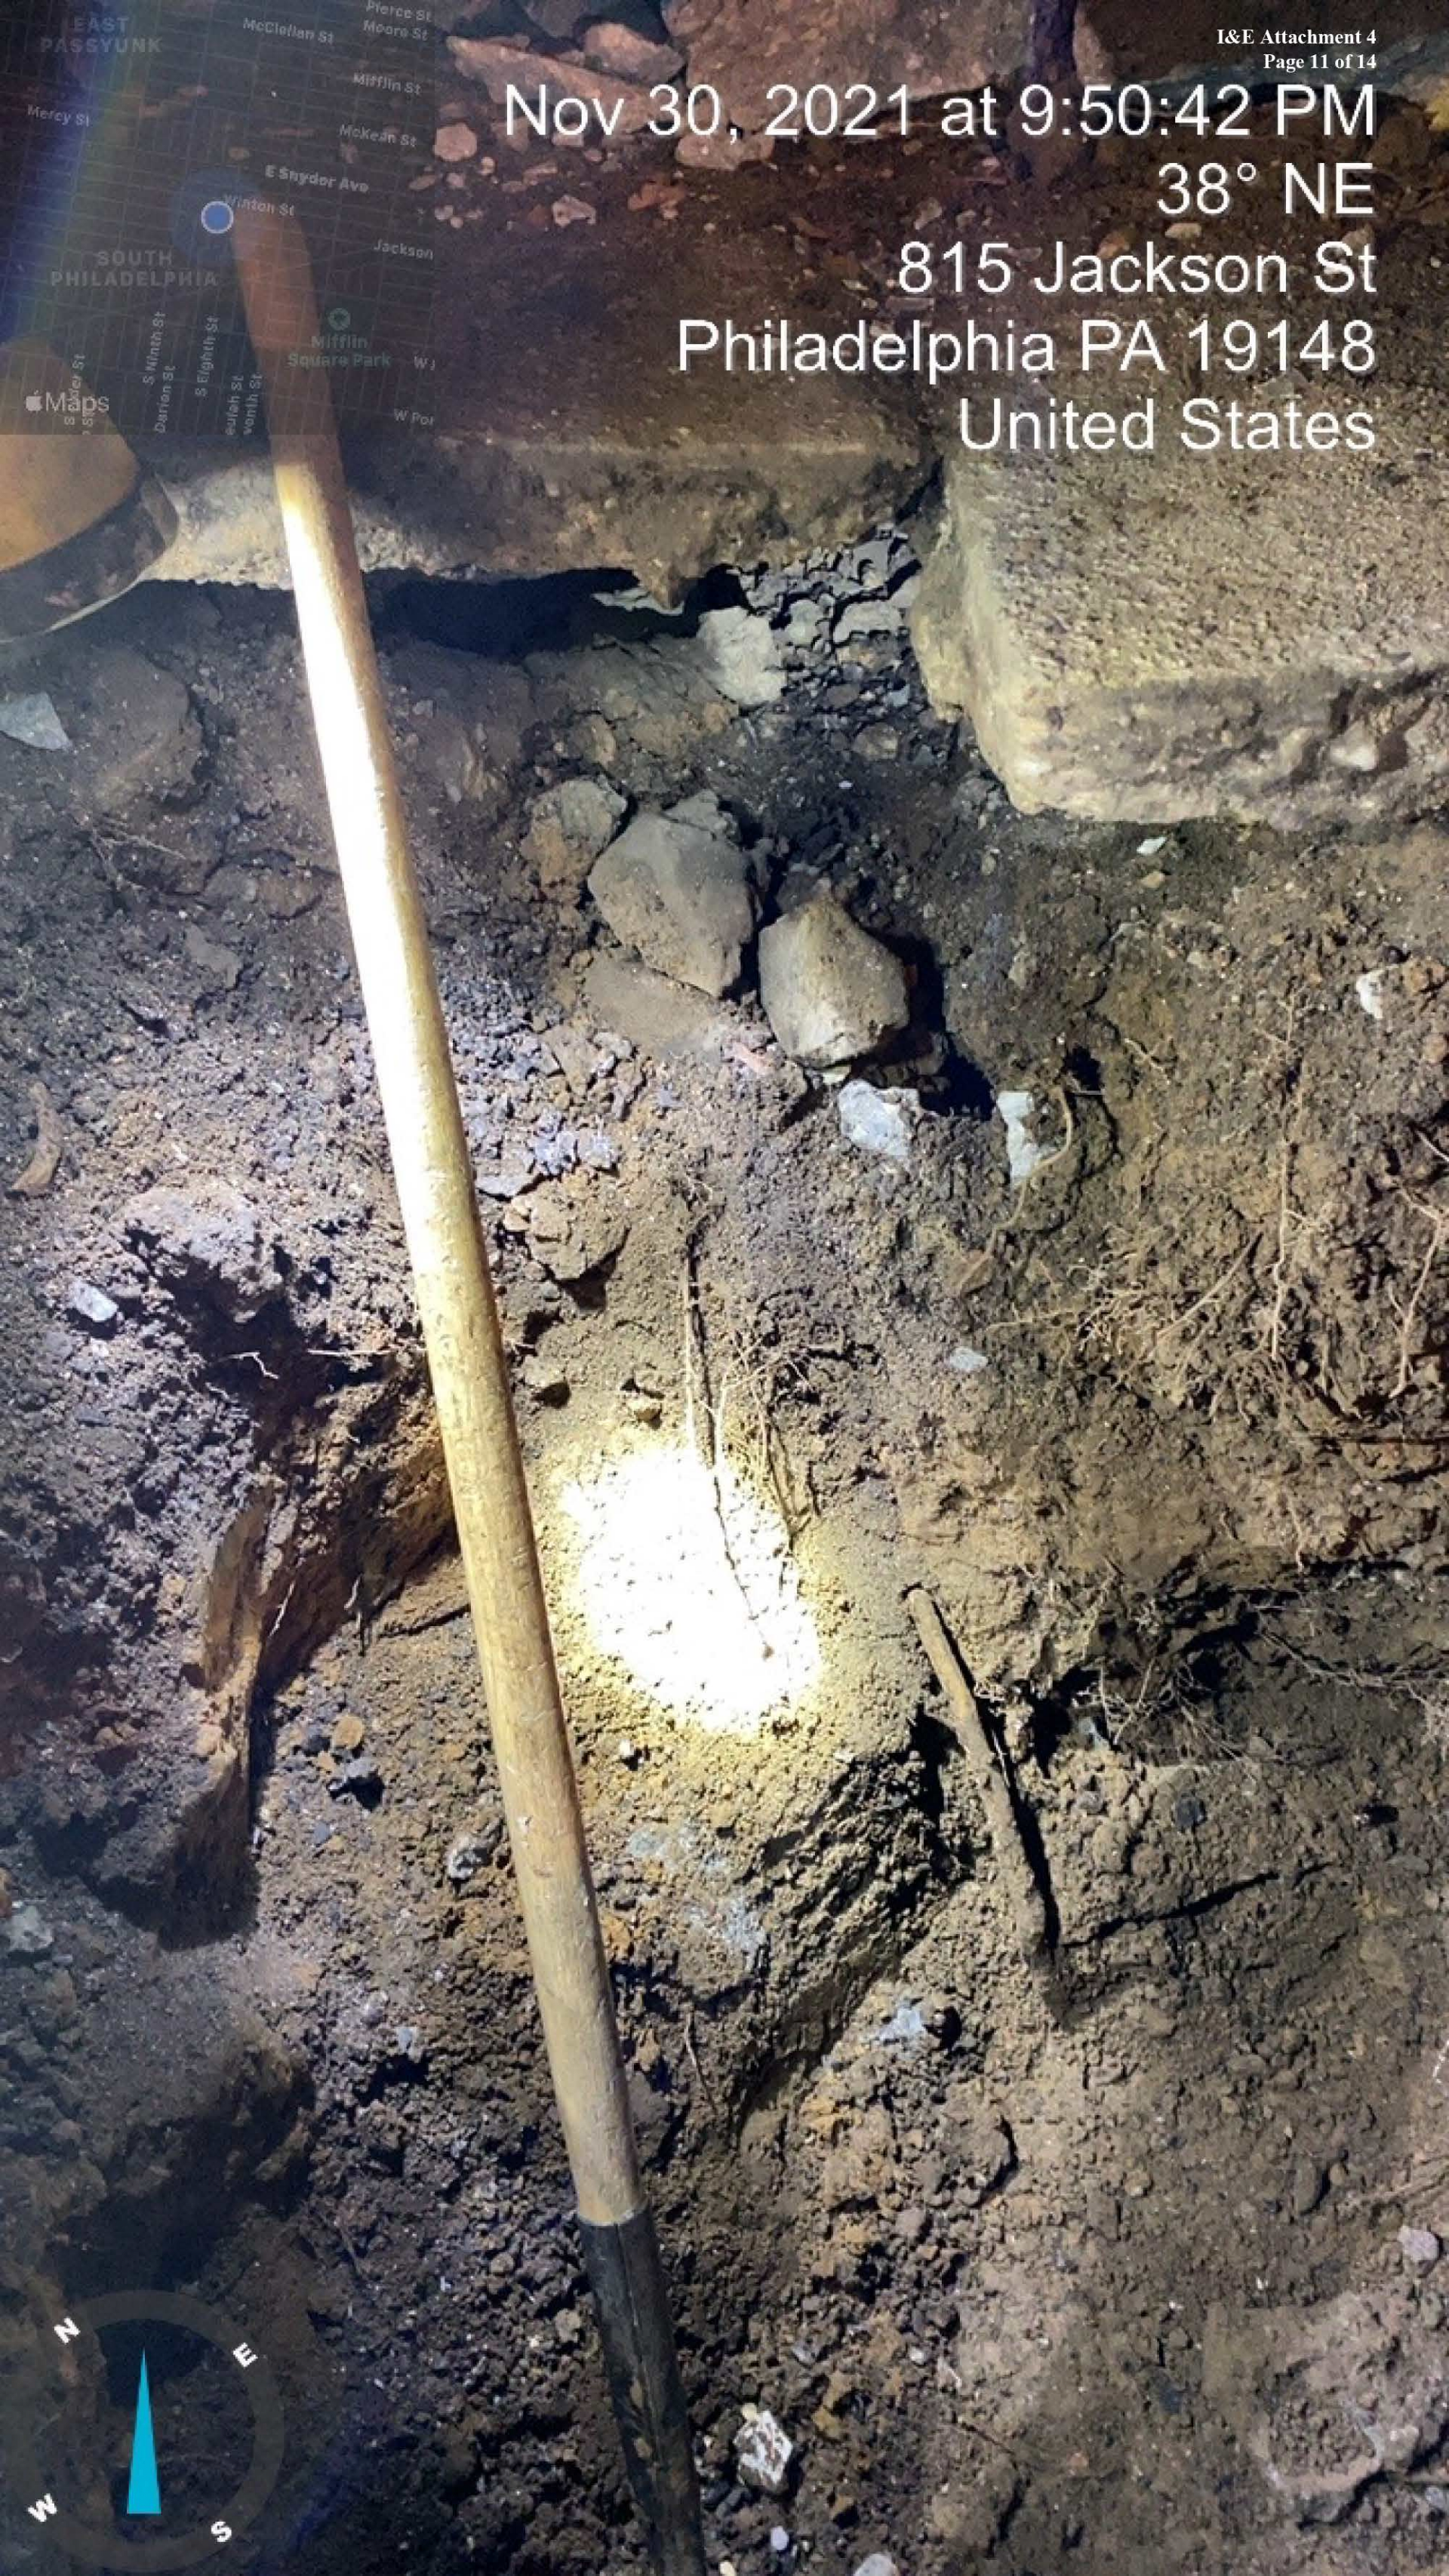
Nov 30, 2021 at 9:50:42 PM  
38° NE  
815 Jackson St  
Philadelphia PA 19148  
United States

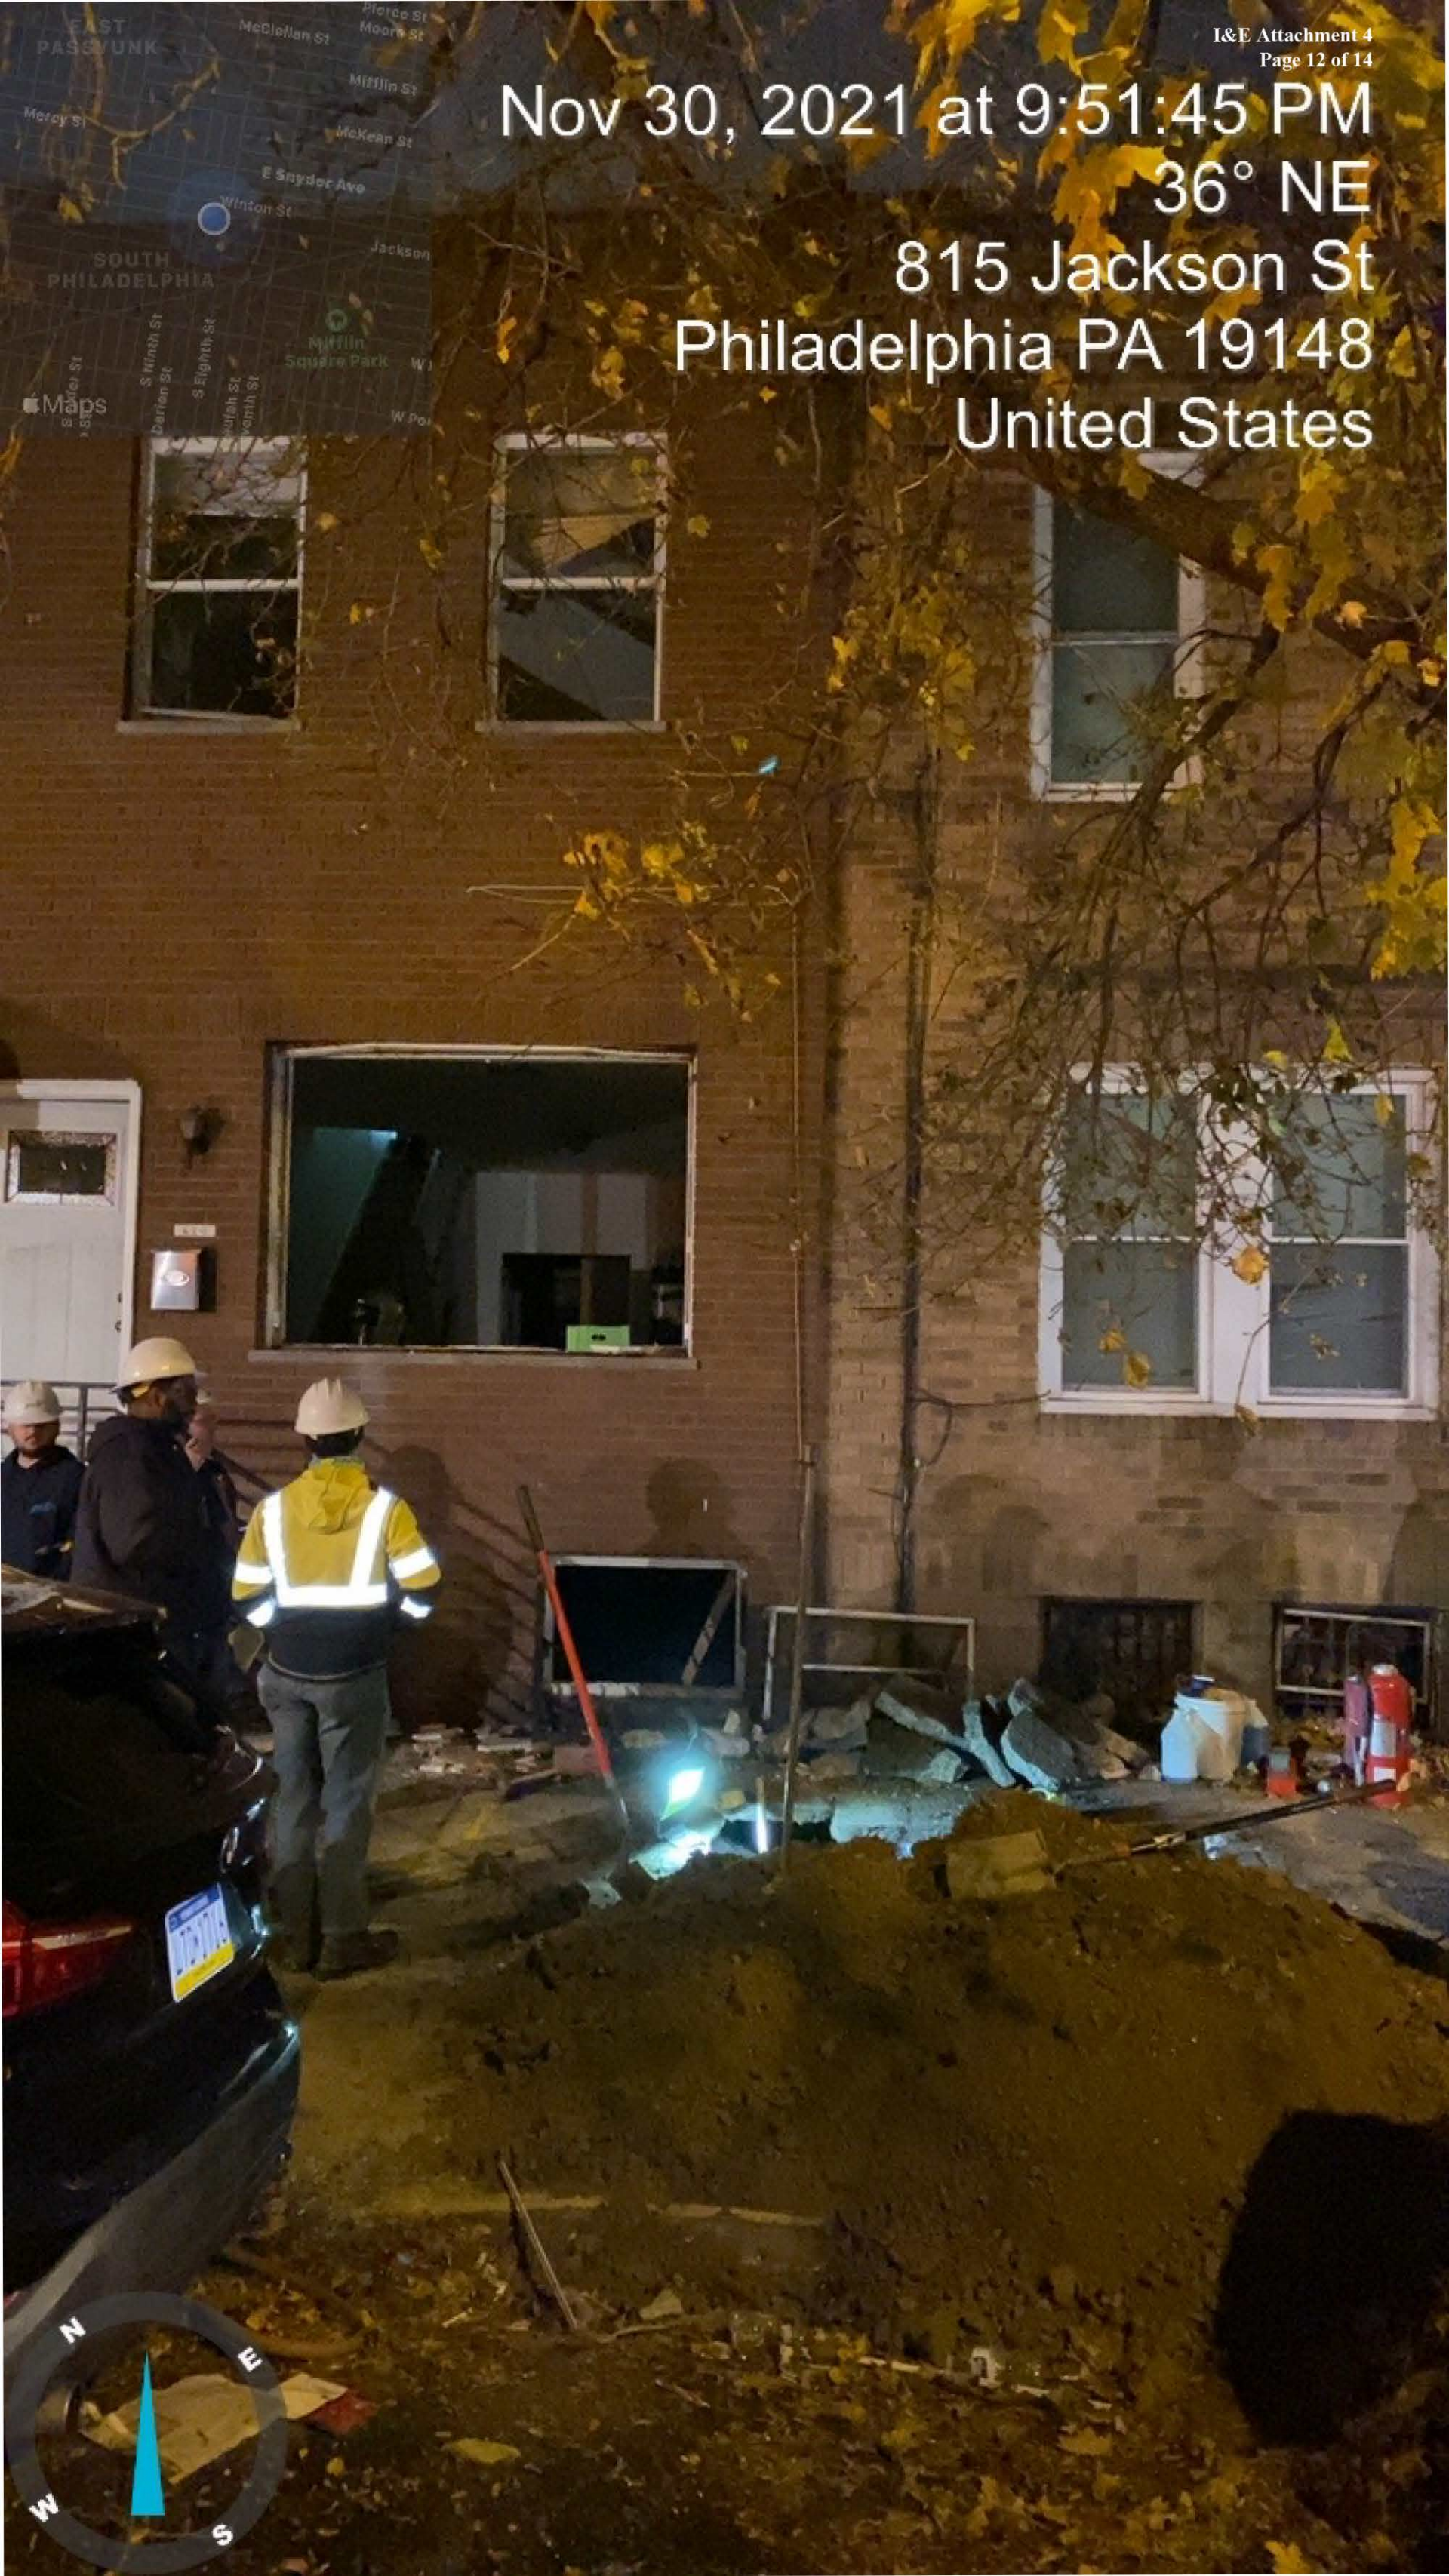
Nov 30, 2021 at 9:51:45 PM  
36° NE  
815 Jackson St  
Philadelphia PA 19148  
United States

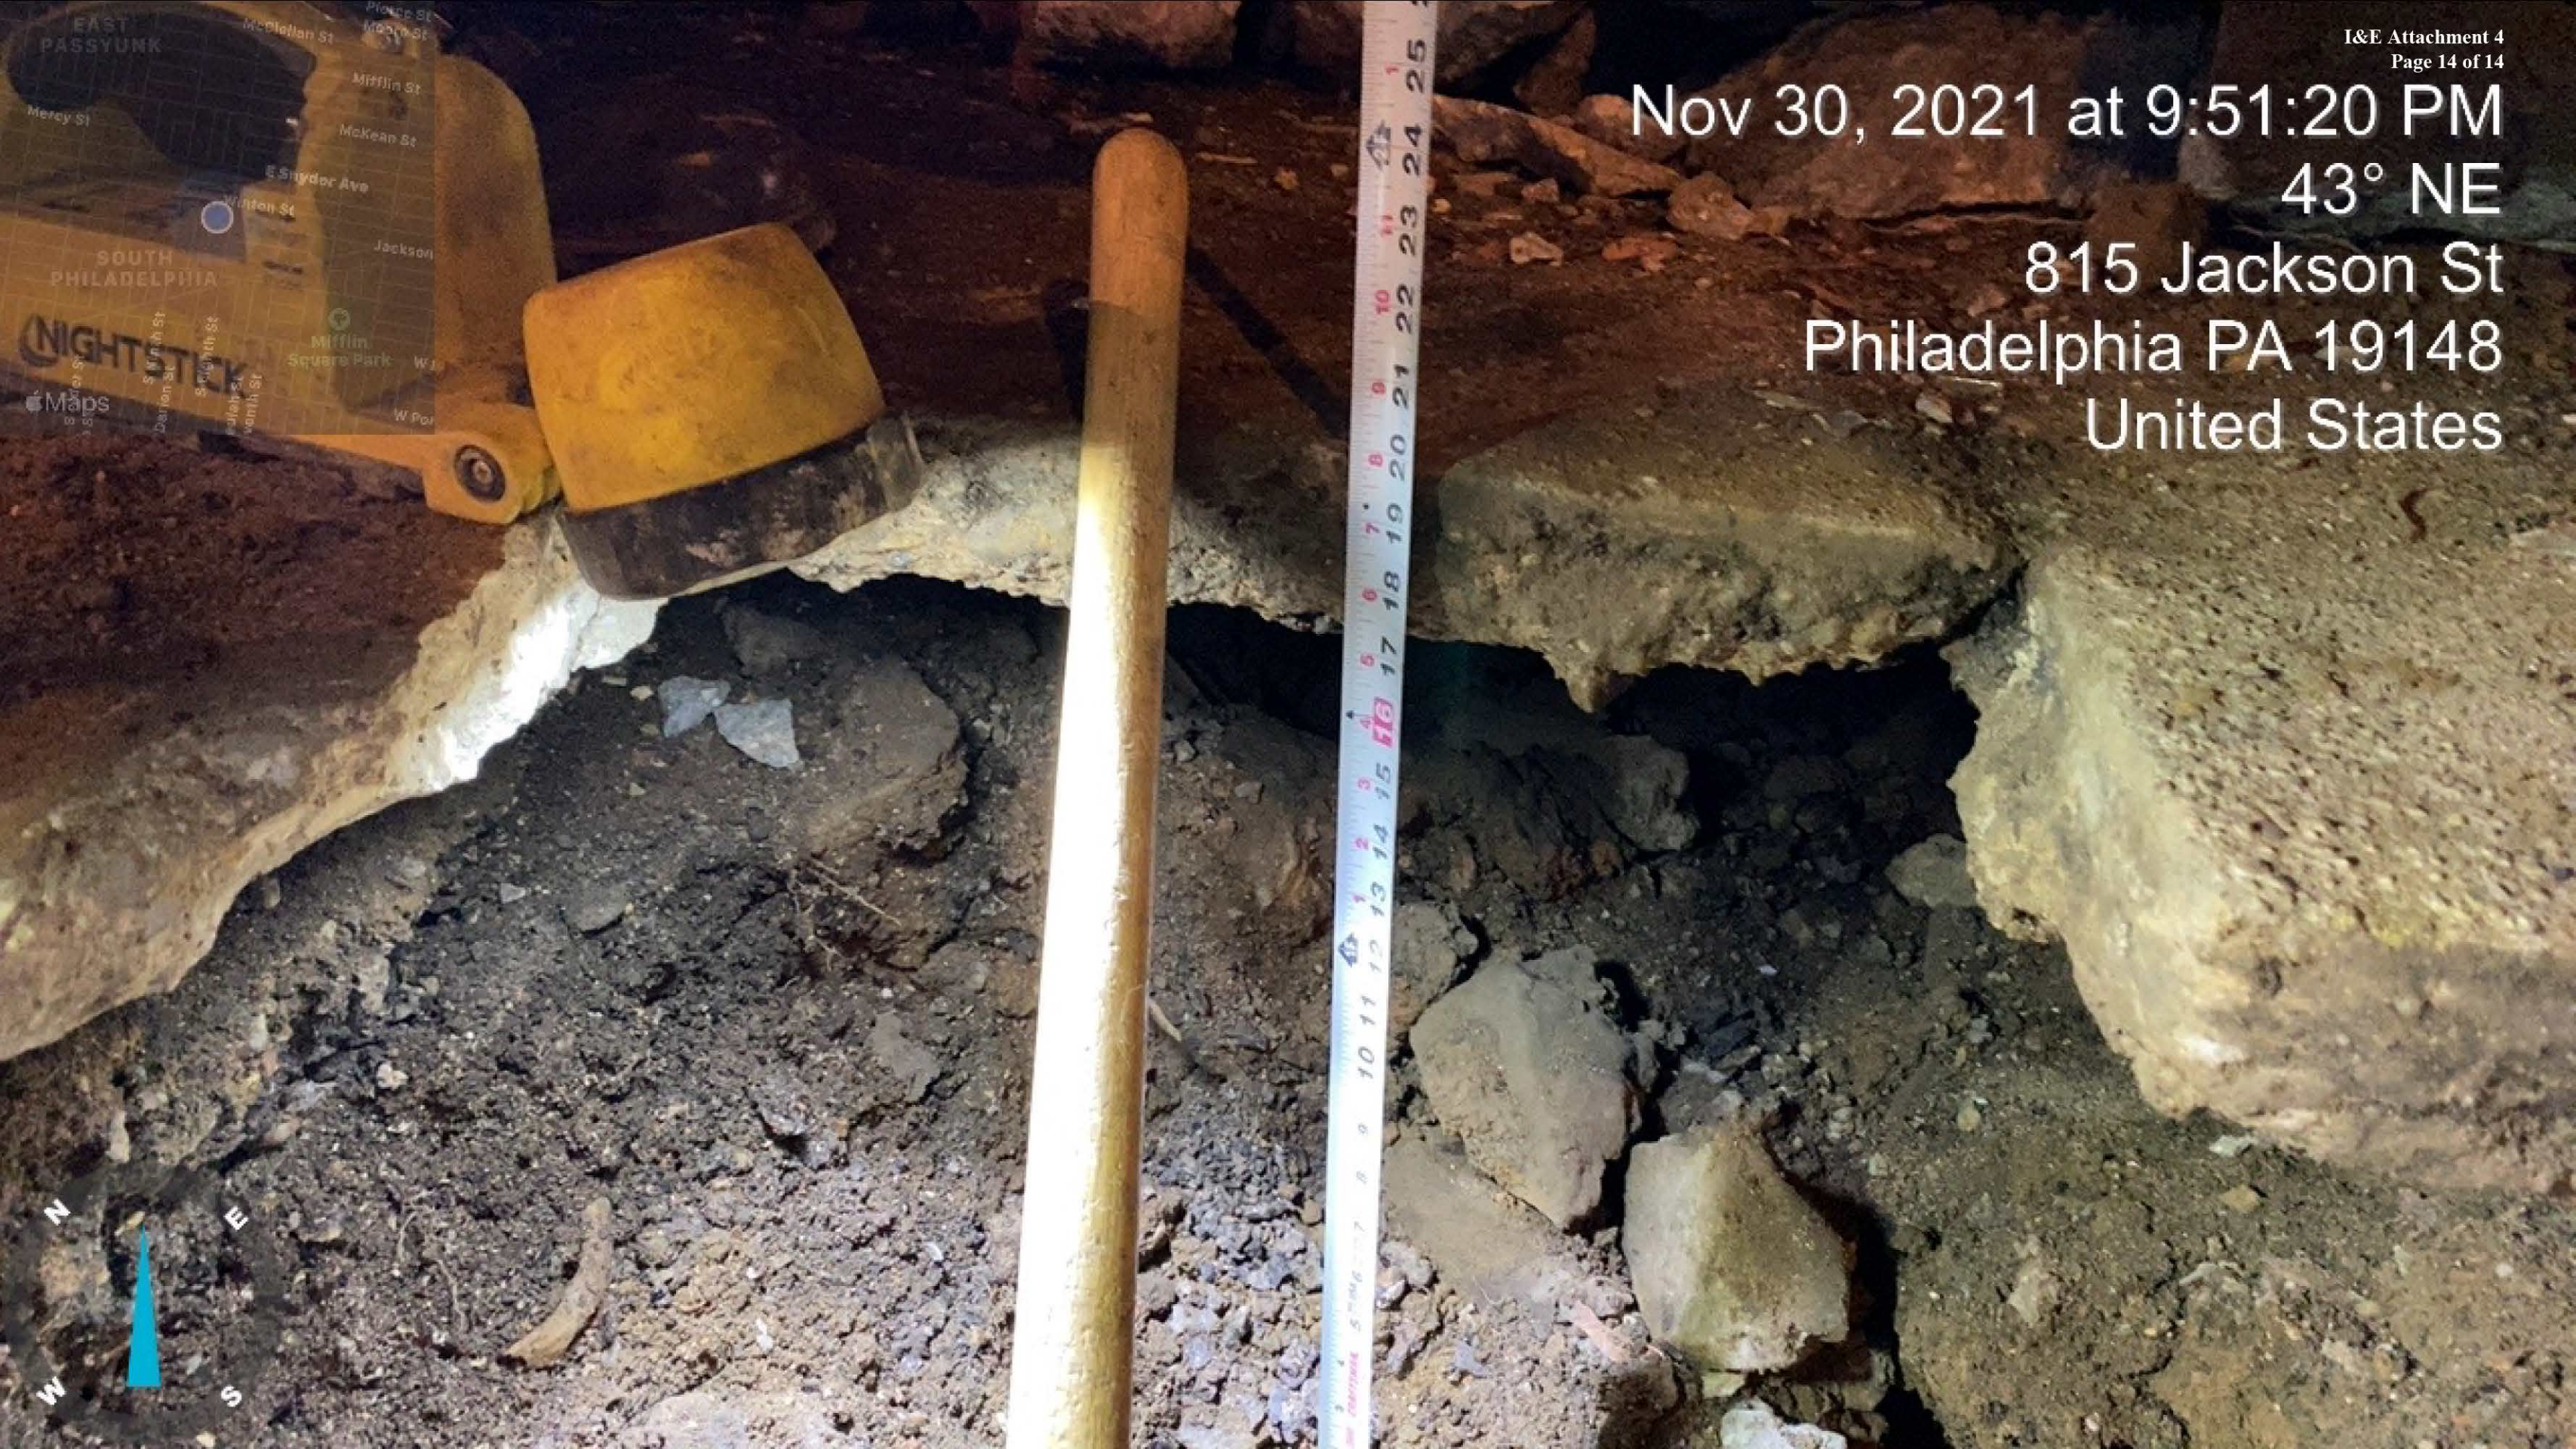
Nov 30, 2021 at 9:51:20 PM  
43° NE  
815 Jackson St  
Philadelphia PA 19148  
United States
